City of Burnsville

Transition Plan

Birnamwood Golf Course

Accessibility Review

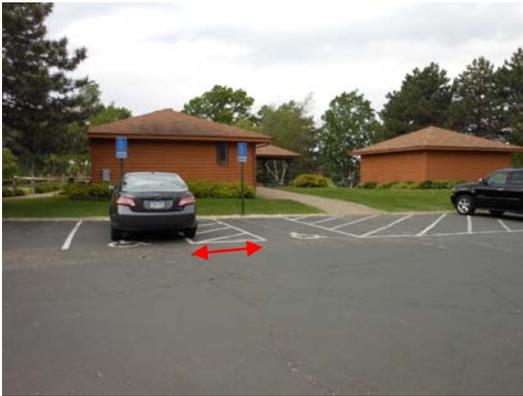
Parking									
05E	14308	Relocate the sign identifying each designated accessible parking stall, so centered at the head end of the parking space and mounted 60"-66" above the floor (measured to the bottom of the sign). MN1341 502.7 <i>The signs are currently at 73".</i>	2	\$250	\$500	3			
05H	14306	Stripe to provide an accessible parking stall that is 8' wide with an adjacent 8' access aisle. It is preferred that the access aisle be located on the passenger side of the vehicle. MN 1341 502.4.2 <i>Currently there is (1) 5' wide aisle and (1) 25' aisle (that aligns with the route to the building). Photo 1.</i>	1	\$150	\$150	3			
				<i>Location Subtotal:</i>		\$650

Photo 1: View of parking. Restripe the parking to provide an 8' wide parking space. Lower the signs to 60"-66" (currently at 73").

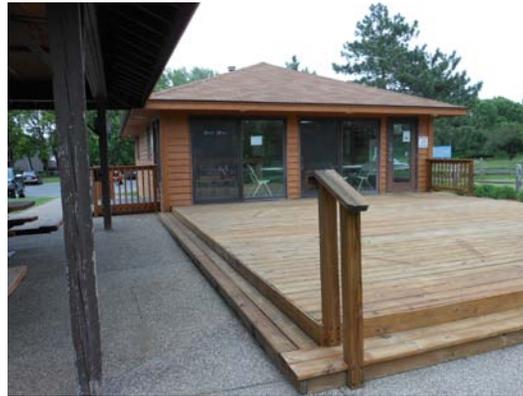
Location	Solution / Comments	Qty	Unit Cost	Total Cost	Priority	Estimated Compl. Date	Person Responsible	Actual Compl. Date	Actual Cost
Clubhouse- Men's Toilet Room									
22C6 (MN)	14294 Relocate the lavatory or enlarge the room to provide a minimum 60" clearance around the water closet, measured perpendicular from the side wall. ANSI 604.3.2 <i>Currently provides 52" clearance on the back wall (versus 60" minimum). No action recommended at this time.</i>	1	\$5,000	\$5,000	4				
Clubhouse- Women's Toilet Room									
22C6 (MN)	14302 Relocate the lavatory or enlarge the room to provide a minimum 60" clearance around the water closet, measured perpendicular from the side wall. ANSI 604.3.2 <i>Currently provides 52" clearance on the back wall (versus 60" minimum). No action recommended at this time.</i>	1	\$5,000	\$5,000	4				
Deck									
08G	14280 Provide an accessible route to an entry. Provide a fully compliant ramp. IBC 1104.1 and 1104.2 <i>There is currently a 9 1/2" rise to the ramp. No action is recommended at this time- an accessible route through the building is available to the deck. Photo 2.</i>	1	\$0	\$0	4

Photo 2: View of the deck. There is an accessible route to the deck through the clubhouse building.

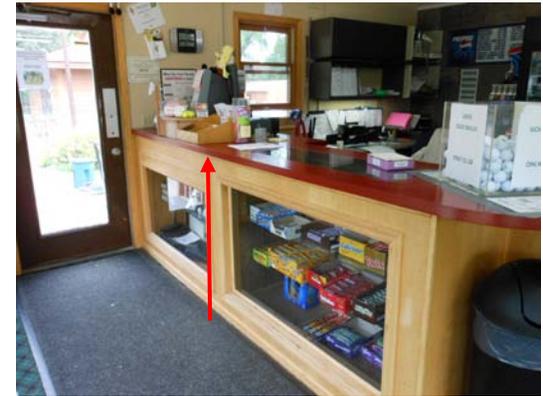
Location	Solution / Comments	Qty	Unit Cost	Total Cost	Priority	Estimated Compl. Date	Person Responsible	Actual Compl. Date	Actual Cost
JQP # / Item #									
Clubhouse- Counter									
21A1	14286 Lower a minimum 36" wide section of counter to a maximum height of 36" above the floor. ICC ANSI 904.3 <i>The counter is currently at 42 1/2". The counter is used for concession sales, retail and checking-in golfers. Photo 3.</i>	1	\$1,000	\$1,000	3				
Clubhouse- Main Entry									
09L	14278 Reconstruct the exterior route to provide a maximum slope of 1:20. ANSI 402.2, Exception 1 <i>The ramp at the main entry currently has a slope of 10.3%. When reconstructing the ramp, provide a 48" clear width (currently 41").</i>	1	\$3,000	\$3,000	3				
Clubhouse- Men's Toilet Room									
22B1	14288 Relocate compliant sign to the wall adjacent to latch side of door, 48" minimum to the baseline of the lowest Braille characters and 60" maximum to the baseline of the highest tactile character. ICC/ANSI 703.3.10, 703.4.5	1	\$40	\$40	3

Photo 3: Lower the service counter in the clubhouse to 36" maximum (currently at 42 1/2").

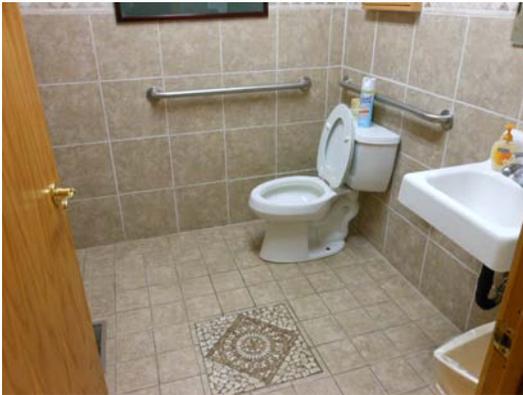
22K6 (MN)	14290 Remove the existing grab bar configuration and replace with a compliant grab bar configuration. MN 1341 604.5.1 ANSI 604.5.2 <i>The side horizontal grab bar is currently 36" long (versus 42" minimum). Photo 4.</i>	1	\$400	\$400	3				
22V	14291 Install a full-height mirror or provide a mirror where the bottom of the reflective surface is no higher than 40" above the floor. MN 1341 603.3 <i>Currently at 50".</i>	1	\$300	\$300	3				
22Z	14295 Provide a coat hook positioned so the highest operable part is no higher than 48". ICC / ANSI 604.11	1	\$50	\$50	3				
				<i>Location Subtotal:</i>	<i>\$790</i>

Photo 4: View of toilet room. Add a vertical grab bar and relocate the toilet paper dispenser to below the side horizontal grab bar.

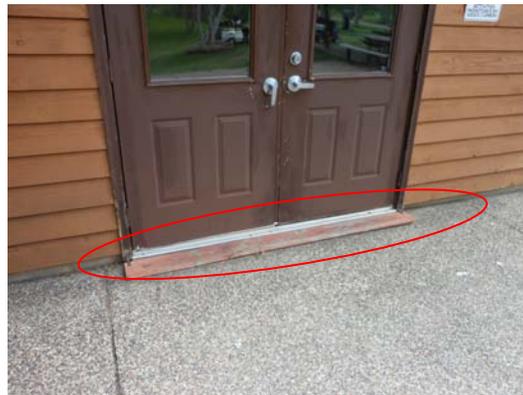
Location	Solution / Comments	Qty	Unit Cost	Total Cost	Priority	Estimated Compl. Date	Person Responsible	Actual Compl. Date	Actual Cost
JQP # / Item #									
Locker Building									
12H	14283	Bevel / replace / reset threshold so there is no abrupt rise greater than 1/2" or slope greater than 1:2. ICC / ANSI 404.2.4 <i>Currently a 2" rise at the threshold. Photo 5.</i>	1	\$200	\$200	3			
24V	14284	In the changing/locker room, provide a bench, 20"-24" deep x 48" long, fixed to the wall or with a back along the longer dimension. The bench is to be mounted 17"-19" above the floor at the accessible dressing room and provide clear floor space at the end of the bench. MN1341 903 <i>Photo 6.</i>	1	\$200	\$200	3			
				<i>Location Subtotal:</i>		\$400			
Maintenance Garage- South Entrance									
20D	14285	Provide door hardware that does not require grasping, pinching or twisting to operate, such as lever. ICC / ANSI 404.2.6	1	\$250	\$250	3

Photo 5: Modify the entry to the locker room building to eliminate the 2" rise at the threshold.

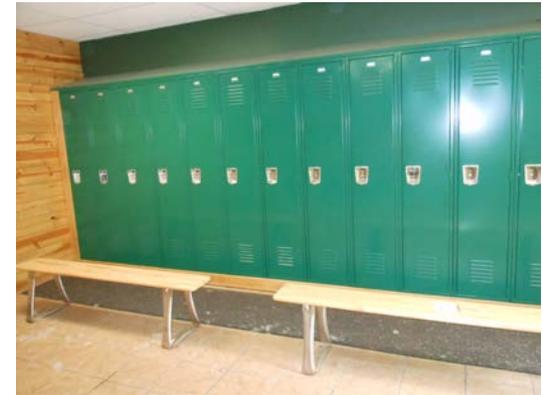
Photo 6: Provide a bench in the locker room that is 20"-24" deep x 48" long, with a back or positioned against the wall.

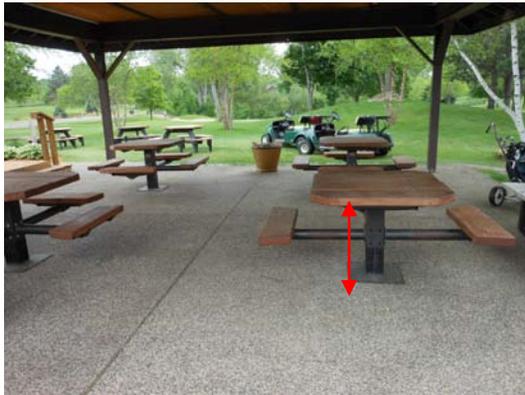
<i>Location Subtotal:</i>					<i>\$740</i>
Deck									
50C	<i>14281</i> Replace some of the picnic table with tables that provide accessible seating positions. IBC 1108.2.8.1 <i>There are 3 tables typically placed on the deck (in grass at the time of site visit due to staining the deck). Currently none of the tables provides knee and toe clearance. Photo 7.</i>	1	\$200	\$200	3

Photo 7: A section of bench has been removed from one of the tables. Currently that location provides 25" knee clearance (versus 27" minimum).

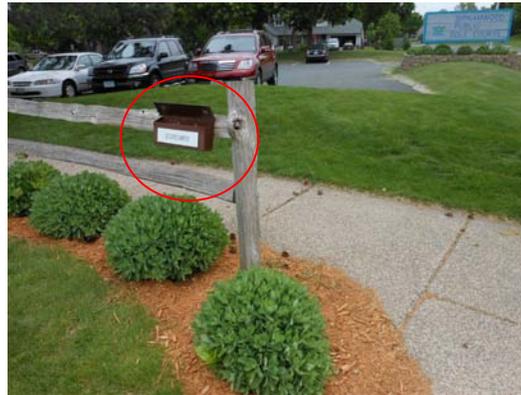
Location JQP # / Item #	Solution / Comments	Qty	Unit Cost	Total Cost	Priority	Estimated Compl. Date	Person Responsible	Actual Compl. Date	Actual Cost
Picnic Tables									
50C 14282	Replace some of the picnic table with tables that provide accessible seating positions. IBC 1108.2.8.1 <i>There are 5 picnic tables positioned under the shade structure- currently 1 of the tables has had a section of bench removed. The section that was removed provides 25" knee clearance (versus 27" minimum).</i>	1	\$200	\$200	3				
Scorecards									
14305	<i>There are scorecards in a mailbox near the 1st hole. There is not currently an accessible route to the scorecards. Relocate to an accessible location. Photo 8.</i>	1	\$50	\$50	3				
				Priority # 3 Total		\$7,320

Photo 8: Relocate the score cards to an accessible location.

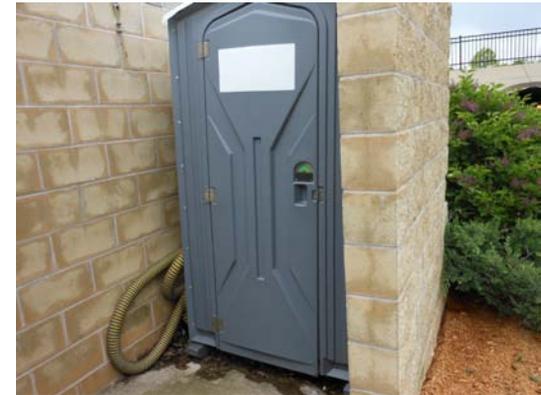
Location	Solution / Comments	Qty	Unit Cost	Total Cost	Priority	Estimated Compl. Date	Person Responsible	Actual Compl. Date	Actual Cost
JQP # / Item #									
Portable Toilet									
64B	14303								
	Renegotiate lease for an accessible portable toilet facility. ADA 213.2 <i>There is a portable toilet located near the 2nd hole. Photo 9.</i>	1	\$150	\$150	4				
				Priority # 4 Total		\$11,650

Photo 9: Provide an accessible portable toilet facility on the golf course.
