City of Burnsville

Transition Plan

City Hall / Police Station

JQP, Inc. Accessibility Consultants

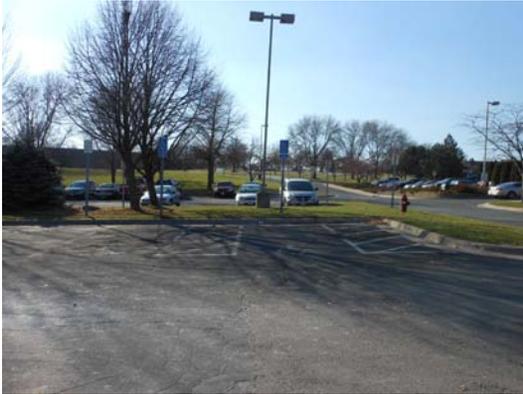
Photo 1: Restripe the accessible parking spaces to provide an 8' wide space with an adjacent 8' wide access aisle.

Location JQP # / Item #	Solution / Comments	Qty	Unit Cost	Total Cost	Priority	Estimated Compl. Date	Person Responsible	Actual Compl. Date	Actual Cost
Parking									
05E 14247	Relocate the sign identifying each designated accessible parking stall, so centered at the head end of the parking space and mounted 60"-66" above the floor (measured to the bottom of the sign). MN1341 502.7 <i>The signs are currently too high.</i>	1	\$250	\$250	4				
05H 14245	Stripe to provide an accessible parking stall that is 8' wide with an adjacent 8' access aisle. It is preferred that the access aisle be located on the passenger side of the vehicle. MN 1341 502.4.2 <i>Currently 2 of the accessible spaces each have 8' aisles, 2 of the accessible spaces each have 6' aisles. Restripe the spaces with 6' aisles so the 2 spaces share an 8' aisle. Photo 1.</i>	2	\$150	\$300	4				
				<i>Location Subtotal:</i>					\$550

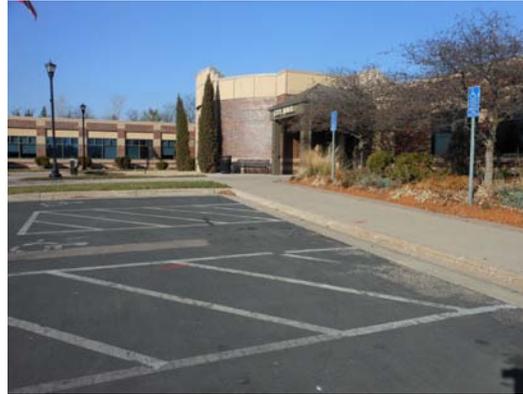
Photo 2: Modify or relocate the parking spaces to eliminate slope (currently up to 5.4% versus 2% maximum).

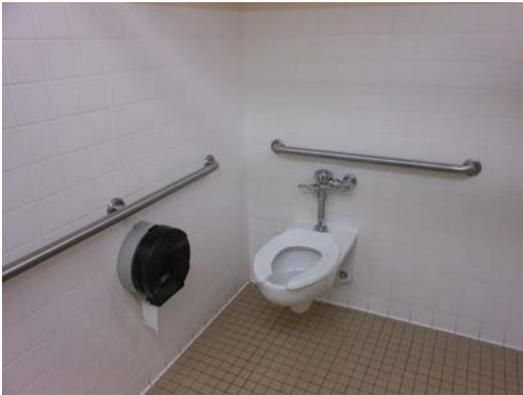
Photo 4: Add a vertical grab bar to the unisex accessible toilet room in the lower level.

Location	Solution / Comments	Qty	Unit Cost	Total Cost	Priority	Estimated Compl. Date	Person Responsible	Actual Compl. Date	Actual Cost
Council Chambers									
26B	14183 Provide a portable assistive listening system with signage. IBC 1108.2.6	1	\$1,200	\$1,200	2				
Large Community Room- 1014									
26B	14182 Provide a portable assistive listening system with signage. IBC 1108.2.6	1	\$1,200	\$1,200	2				
Single User Toilet Room- Lower Level									
22K1 (MN)	14146 Install compliant vertical grab bar on the side wall of the water closet. MN 1341 604.5.1 Photo 4.	1	\$200	\$200	2				
				Priority # 2 Total	\$2,600

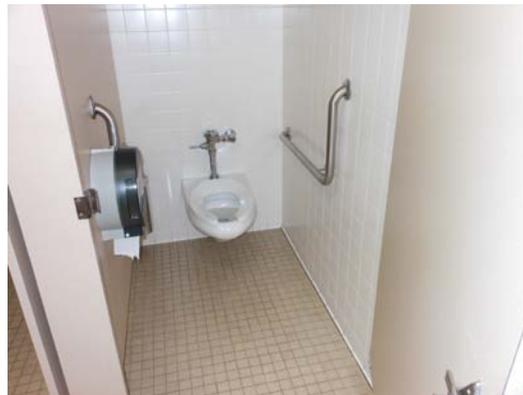
Photo 5: View of typical multi-fixture toilet room. Post a sign at the entry directing to the accessible unisex toilet room in the lower level.

Location	Solution / Comments	Qty	Unit Cost	Total Cost	Priority	Estimated Compl. Date	Person Responsible	Actual Compl. Date	Actual Cost
JQP # / Item #									
Men's Toilet Room- Lower Level									
22A3	14164	Remove the sign displaying the International Symbol of Accessibility as this toilet room is NOT accessible, or is not fully accessible. Install directional signage identifying the location of the nearest accessible toilet room. MN 1341 1110.2 <i>Photo 5.</i>	1	\$50	\$50	1			
Men's Toilet Room- Upper Level									
22A2	14121	Install directional signage to the nearest accessible toilet room. MN 1341 1110.2, 1113.10.3.3 <i>Photo 5.</i>	1	\$50	\$50	1			
Women's Toilet Room- Lower Level									
22A3	14153	Remove the sign displaying the International Symbol of Accessibility as this toilet room is NOT accessible, or is not fully accessible. Install directional signage identifying the location of the nearest accessible toilet room. MN 1341 1110.2 <i>Photo 5.</i>	1	\$50	\$50	1

Women's Toilet Room- Upper Level									
22A2	14103	Install directional signage to the nearest accessible toilet room. MN 1341 1110.2, 1113.10.3.3 <i>Photo 5.</i>	1	\$50	\$50	1			
				Priority # 1 Total	\$200

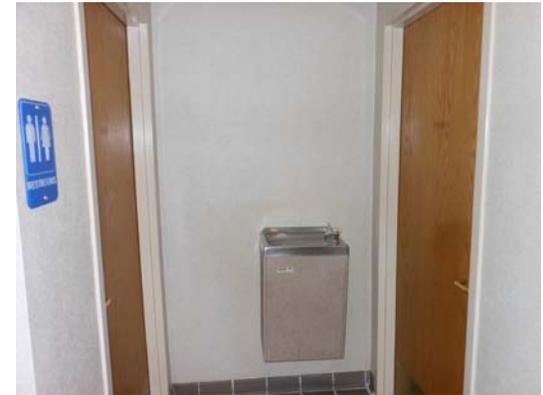
Photo 6: The drinking fountain currently obstructs the maneuvering clearance into the men's and women's toilet rooms on the upper level.

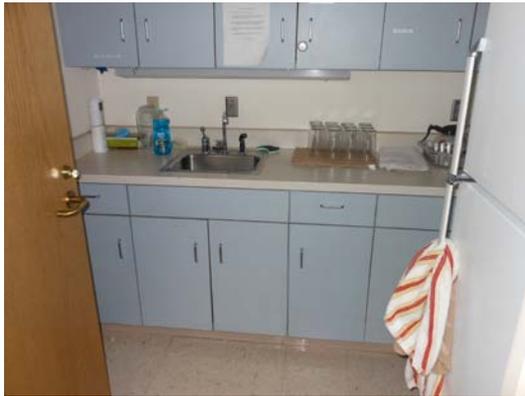
Council Kitchen									
	14113 <i>The kitchen is very small, there is not a 30"x48" clear floor space that is free of the door swing. Consider removing the door from this space.</i>	1			4				
25J1.1	14112 Modify height of sink counter to 34" maximum. ANSI 804.4 <i>Currently at 36". Photo 7.</i>	1	\$1,000	\$1,000	4				
				<i>Location Subtotal:</i>					\$1,000

Photo 7: View of council chambers kitchenette.

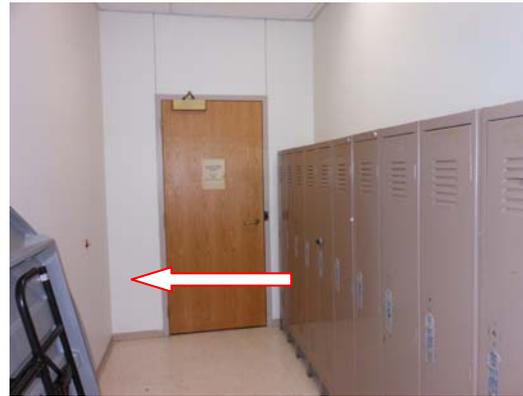
Photo 8: View of exercise room. Relocate the lockers to the opposite side of the hallway to provide 18" maneuvering clearance on the pull side of the door.

Exercise Room- 10046									
20B1	14150	Relocate object to achieve needed maneuvering clearance on the pull side of the door. ICC / ANSI 404.2.3, Table 404.2.3.1 <i>The lockers currently obstruct the maneuvering clearance on the pull side of the door. Relocate the lockers to the other side of the hall. Photo 8.</i>	1	\$50	\$50	3			
67A	14151	Rearrange (or remove) equipment to provide a 30"x48" clear floor space adjacent to 1 of each type of machine or piece of equipment. ADAABAAG 236.1, 1004.1 <i>Photo 9.</i>	1	\$100	\$100	3			
				<i>Location Subtotal:</i>					\$150

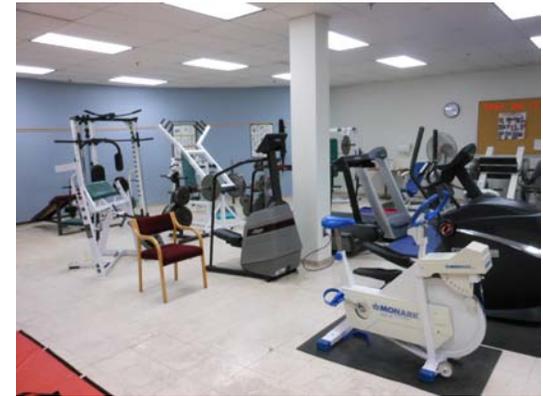
Photo 9: Rearrange the equipment in the exercise room to provide a 30"x48" clear floor space adjacent to 1 of each type of equipment.

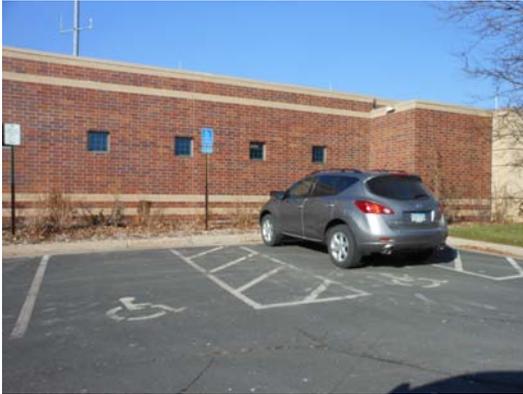
Photo 1: Restripe the accessible parking spaces to provide an 8' wide space with an adjacent 8' wide access aisle (the 2 spaces can share 1 aisle).

05F 14244	Provide a permanent, upright sign that complies with MN Statutes 169.346. MN 1341 502.7	1	\$250	\$250	3				
05H 14243	Stripe to provide an accessible parking stall that is 8' wide with an adjacent 8' access aisle. It is preferred that the access aisle be located on the passenger side of the vehicle. MN 1341 502.4.2 <i>Currently there is 1 5' aisle and 1 6' aisle. Restripe so the 2 accessible parking spaces share an 8' aisle. Photo 1.</i>	1	\$150	\$150	3				
				<i>Location Subtotal:</i>					\$400

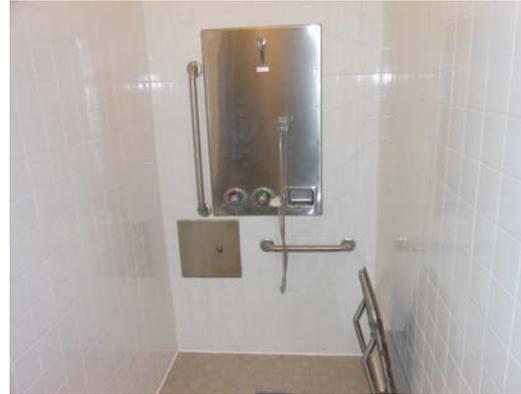
24.1	14194	1	\$10,000	\$10,000	3				
	Provide a fully compliant shower room. IBC 1109.2 <i>The shower room is 47" wide x 42" deep. Photo 2.</i>								
Men's Locker Room- 1060									
22E3	14213	1	\$1,350	\$1,350	3				
	Create a fully compliant 60" minimum wide toilet stall by combining two existing stalls and removing one toilet. Ensure that the new stall provides 48" minimum in front of the toilet, side and rear grab bars, toilet paper dispenser located below the horizontal grab bar, a low coat hook, easily operable stall locking hardware and staple style pulls on both sides of the stall door. MN 1341 604.3.1								
22H1	14216	1	\$50	\$50	3				
	Provide staple style pulls on both sides of the accessible stall door near the latch. ANSI 604.8.3								
22K6 (MN)	14214	1	\$400	\$400	3				
	Remove the existing grab bar configuration and replace with a compliant grab bar configuration. MN 1341 604.5.1 ANSI 604.5.2

Photo 2: View of shower in the holding cells. The room is not wide enough to provide turning space.

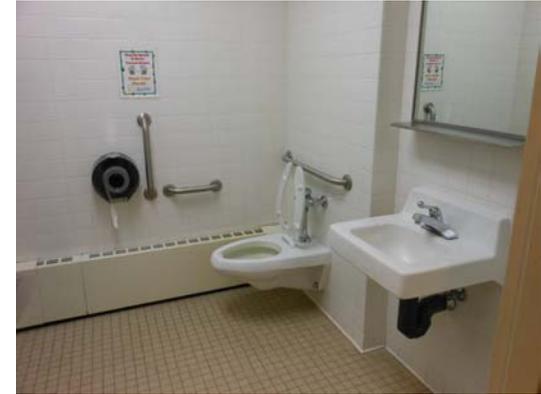
Photo 3: View of men's toilet room in the lobby. Replace the side wall grab bars. Convert this location to a unisex accessible toilet room.

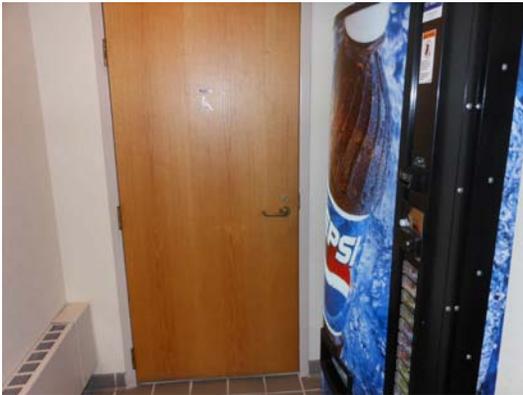
Photo 4: View of entry to the men's toilet room in the lobby. Add a raised and braille sign adjacent to the door. Relocate (or remove) the vending machine that currently obstructs the approach to the toilet room door.
