Acorn

Activities / Amenities

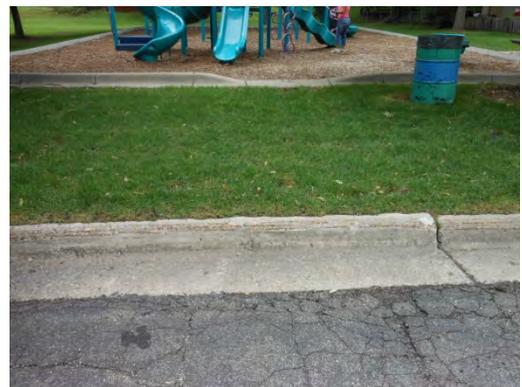
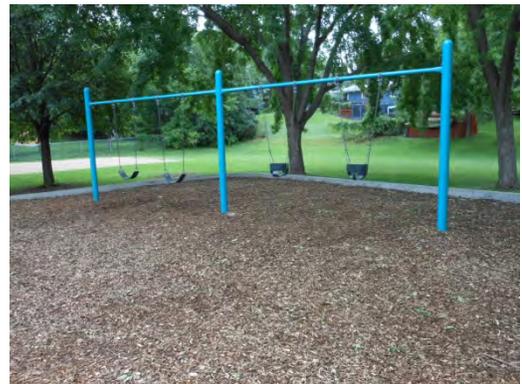
Defined Play Area

The defined play area includes 1 composite play structure, to-fro swings and a rocker. Engineered wood fiber surface material is used throughout. There is not currently a route from the street to the entry to the defined play area.

Priority 2- Ensure the loose fill surface material is maintained to provide an accessible surface material. *ADA 206.2.17*

Priority 2- Create an accessible route to the entry to the defined play area. (Approximately 15') *ADA 206.2.17*

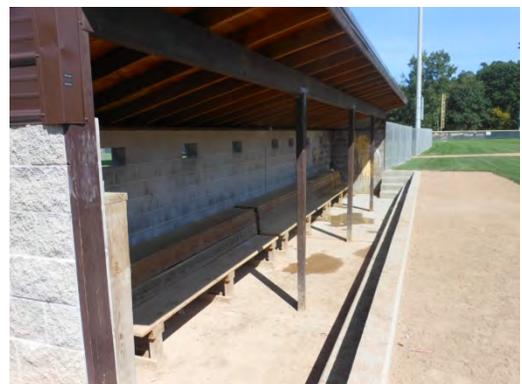
Team Seating- Fields A, B, West and Northeast

The team/player seating provides fixed benches with room for a wheelchair position adjacent.

No recommendations at this time.

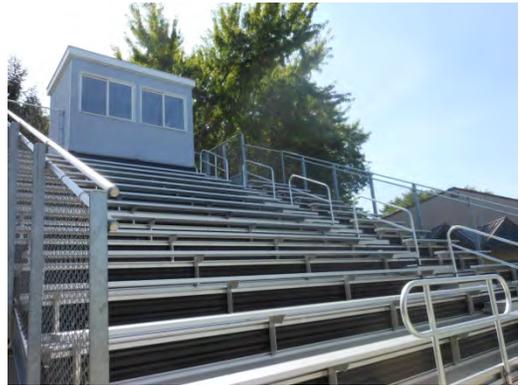
Spectator Seating- Bob Bunnell Field

There are 4 bleachers positioned on asphalt behind the backstop. There is some room for wheelchair positions adjacent to the bleachers, but not integrated.

Priority 3- At such time the bleachers are replaced, provide the required number of wheelchair spaces. *ADA 221.2.1*

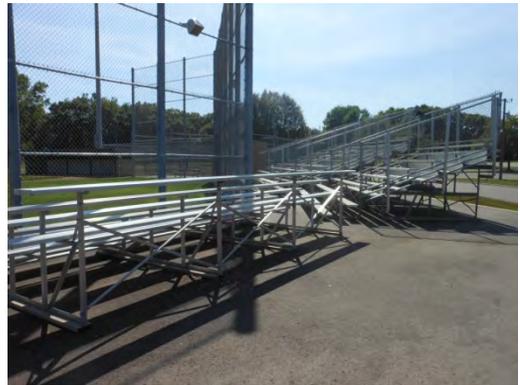
Spectator Seating- Bob Bunnell Field

The accessible route to the wheelchair positions (and to the bleachers in general) is tight. There is also a corner of the bleacher that protrudes 24" at a height of 56".

Priority 3- Modify the bleacher system, or reposition, to eliminate the protruding hazard. *ADA 307*

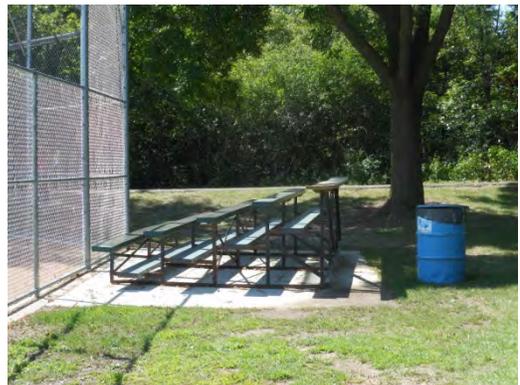
Route- Field A

There is not currently an accessible route to the spectator seating. A curb cut and compacted gravel is provided to the field and player seating areas.

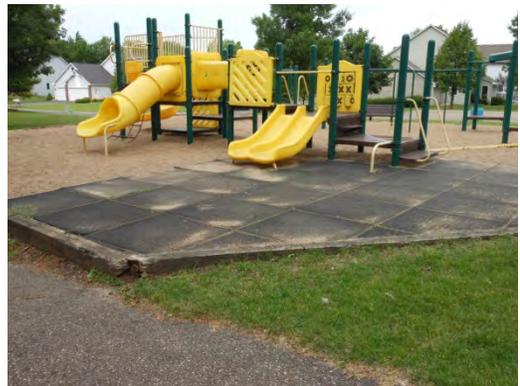
Equipment

The playground includes 1 composite structure with a transfer system as well as 2 different types of ground level events (tire swing and to-fro swing). There are 12 elevated events on the composite structure.

Priority 3- At such time equipment is added or replaced at this location, ensure additional ground level events are provided and are located on an accessible route. Based on the total number of elevated events (12) a total of 4 ground level play events are required. *ADA 240.2.1.2*

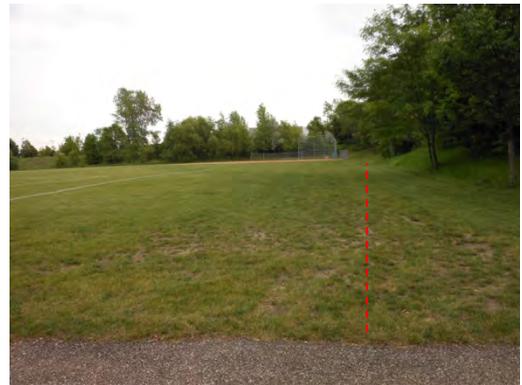
Access to field

There are fences that reduce the opening onto the field from the player seating. The opening is currently 35" wide for a distance of 36".

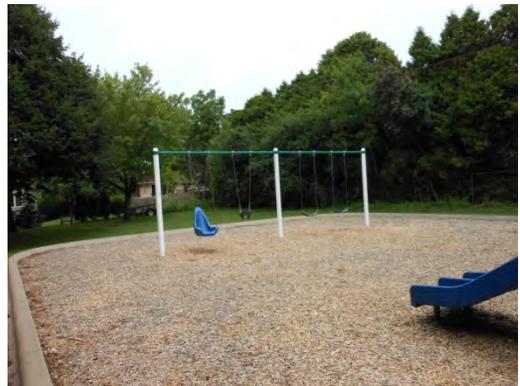
Route

An accessible route is provided to the defined play area. Currently the trash container is blocking the entry.

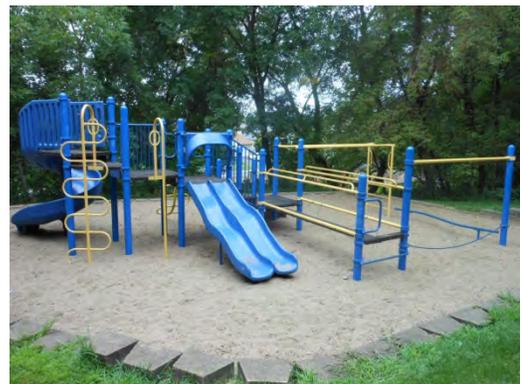
Equipment

There is a composite play structure with a transfer system.

Priority 3- At such time equipment is added or replaced at this location, ensure additional ground level events are provided and are located on an accessible route. *ADA 240.2.1.2*

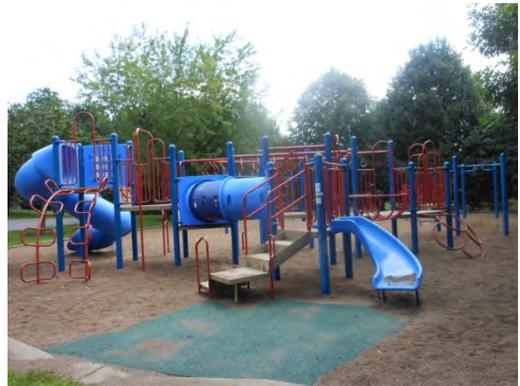
Route

The defined play area is located near the accessible route, but is not connected.

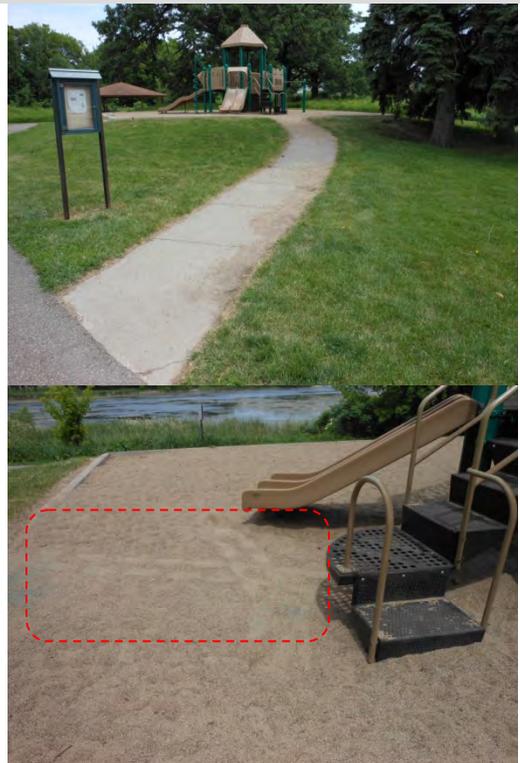
Equipment

The playground includes 1 composite structure with 14 elevated events and 5 ground level events.

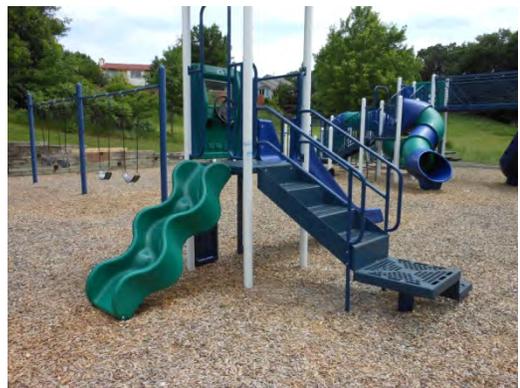
Route

An accessible route is provided to the defined play area. Currently the trash container is blocking the entry.

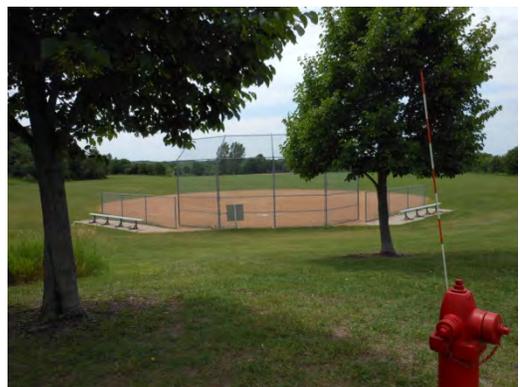
Field 1

There are fences that reduce the opening onto the field from the player seating. The opening is currently 34" wide for a distance of 36".

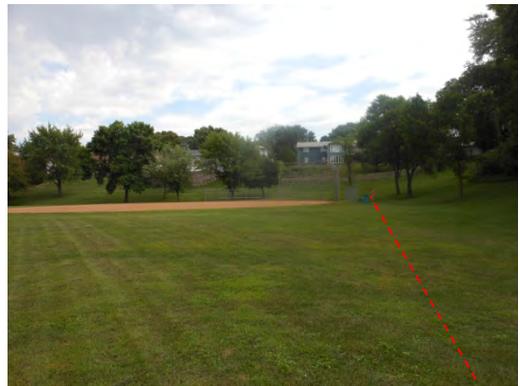
Access to field- Field 2

There are fences that reduce the opening onto the field from the player seating. The opening is currently 32" wide for a distance of 36".

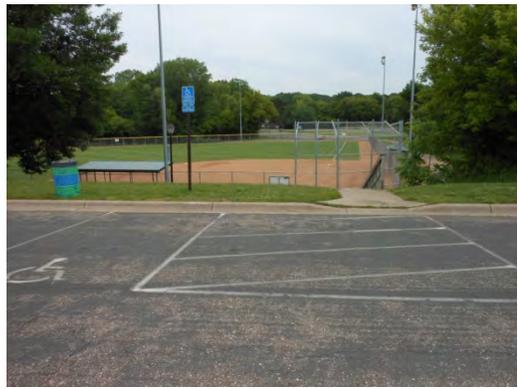
Parking- West

There are 142 parking spaces in the west parking lot, including 5 designated as accessible. Currently 2 of the accessible parking spaces are located on the north end of the lot; 3 of the accessible parking spaces are at the south end of the parking space. Two of the spaces at the south end share a 5' wide aisle, one of the spaces has a pie shaped aisle that is 2' wide at the head end.

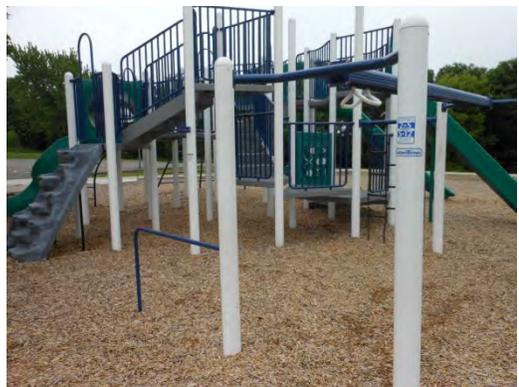
Defined Play Area- Smaller

The defined play area includes 1 composite play structure, to-fro swings and a rocker. Engineered wood fiber surface material is used throughout. There is not currently a route to the entry to the defined play area.

Priority 2- Create an accessible route to the entry to the defined play area. (Approximately 15') *ADA 206.2.17*

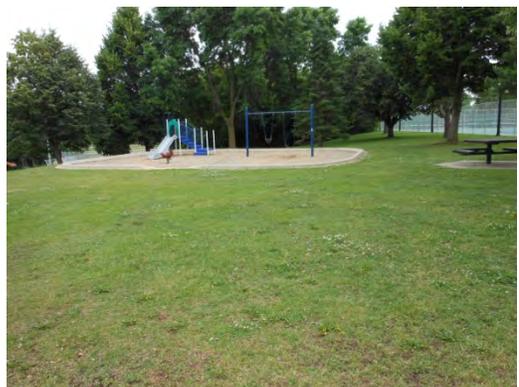
Equipment- Smaller

The playground includes 1 composite structure with 3elevated events. There is also a 2 position to-fro swing with 1 strap swing and 1 tot swing and a ground level spring rocker.

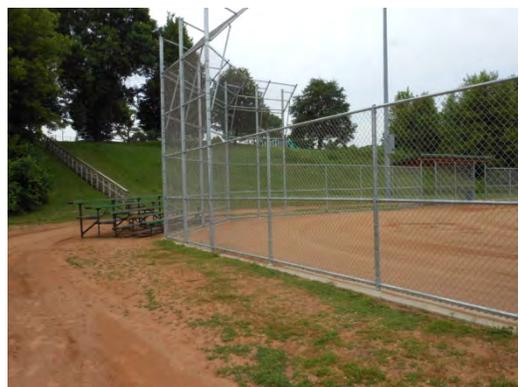
Route- Field 2

There is not currently an accessible route to the field or the player seating. A dirt/gravel road runs along the 3rd base side of the field (muddy at the time of site visit).
