City of Burnsville

Transition Plan

Parking Ramp

JQP, Inc. Accessibility Consultants

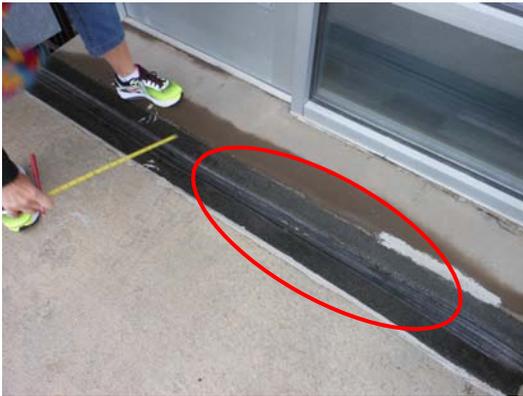
Photo 1: There is a gap along the accessible route at the entry to the elevator lobby.

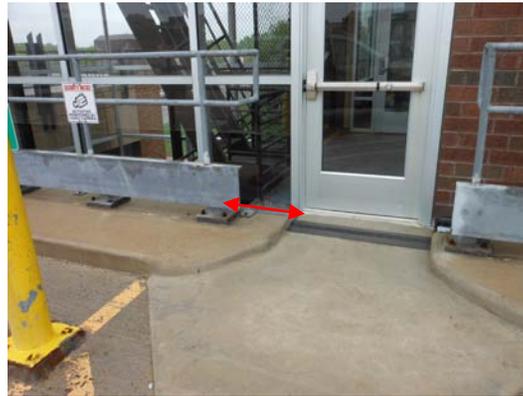
Photo 2: The entries to the west elevator lobbies do not currently have maneuvering clearance on the 'push' side of the door (extending 12" beyond the latch).

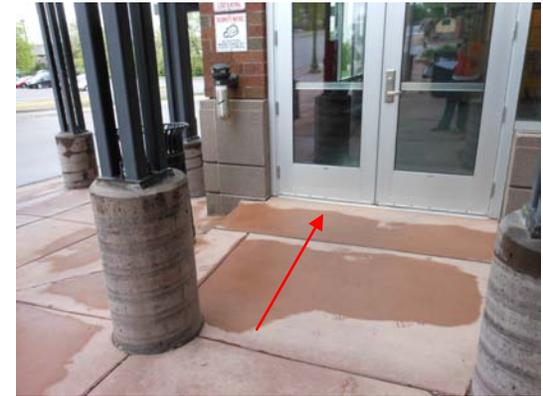
08B	<i>14331</i>	Modify walkway to provide a maximum 1:20 (5%) slope. MN 1341 403.5.3 <i>Currently 6.8% between the bottom of the ramp and the shelter/toilet room area.</i>	1	\$10,000	\$10,000	3			
12B1.1	<i>14330</i>	Modify the slope of the area necessary for maneuvering clearance to ensure there is no slope greater than 2% (1:48) in any direction. ICC / ANSI 304.2 <i>Currently at 5.6%. Photo 3.</i>	1	\$2,000	\$2,000	3

Photo 3: The entry to the west ground level elevator lobby (also transit shelter and toilet rooms) currently has a slope of 5.6% (versus 2% maximum).

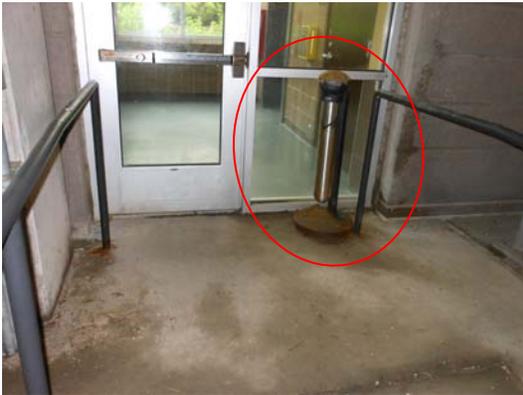
20B3	<i>14322</i>	Relocate object to achieve needed maneuvering clearance on the pull side of the door. ICC / ANSI 404.2.3, Table 404.2.3.1 <i>Relocate the cigarette disposal so it does not obstruct the clearance at the door. Photo 4.</i>	1	\$50	\$50	3			
-------------	--------------	--	---	------	------	---	--	--	--

Photo 4: Relocate the cigarette disposal so it does not obstruct maneuvering clearance at the ground level east elevator lobby.

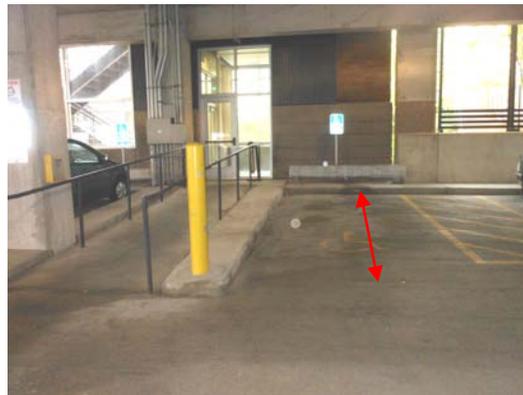
Location JQP # / Item #	Solution / Comments	Qty	Unit Cost	Total Cost	Priority	Estimated Compl. Date	Person Responsible	Actual Compl. Date	Actual Cost
Parking- Ground East									
05F 14337	Provide a permanent, upright sign that complies with MN Statutes 169.346. MN 1341 502.7 <i>Currently 3 of the spaces to the south of the elevator lobby are marked on the surface but do not have signs.</i>	3	\$250	\$750	3				
05H 14336	Stripe to provide an accessible parking stall that is 8' wide with an adjacent 8' access aisle. It is preferred that the access aisle be located on the passenger side of the vehicle. MN 1341 502.4.2 <i>Currently 2 of the spaces (to the north of the elevator lobby) share an 8' wide aisle; the 4 spaces to the south of the elevator lobby have 5' wide aisle.</i>	1	\$150	\$150	3				
05N 14335	Alter the slope of the accessible parking stall and / or access aisle to be no greater than 1:48 (2%) in any direction. ICC / ANSI 502.5 <i>The parking space to the south of the elevator lobby currently has a running slope of 5.6%. Cost for corrective action unknown. Photo 5.</i>	1	\$0	\$0	3

Photo 5: Modify the slope of the parking space and aisle so it does not exceed 2% (currently 5.6%).

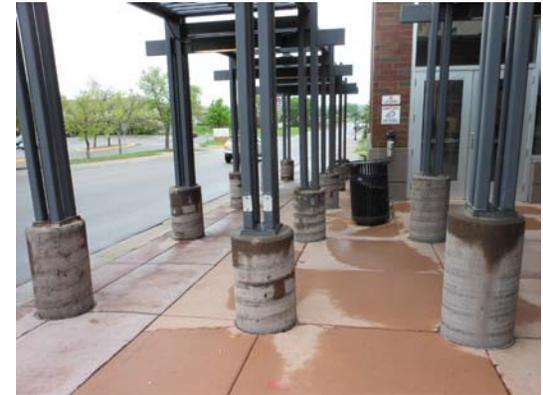
11C	<i>14345</i>	Provide compliant signage identifying the accessible route. MN1341 1110.6 <i>Post a sign regarding the accessible route to the Performing Arts Center. A pedestrian route is not provided from the north entrance (only a vehicle route). The route along Pillsbury Ave is as steep as 7.6% (follows the grade of the street). Note: accessible parking is also provided at the parking deck to the north of the PAC. Photo 6.</i>	1	\$50	\$50	3			
------------	--------------	--	---	------	------	---	--	--	--

Photo 6: The pedestrian route from the parking ramp to the PAC is along the city sidewalk adjacent to Pillsbury Ave, which has a slope of up to 7.6%. Post a sign identifying the pedestrian route to the PAC as well as noting that additional accessible parking is available at the parking deck north of the PAC.

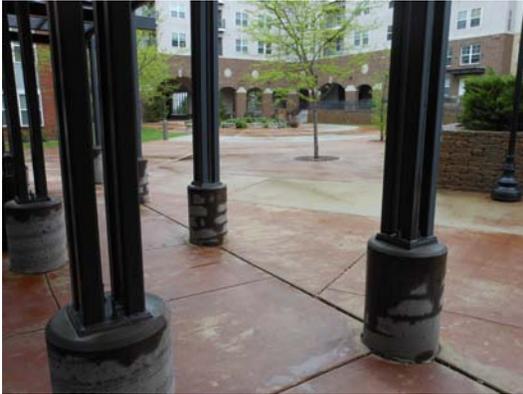
08D1	<i>14323</i>	Modify / replace existing surface material to eliminate changes in level greater than 1/2". ANSI 303.2, Figure 303.2 <i>The plaza to the east of the parking ramp does not currently provide an accessible route as the sections of concrete have shifted. (Verify if city or owner responsibility.) Photo 7.</i>	1	\$1,000	\$1,000	4			
-------------	--------------	---	---	---------	---------	---	--	--	--

Photo 7: The plaza to the east of the parking ramp currently has an uneven surface with changes in level exceeding 1/2" where the sections of concrete come together. (Verify if this is city or owner responsibility.)

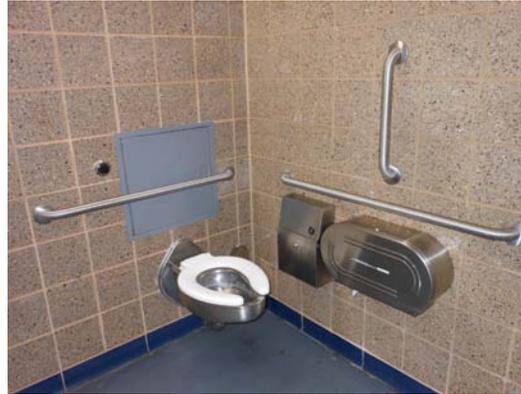
Photo 8: View of toilet room provided on the ground level of the west elevator lobby. *This is a good example of accessibility.*

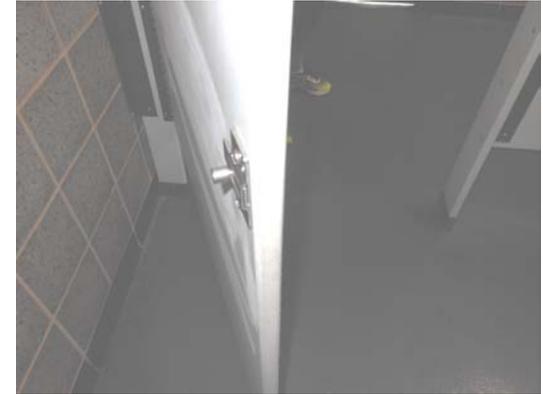
<i>Location Subtotal:</i>					<i>\$300</i>
Men's Toilet Room									
22H1 14327	Provide staple style pulls on both sides of the accessible stall door near the latch. ANSI 604.8.3 <i>Photo 9.</i>	1	\$50	\$50	3				
22Q 14329	Insulate or otherwise protect exposed pipes at lavatory. ICC / ANSI 606.6	1	\$50	\$50	3				
22Z 14328	Provide a coat hook positioned so the highest operable part is no higher than 48". ICC / ANSI 604.11	1	\$50	\$50	3				
				<i>Location Subtotal:</i>					<i>\$150</i>

Location	Solution / Comments	Qty	Unit Cost	Total Cost	Priority	Estimated Compl. Date	Person Responsible	Actual Compl. Date	Actual Cost
Women's Toilet Room									
22H1	14324 Provide staple style pulls on both sides of the accessible stall door near the latch. ANSI 604.8.3 <i>Photo 9.</i>	1	\$50	\$50	3				
22Q	14326 Insulate or otherwise protect exposed pipes at lavatory. ICC / ANSI 606.6	1	\$50	\$50	3				
22Z	14325 Provide a coat hook positioned so the highest operable part is no higher than 48". ICC / ANSI 604.11	1	\$50	\$50	3				
				<i>Location Subtotal:</i>					<i>\$150</i>
									Priority # 3 Total \$15,150

Photo 9: Provide pull style hardware on both sides of the stall door in the toilet rooms.
