City of Burnsville

Transition Plan

The Garage

Accessibility Review

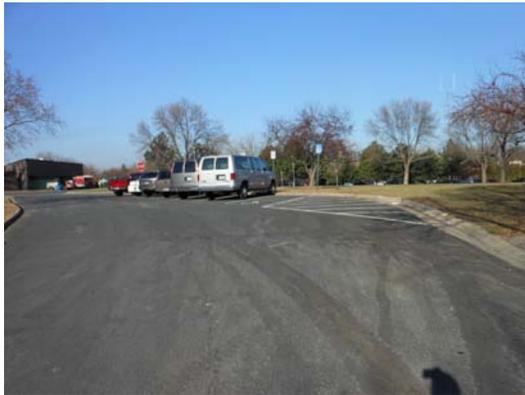
05H	<i>14274</i>	Stripe to provide an accessible parking stall that is 8' wide with an adjacent 8' access aisle. It is preferred that the access aisle be located on the passenger side of the vehicle. MN 1341 502.4.2 <i>The accessible parking space has a pie shaped aisle that does not provide 8' width for the entire aisle.</i>	1	\$150	\$150	3			
------------	--------------	------------------------------------------------------------------------------------------------------------------------------------------------------------------------------------------------------------------------------------------------------------------------------------------------------------------------------	---	-------	-------	---	--	--	--

Photo 1: Stripe the accessible parking space to provide an 8' wide space with an adjacent 8' wide access aisle.

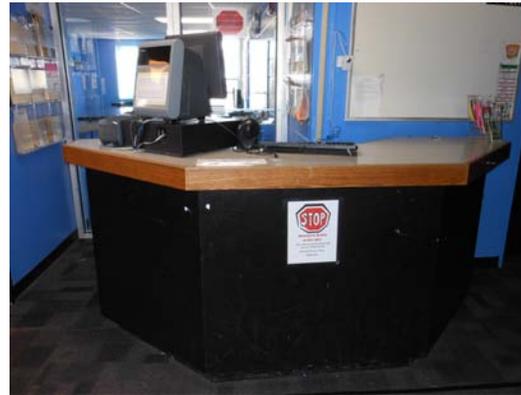
21A1	<i>14249</i>	Lower a minimum 36" wide section of counter to a maximum height of 36" above the floor. ICC ANSI 904.3 <i>Currently at 42". Photo 2.</i>	1	\$1,000	\$1,000	3			
-------------	--------------	------------------------------------------------------------------------------------------------------------------------------------------------	---	---------	---------	---	--	--	--

Photo 2: Lower the service counter to 36" maximum (currently at 42").

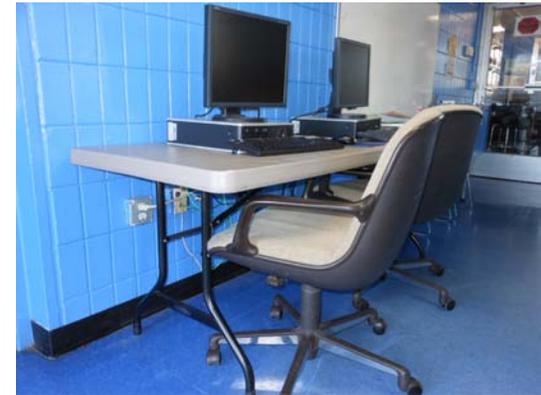
29A	14253 Provide a minimum of one computer lab on an accessible permanent or movable table / counter. The top height of the surface is to be 28"-34" above the floor, with knee clearance a minimum 27" high by 30" wide x 19" deep. ICC / ANSI 902.2 <i>Currently all of the tables are folding tables where the brace/leg obstructs the knee clearance. Photo 3.</i>	1	\$200	\$200	3				
-----	---------------------------------------------------------------------------------------------------------------------------------------------------------------------------------------------------------------------------------------------------------------------------------------------------------------------------------------------------------------------------	---	-------	-------	---	--	--	--	--

Photo 3: Provide a table for the computer that provides knee and toe clearance. The supports for the folding tables currently used obstruct the knee clearance.

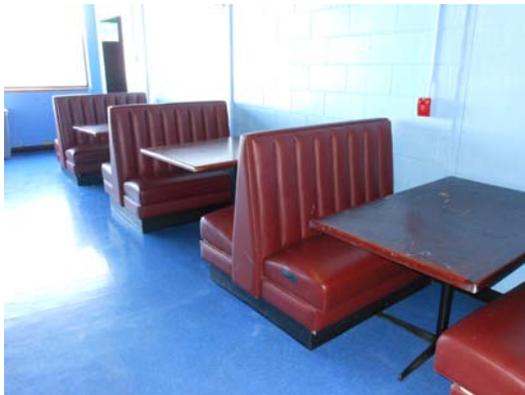
21A1	<i>14250</i>	Lower a minimum 36" wide section of counter to a maximum height of 36" above the floor. ICC ANSI 904.3 <i>Currently at 45".</i>	1	\$1,000	\$1,000	3			
25E.1	<i>14252</i>	Provide a table with knee clearance below, a minimum 27" high by 30" wide by 19" deep. IBC 1108.2.8.1, ICC / ANSI 902 <i>There are currently 4 booths. Photo 4.</i>	1	\$200	\$200	3			
<i>Location Subtotal:</i>					<i>\$1,200</i>

Photo 4: Provide accessible seating in the dining area (currently all booth seating).

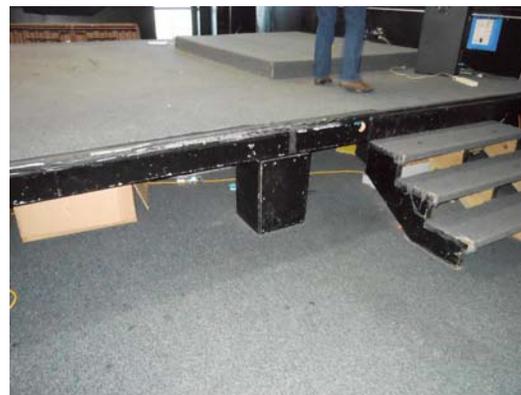
14D	14309 Provide a portable ramp to provide access between levels. IBC 1104.1 <i>The stage is currently at 26". Photo 5.</i>	1	\$5,000	\$5,000	3				
14G	14255 Eliminate protruding hazard by positioning an object below. This will create a detectable object to direct a person with a visual impairment using proper cane technique around the protruding object. ICC / ANSI 307.1 <i>The area below the sound booth provides 75" clearance.</i>	1	\$50	\$50	3				
25E.1	14254 Provide a table with knee clearance below, a minimum 27" high by 30" wide by 19" deep. IBC 1108.2.8.1, ICC / ANSI 902 <i>Currently only high (41") tables are available.</i>	1	\$200	\$200	3				
				<i>Location Subtotal:</i>					\$5,250

Photo 5: Create an accessible route onto the stage.

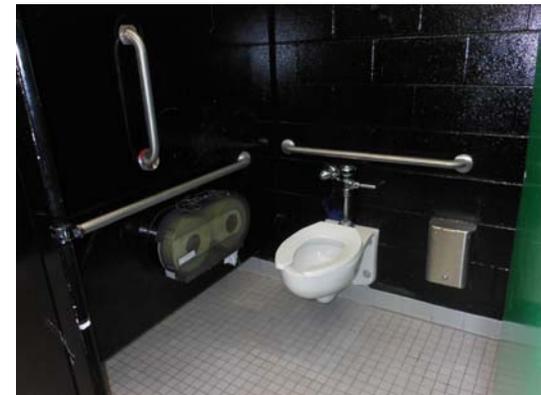
22W2	14265 Relocate the sanitary product receptacle in the accessible stall. The sanitary product receptacle should be located 1 1/2" minimum below the horizontal grab bar and 18" minimum above the floor and 12"-40" from the rear wall. MN 1341 604.7 <i>There are (2) 5' stalls. Photo 6.</i>	2	\$50	\$100	4				
				<i>Location Subtotal:</i>					\$2,600
				Priority # 4 Total					\$8,900

Photo 6: View of toilet room. Features of accessibility have been provided in the men's and women's toilet rooms. Relocate the sanitary waste receptacle to below the side horizontal grab bar in the women's toilet room.
