Acorn

Activities / Amenities

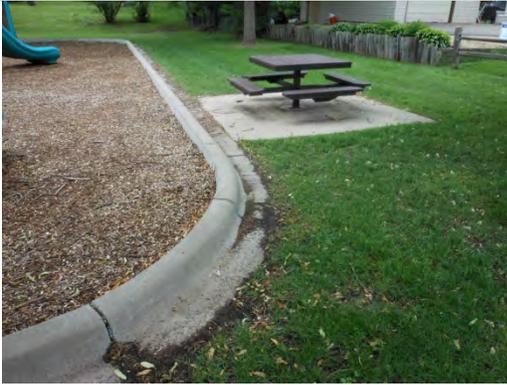
Picnic Table

There is a picnic table located adjacent to the defined play area. A section with knee and toe clearance is not currently provided and it is not located on an accessible route.

Priority 3- Replace the picnic table with a style that provides knee and toe clearance and is located on an accessible route. *Recommended based on Draft Accessibility Guidelines for Outdoor Developed Areas 1011.4*

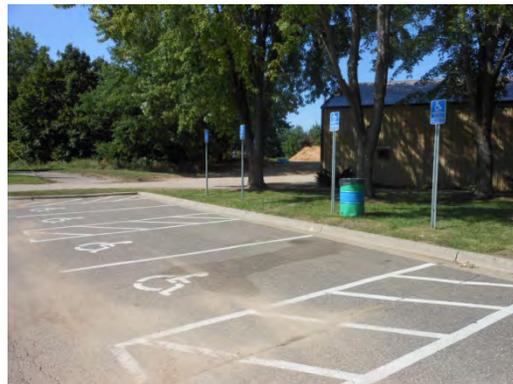
Parking- Bob Bunnell Field

There are 21 parking spaces, including 1 accessible space. The aisle leads to the service entrance to Bob Bunnell Field. The accessible parking does not link to any accessible routes.

No recommendations at this time.

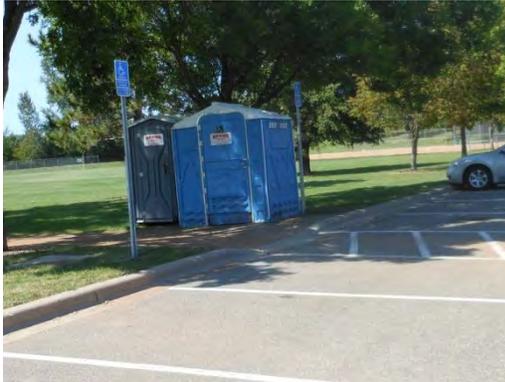
Portable Toilet- Field B

There are 2 portable toilets, located adjacent to the parking lot near right field of field B. One is a larger style that provides features of accessibility.

No recommendations at this time.

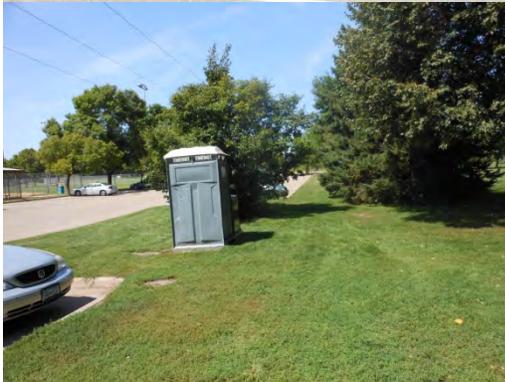
Portable Toilet- Dog Park

A portable toilet is located in the grass adjacent to the dog park.

No action at this time- the accessible portable toilet is located across the parking lot.

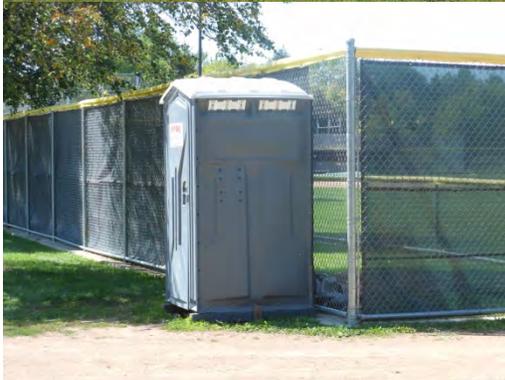
Portable Toilet- Field A

A portable toilet is located adjacent to baseball field A. There is compacted gravel up to the toilet.

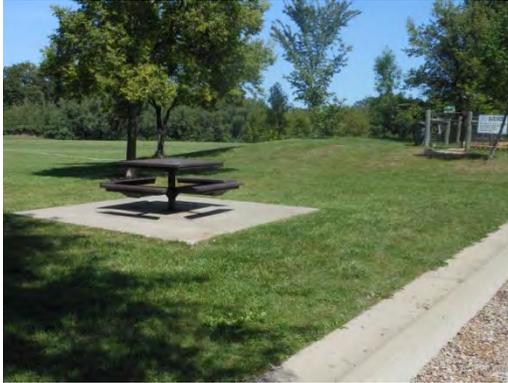
Picnic Table- Play

There is a picnic table located to the north of the defined play area. A section with knee and toe clearance is not currently provided and it is not located on an accessible route.

Priority 3- Replace the picnic table with a style that provides knee and toe clearance and is located on an accessible route (approximately 9' from the border of the defined play area).

Recommended based on Draft Accessibility Guidelines for Outdoor Developed Areas 1011.4

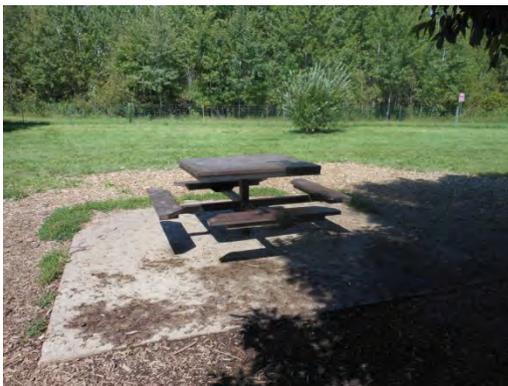
Picnic Tables- Dog Park

There are picnic tables located throughout the dog park. Currently none of the tables provide knee and toe clearance and they are not located on an accessible route.

Priority 3- Provide a picnic table that provides knee and toe clearance and is located on an accessible route. *Recommended based on Draft Accessibility Guidelines for Outdoor Developed Areas 1011.4*

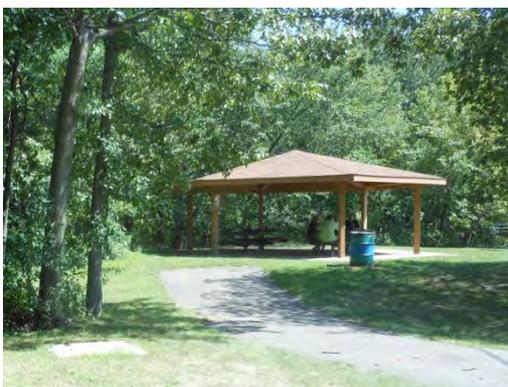
Picnic Shelter

There are 4 tables and a grill in the sheltered picnic area. One table provides knee and toe clearance. The route does not extend to the picnic shelter.

Priority 3- Extend the accessible route to the picnic shelter (approximately 5'-6").

Recommended based on Draft Accessibility Guidelines for Outdoor Developed Areas 1011.4

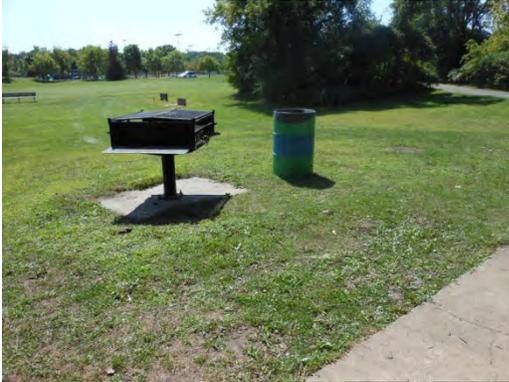
Grill

There is a grill positioned near the covered picnic shelter in the grass. A route to the grill is not currently provided.

Priority 3- Link the grill to picnic shelter to create an accessible route. (Approximately 10')

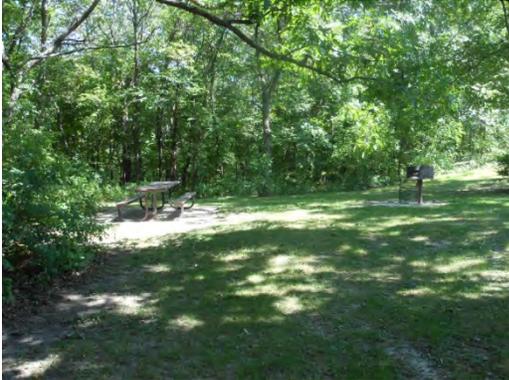
Picnic Tables- North

There are 2 single picnic tables on concrete pads located in the grass and woods in the north portion of the park. There are 2 grills and 1 fire pit. Currently neither of the tables provide knee and toe clearance or are located on an accessible route.

Priority 3- Create an accessible route to 1 of the picnic tables and provide knee and toe clearance. *Recommended based on Draft Accessibility Guidelines for Outdoor Developed Areas 1011.4*

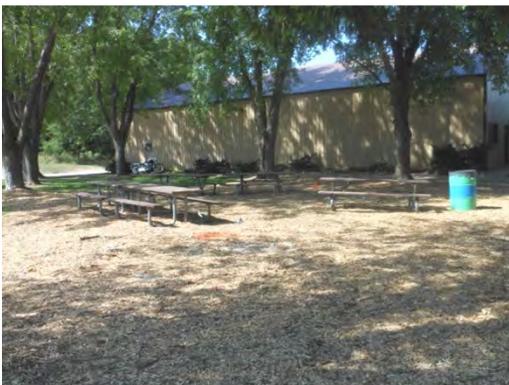
Picnic Tables- Baseball Fields

There are picnic tables adjacent to the baseball fields. It appears that the tables get moved throughout the park as needed. Currently none of the tables provide knee or toe clearance.

Priority 3- Provide tables with knee and toe clearance that can be relocated throughout the park as needed. *Recommended based on Draft Accessibility Guidelines for Outdoor Developed Areas 1011.4*

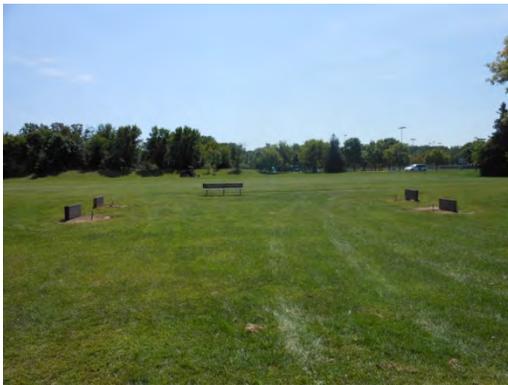
Accessible Route

There is not currently an accessible route to the horseshoe pits.

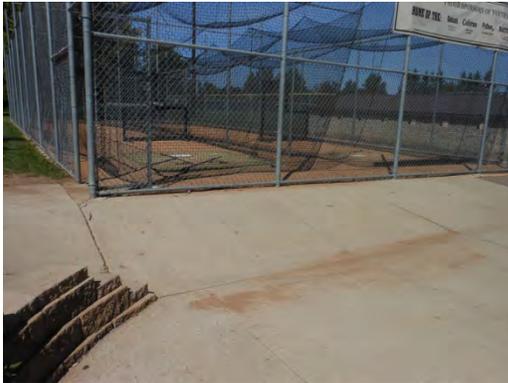
Accessible Route- Rich Vanderlaan Field

There is not currently an accessible route into the batting cage due to the slope/cross slope near the entry.

Priority 3- Create an accessible route to the north entry of the batting cage. *ADA 206.2.2*

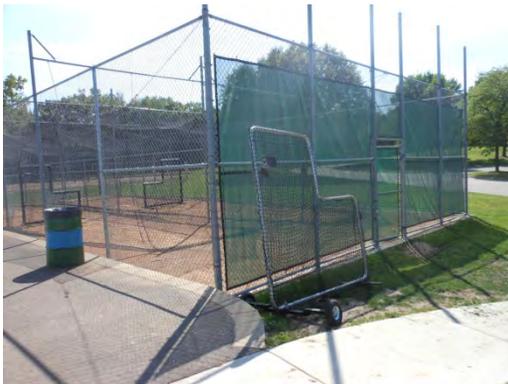
Accessible Route- Bob Bunnell Field

There is not currently an accessible route into the batting cage.

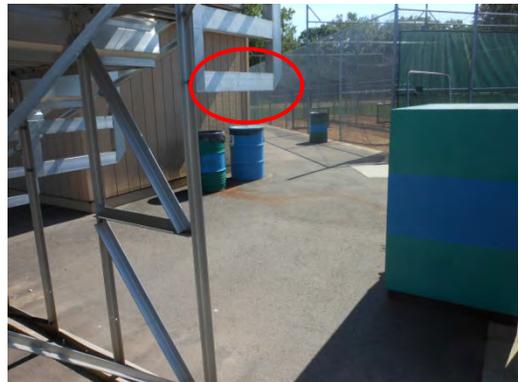
Route- Northeast Field

There is not currently an accessible route to the spectator seating or the 1st base player seating.

Priority 3- Create an accessible route to the boundary of the baseball field and the player seating. *ADA 206.2.2*

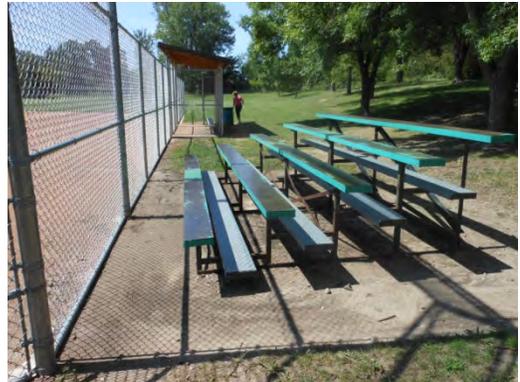
Route- West Field

There is not currently an accessible route to the field.

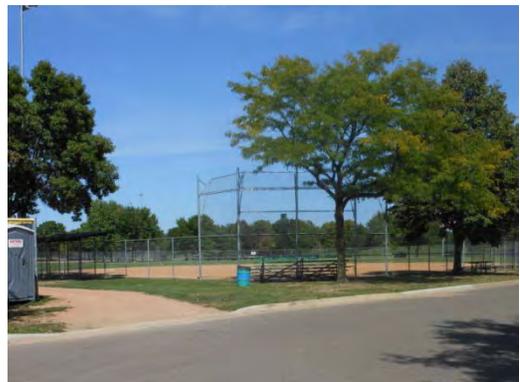
Route- Field B

There is not currently an accessible route to the field.

Priority 3- Create an accessible route to the boundary of the baseball field, spectator seating and the player seating. *ADA 206.2.2*

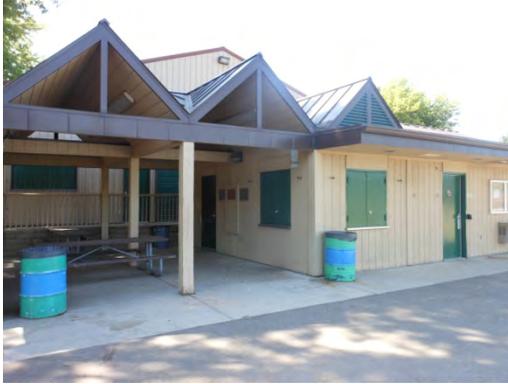
Concession Window

The service windows of the concession stand are currently at 37" (versus 36" maximum).

Priority 3- At such time the concession counter is modified, lower 1 of the windows to 36" maximum. *ADA 904.4*

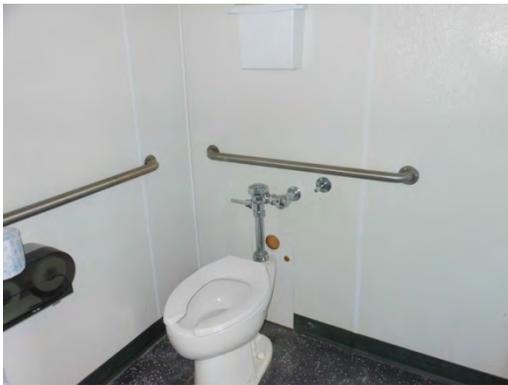
Toilet Rooms

The men's and women's toilet rooms provide features of accessibility including transfer space and grab bars. The towel dispenser is currently at 63".

Priority 3- Replace the locking hardware on the stall door and add pull hardware. *MN1341 604.8.3*

Priority 3- Relocate the sanitary waste receptacle to adjacent to the toilet paper dispenser. *MN1341 604.7*

Priority 2- Insulate the waste pipes at the sink. *MN1341 606.6*

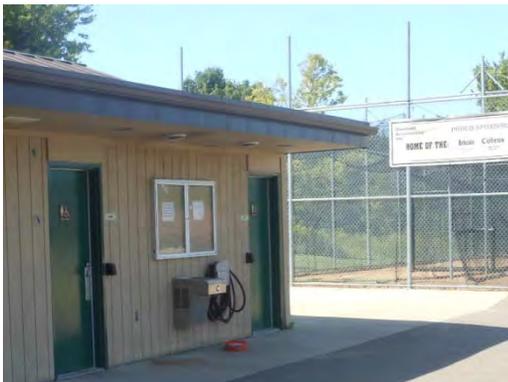
Drinking Fountain

There is a drinking fountain located between the toilet rooms. The spout is currently at 37".

Priority 3- At such time the drinking fountain is replaced, provide a dual height style. *ADA 211.2*

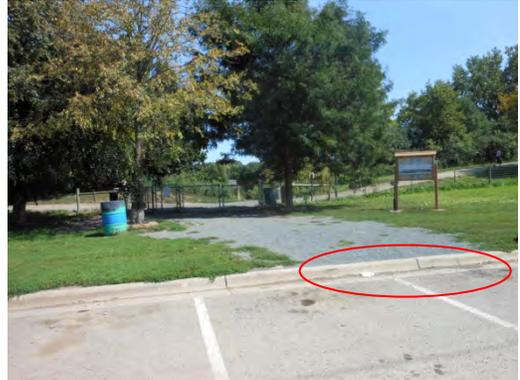
Route

There is not currently an accessible route to the entry gate to the 'Special Needs' area of the park.

Priority 2- Create an accessible route to the special needs area. (Approximately 69') *ADA 206.2.2*

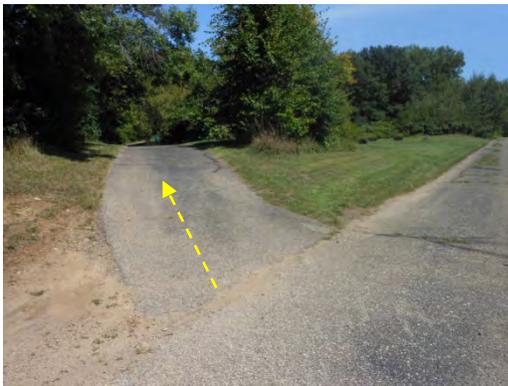
Route

The spur route up to the picnic pavilion at the north end of the park is currently steeper than 8.33% for a distance of 45'.

Priority 3- At such time the sidewalk/path is replaced, re-route to reduce the slope. *ADA 403.3, 405.2*

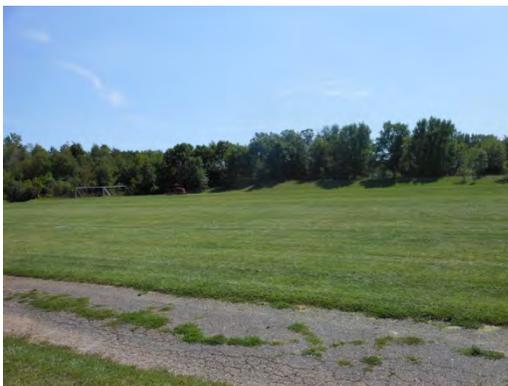
Surface

The surface of the existing route is rough and deteriorating at multiple locations throughout the park, including near the soccer field and near the northeast baseball field.

Priority 2- Repair the surface of the route to provide a firm, stable surface. *ADA 302.1*

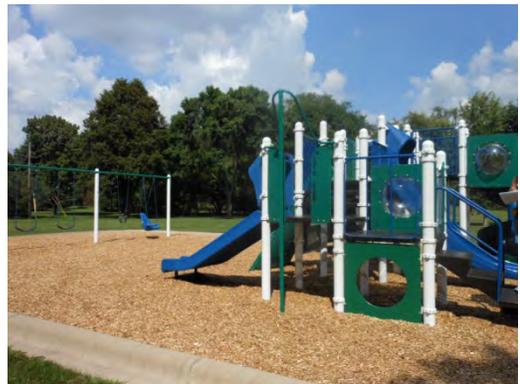
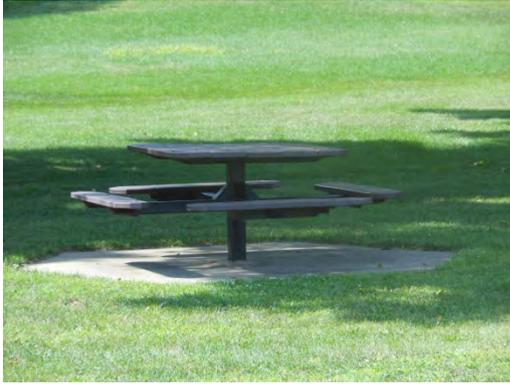
Picnic Table

There is a picnic table located in the grass under a tree. A section with knee and toe clearance is not currently provided and it is not located on an accessible route.

Priority 3- Replace the picnic table with a style that provides knee and toe clearance and is located on an accessible route. *Recommended based on Draft Accessibility Guidelines for Outdoor Developed Areas 1011.4*

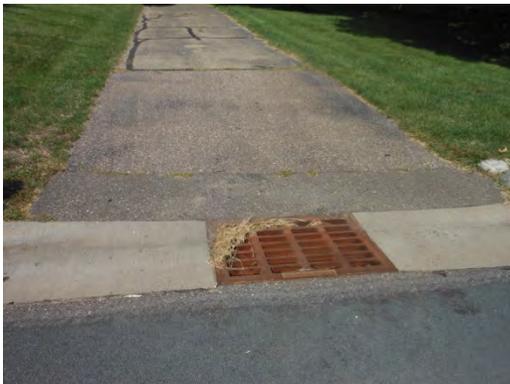
Route

There is a grate with opening larger than 1/2" centered in the curb cut.

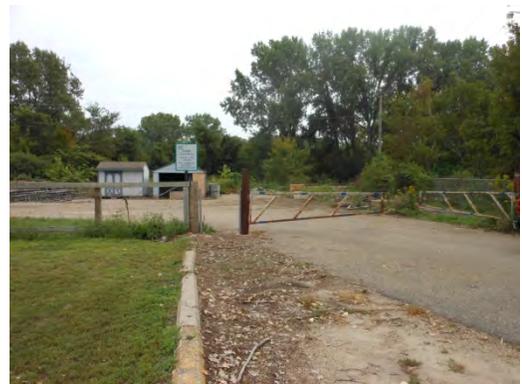
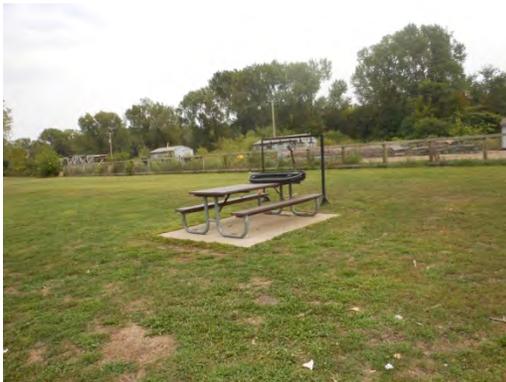
Picnic Table

There are 2 picnic tables on concrete pads located near the shooting area. A section with knee and toe clearance is not currently provided and they are not located on an accessible route.

Priority 3- Provide 1 picnic table that provides knee and toe clearance and is located on an accessible route. *Recommended based on Draft Accessibility Guidelines for Outdoor Developed Areas 1011.4*

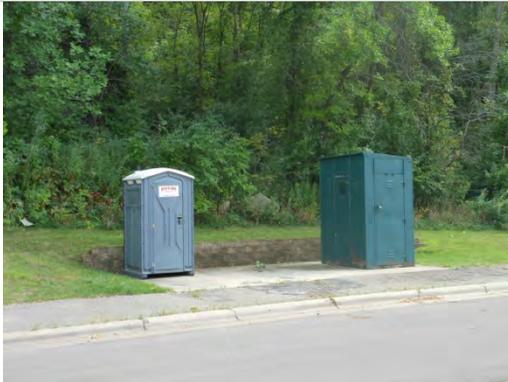
Portable Toilet- Field 5

A portable toilet is located on a concrete pad at the south end of the parking lot.

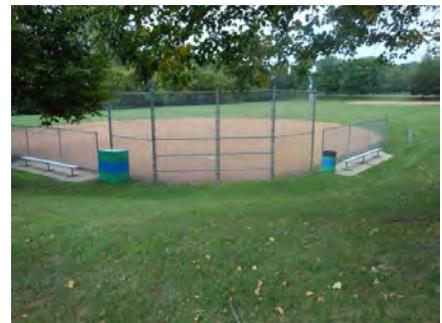
Route- Fields 2-3

There is not currently an accessible route from the parking lot to fields 2 or 3.

Priority 2- Create an accessible route to the boundary of the baseball field and the player seating at fields 2 and 3. (The 2 fields can share 1 route, with a spur, approximately 115' total.) ADA 206.2.2

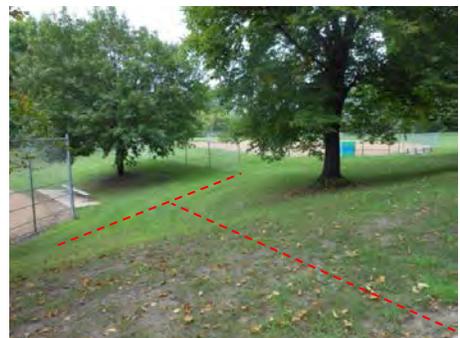
Player / Team Seating- Fields 1 & 3

There are fixed benches on concrete pads for team and player seating. The concrete pad is not currently large enough to provide clear ground space for a wheelchair adjacent to the bench.

Priority 3- Enlarge the concrete pad to provide a clear ground space for a wheelchair. *ADA 221.2.1.4, 802.1*

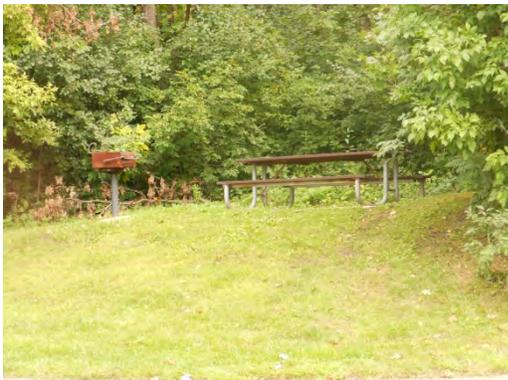
Picnic Table

There are 2 picnic tables, 1 with a grill on the hill. A section with knee and toe clearance is not currently provided and it is not located on an accessible route.

Priority 3- Replace 1 of the picnic tables with a style that provides knee and toe clearance and is located on an accessible route. *Recommended based on Draft Accessibility Guidelines for Outdoor Developed Areas 1011.4*

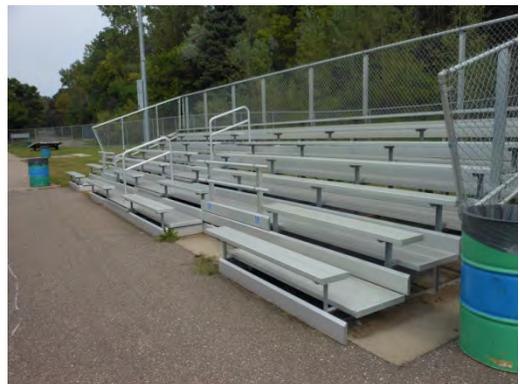
Concession Building

The counter of the concession building is currently at 37". Knob style door hardware is used throughout the building.

Priority 3- At such time the counter is modified, lower the counter to 36" maximum. *ADA 904.4.1*

Priority 3- Replace the knob style hardware with lever style. *ADA 309*

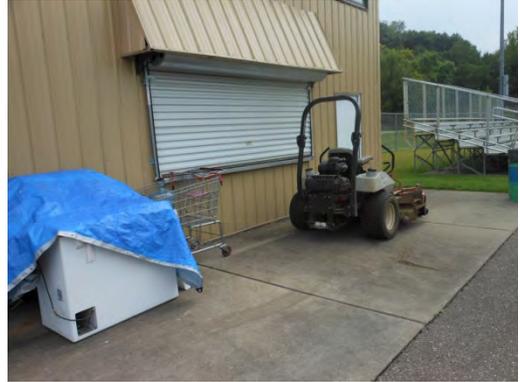
Player Seating

The player seating is on the opposite side of the field from the spectator seating. There is not currently a route to the player seating.

Priority 3- Create an accessible route to the player seating (relocating the player seating to the same side as the spectator seating would reduce the distance of the accessible route). *ADA 221.2.1.4*

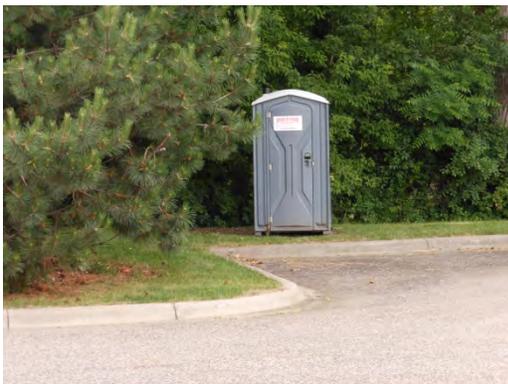
Portable Toilet

A portable toilet is located in the grass near the southwest corner of the parking lot.

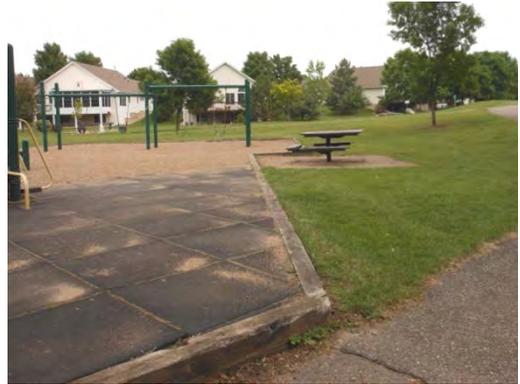
Surface Material

The surface material is currently sand, with unitary tiles from the entry point of the defined play area to the transfer deck of the composite structure and below the double slide. The ground level events are currently located in the sand, not on an accessible route.

Priority 3- Repair the unitary tiles where gaps exceeding 1/2" have developed.

Priority 3- Replace the loose fill sand with a surface material that meets the accessibility requirements of ASTM 1951 as well as the impact attenuation requirements of ASTM 1292.

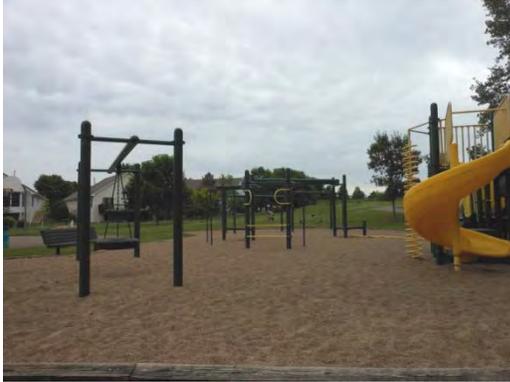
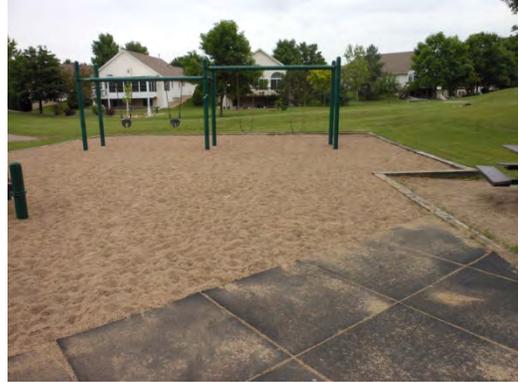
Equipment

The composite structure currently provides a transfer platform. There is not a transfer system as part of the composite structure. (Once on the transfer platform, the next deck is 16" higher.)

Priority 2- At such time the play equipment is replaced, provide a transfer system with access to the elevated events. *ADA 240.2.2*

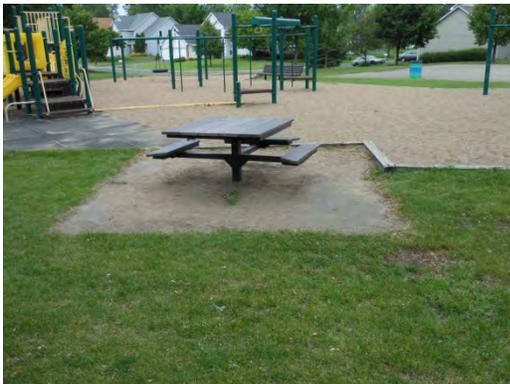
Picnic Table

There is a picnic table located adjacent to the defined play area. A section of bench has been removed to provide knee and toe clearance and the picnic table is located on a hard surface pad. There is not currently an accessible route to the picnic table.

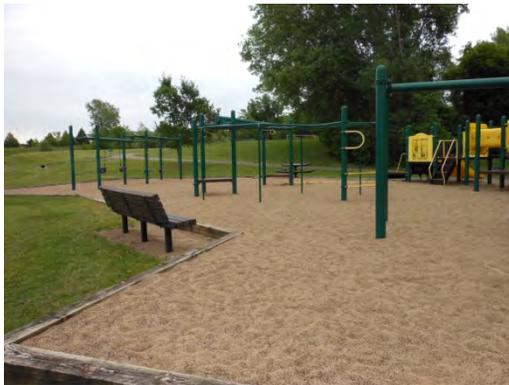
Bench

A bench has been provided adjacent to the defined play area. The bench is not currently located on an accessible route.

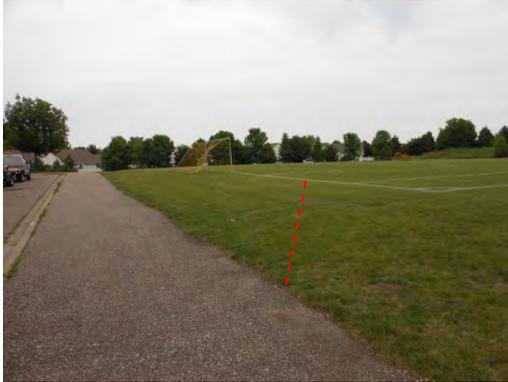
Soccer

The soccer field is located near the parking lot. There is not currently a route from the sidewalk up to the soccer field.

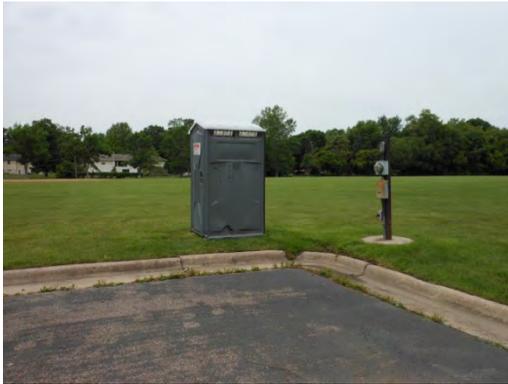
Portable Toilet

A portable toilet is located in the grass adjacent to the parking lot.

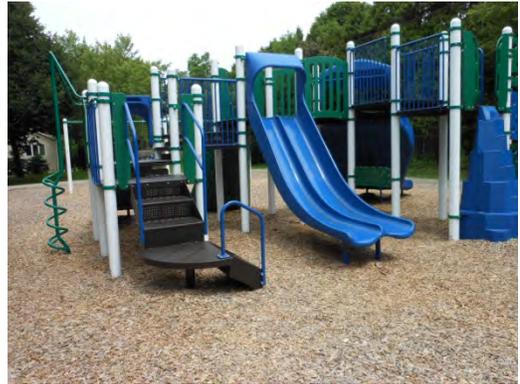
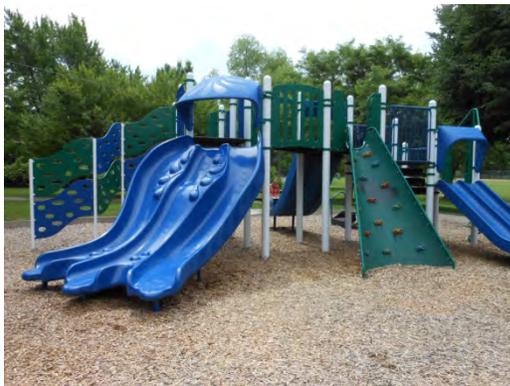
Route

An accessible route is provided to the defined play area. Currently the trash container is blocking the entry.

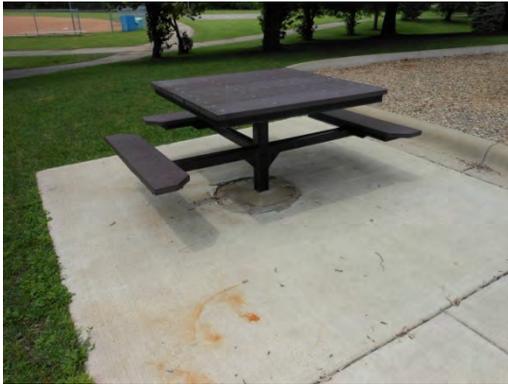
Picnic Table

There is a picnic table located adjacent to the defined play area. The table is linked to the accessible route. A section with knee and toe clearance is provided.

There are no recommendations at this time.

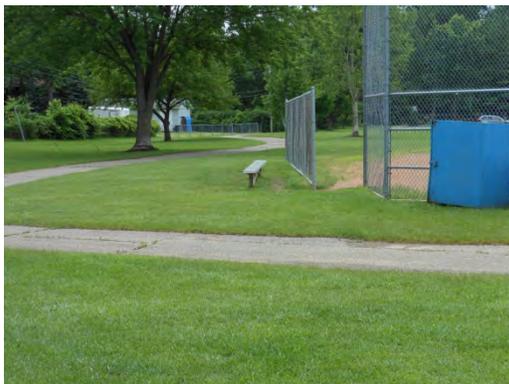
Field 1

The baseball field is located near the center of the park. There are movable benches in the grass for player seating. There is not currently an accessible route to the field.

Priority 3- Create an accessible route to the boundary of the baseball field and the player seating. (Approximately 10'.) ADA 206.2.2

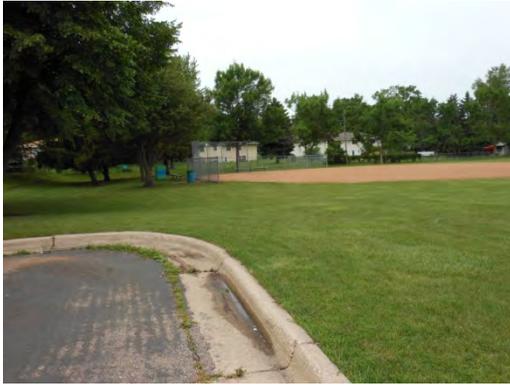
Field 2

The baseball field is located west of the parking lot. There are movable benches in the grass for player seating. There is not currently an accessible route to the field.

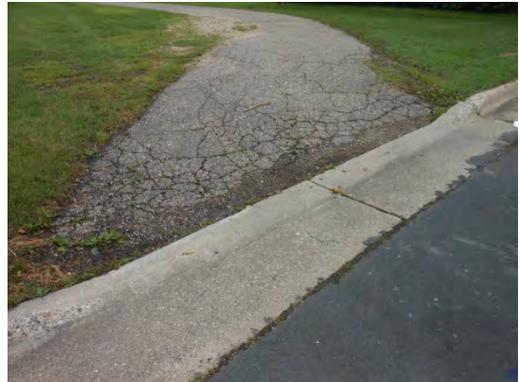
Route

The spur route that connects the defined play area is as steep as 8.6%. (Slopes between 5% and 8.33% are considered a ramp and require handrails.)

Priority 3- At such time the sidewalk/path is replaced, re-route to reduce the slope. *ADA 403.3, 405.2*

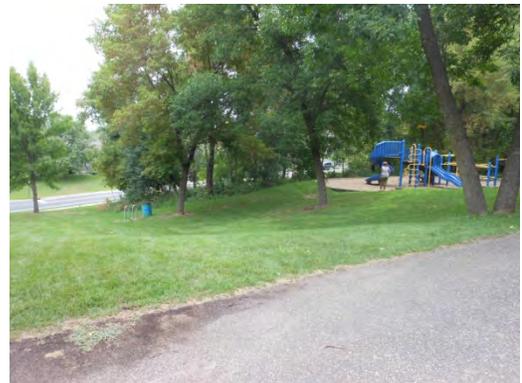
Surface Material

The surface material is currently loose fill sand throughout the defined play area.

Priority 3- Replace the loose fill sand with a surface material that meets the accessibility requirements of ASTM 1951 as well as the impact attenuation requirements of ASTM 1292.

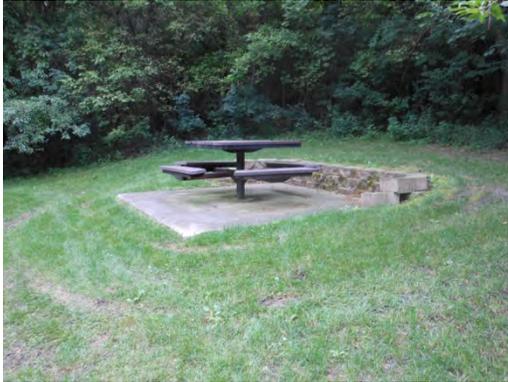
Picnic

There is 1 picnic table located near the defined play area and 1 near the sand volleyball court. A section with knee and toe clearance is not currently provided and it is not located on an accessible route.

Priority 3- Replace 1 of the picnic tables with a style that provides knee and toe clearance and is located on an accessible route. *Recommended based on Draft Accessibility Guidelines for Outdoor Developed Areas 1011.4*

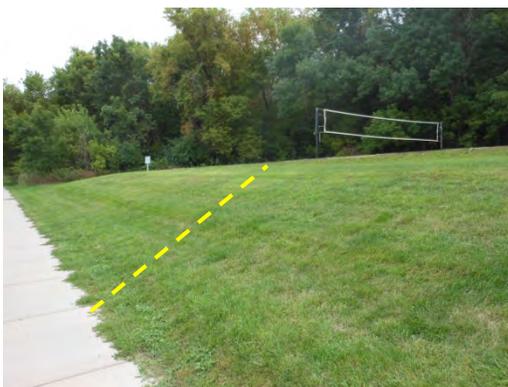
Route

There is not currently an accessible route to the sand volleyball court.

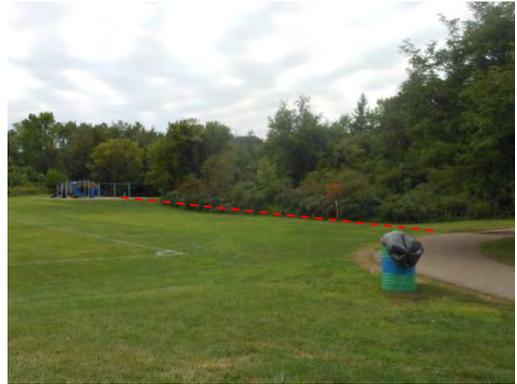
Defined Play Area

The defined play area includes 1 composite play structure and to-fro swings. Engineered wood fiber surface material is used throughout.

Priority 2- Ensure the loose fill surface material is maintained to provide an accessible surface material. *ADA 206.2.17*

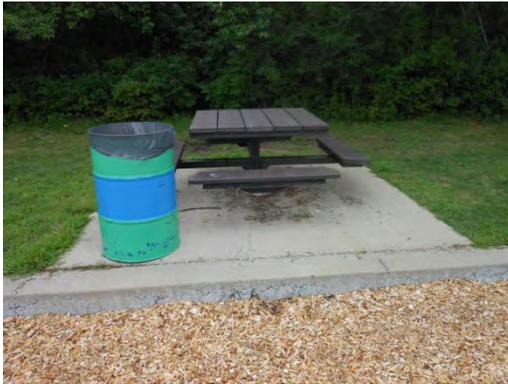
Picnic Table- Play

There is a picnic table located adjacent to the defined play area. A section with knee and toe clearance is not currently provided and it is not located on an accessible route.

Priority 3- Replace the picnic table with a style that provides knee and toe clearance and is located on an accessible route. *Recommended based on Draft Accessibility Guidelines for Outdoor Developed Areas 1011.4*

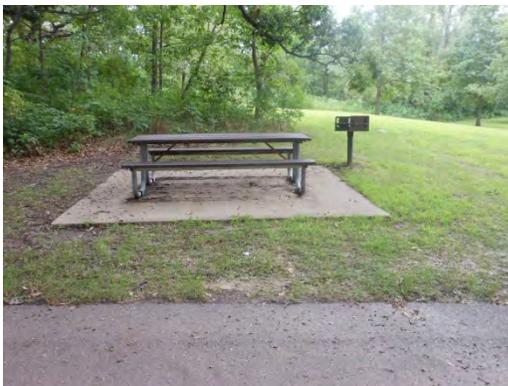
Picnic Table

There are 2 picnic tables with nearby grills on the hill near 14th Ave. A section with knee and toe clearance is not currently provided and it is not located on an accessible route.

Priority 3- Replace the picnic table with a style that provides knee and toe clearance and is located on an accessible route (approximately 6'). *Recommended based on Draft Accessibility Guidelines for Outdoor Developed Areas 1011.4*

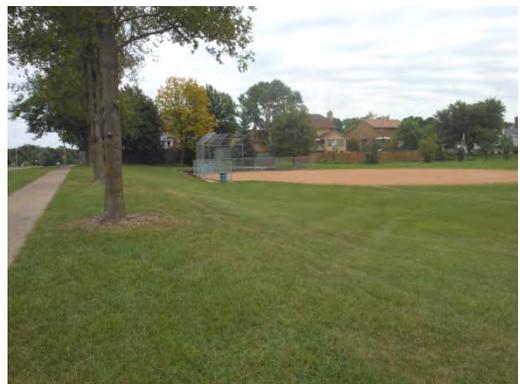
Player / Team Seating

There are fixed benches on concrete pads for team and player seating. The concrete pad is not currently large enough to provide clear ground space for a wheelchair adjacent to the bench.

Priority 3- Enlarge the concrete pad to provide a clear ground space for a wheelchair. *ADA 221.2.1.4, 802.1*

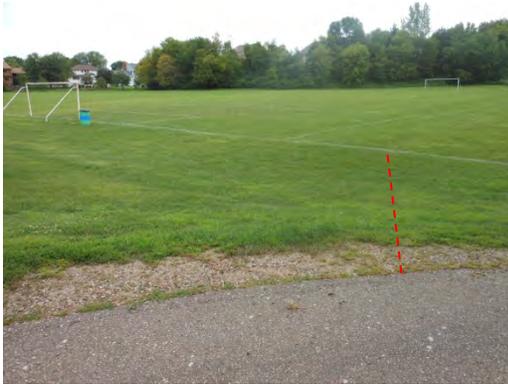
Route

There is not currently an accessible route to the soccer field.

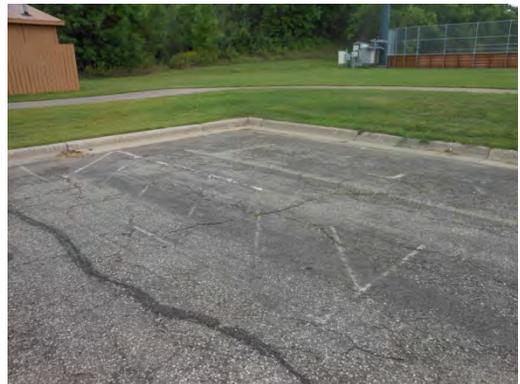
Parking- Skate Park

The parking for the skate rink is shared with the ice rink and the Garage. There is an aisle that aligns with the entry to the skate park.

Priority 3- Add a sign that is centered at the head end of the parking space and 60"-66" above the surface of the parking space (measured to the bottom of the sign). *MN1341 502.7*

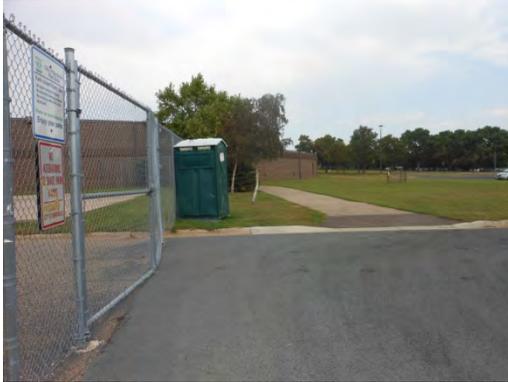
Portable Toilet- Skate Park

A portable toilet is located in the grass adjacent to the skate park.

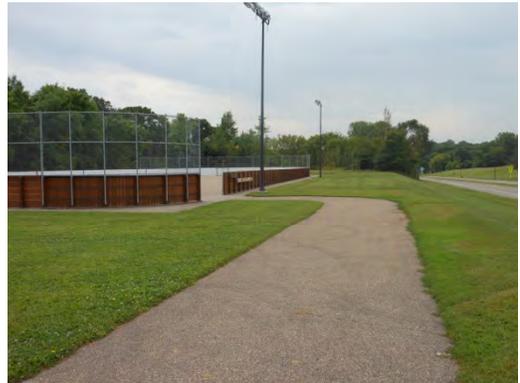
Route

The curb cut from the parking lot currently has a slope of 19.1% for a distance of 4'.

Priority 3- Reconfigure the curb ramp so the slope does not exceed 8.33%. *ADA 406.1, 405.2*

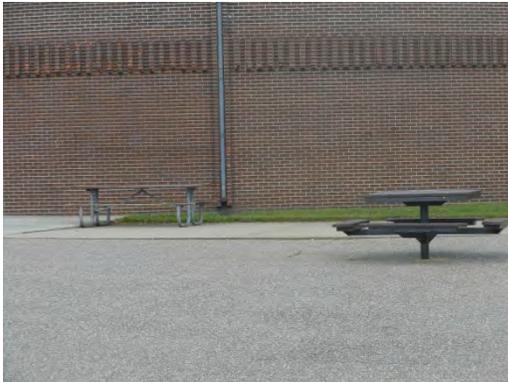
Picnic Tables

The picnic tables are located in the skate park. Currently none of the tables provide knee and toe clearance.

Priority 3- Replace the picnic table with a style that provides knee and toe clearance.

Recommended based on Draft Accessibility Guidelines for Outdoor Developed Areas 1011.4

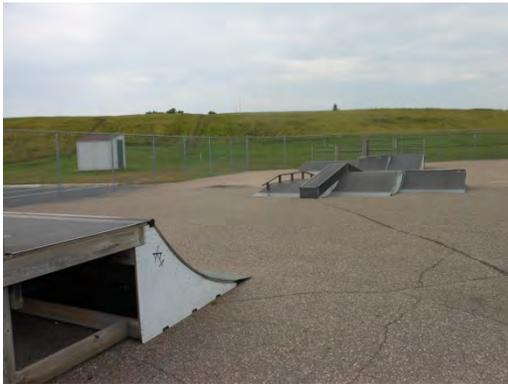
Skate Park

The skate park is located adjacent to the Garage.

No recommendations at this time.

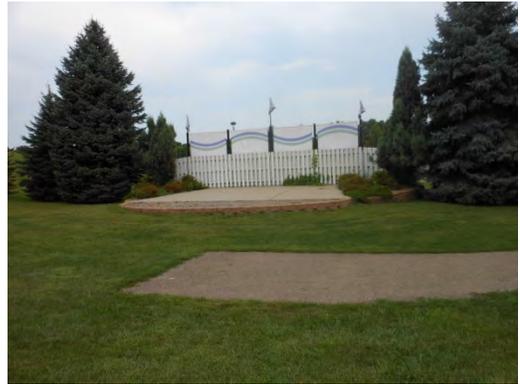
Tables

There are picnic tables scattered throughout the seating area of the amphitheater. Currently none of the tables provide knee and toe clearance or are located on an accessible route.

Priority 3- Provide at least 1 table with knee and toe clearance that is located on an accessible route. *Recommended based on Draft Accessibility Guidelines for Outdoor Developed Areas 1011.4*

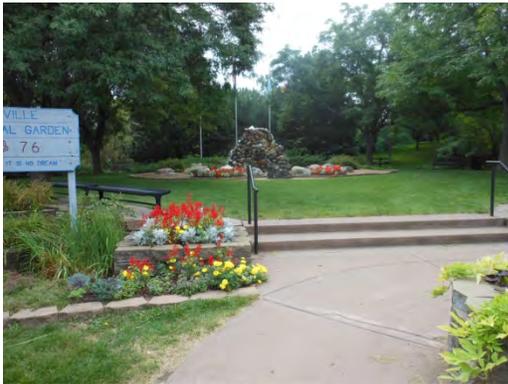
Route

The primary route to the Bicentennial Garden leads to 3 steps.

Priority 2- Post a sign directing to the alternate route from the 130th St.

Priority 3- Create an accessible route to that memorial that coincides with the primary route.

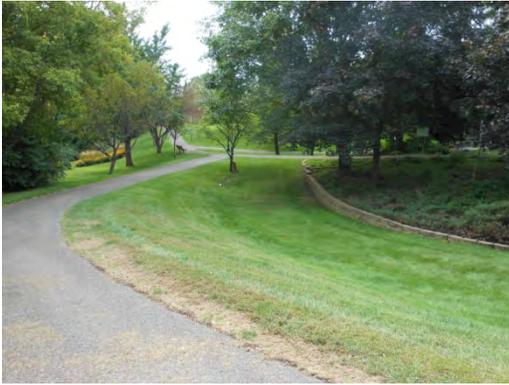
Route

The route from 130th St does not have any steps, but is as steep as 9%. (Slopes between 5% and 8.33% are considered a ramp and require handrails.)

Priority 3- At such time the sidewalk/path is replaced, re-route to reduce the slope. *ADA 403.3, 405.2*

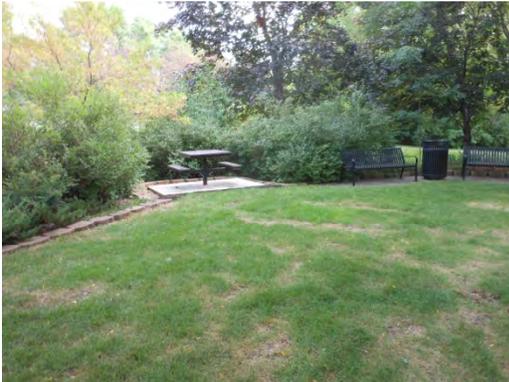
Picnic Tables

There are 2 small picnic tables surrounding the memorial flag poles and fountain. A table with knee and toe clearance is not currently provided and it is not located on an accessible route.

Priority 3- Replace the picnic table with a style that provides knee and toe clearance and is located on an accessible route. *Recommended based on Draft Accessibility Guidelines for Outdoor Developed Areas 1011.4*

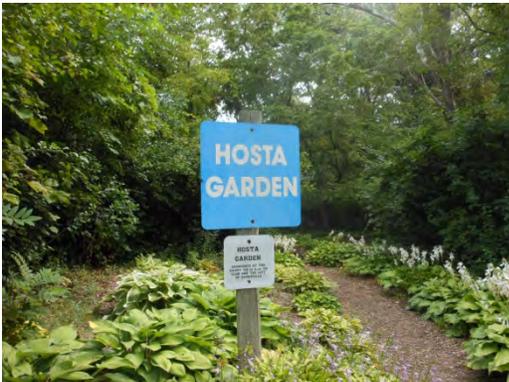
Hosta Garden

There is a hosta garden adjacent to the memorial garden.

No recommendations at this time.

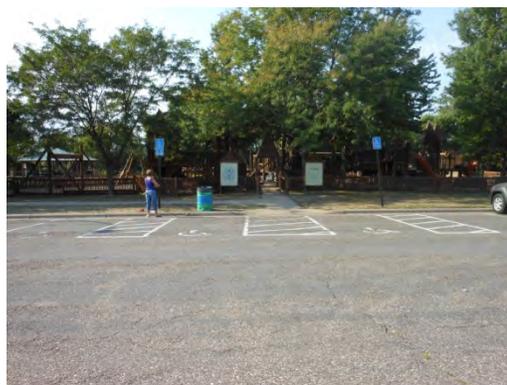
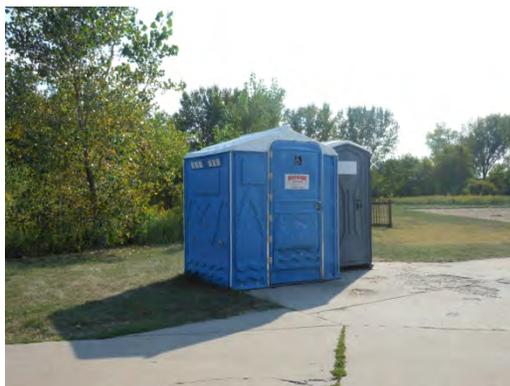
Portable Toilet

There are 2 portable toilets located on a concrete pad near the defined play area. One of the portables is a larger style that provides features of accessibility.

No recommendations at this time.

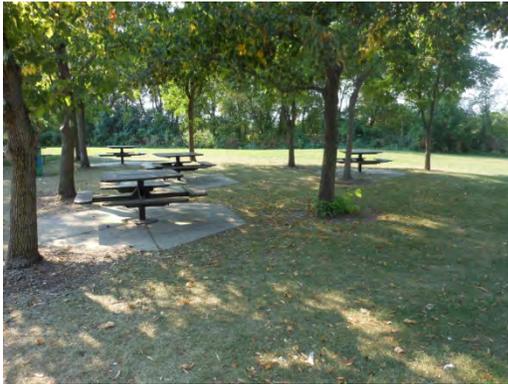
Picnic Tables

There are 7 picnic tables on concrete pads located throughout the park (plus 2 movable tables). Currently 1 table provides knee and toe clearance and is located on an accessible route.

Priority 3- At such time tables are added or replaced, provide additional accessible tables on an accessible route. *Recommended based on Draft Accessibility Guidelines for Outdoor Developed Areas 1011.4*

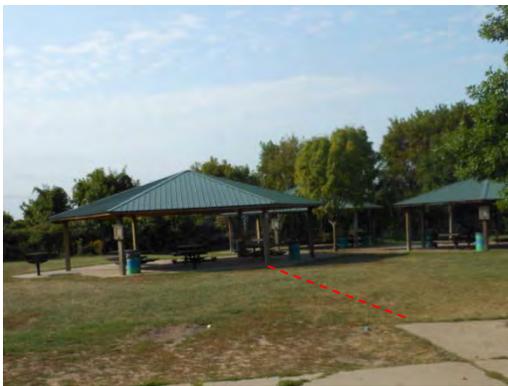
Picnic Pavilions

There are 3 large picnic pavilions that can be reserved. Each pavilion provides 1 table with knee and toe clearance. There is a route connecting the 3 pavilions to each other, but there is not a route from parking.

Priority 3- Create an accessible route to the picnic pavilions. (Approximately 60'). *Recommended based on Draft Accessibility Guidelines for Outdoor Developed Areas 1011.4*

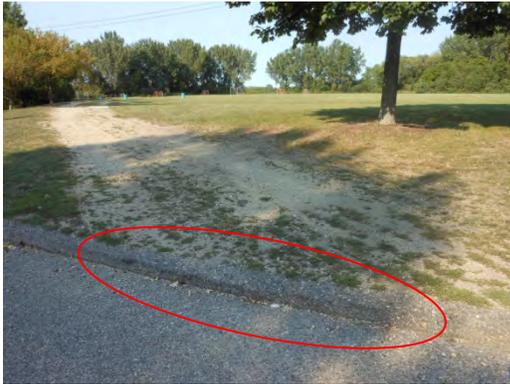
Route

There is not currently an accessible route to the soccer field. There is a gravel road along the northwest boundary of the soccer area, but it does not have a curb cut and does not extend to any of the fields.

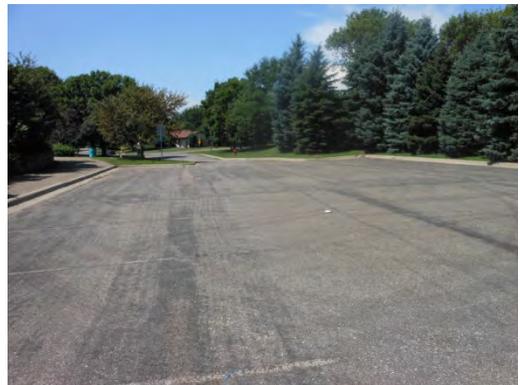
Parking- South

The south parking lot has 19 parking spaces, including 1 space that is designated as accessible. The sign designating the accessible parking space is 95" high.

Priority 3- Designate 1 additional accessible parking space (to accommodate parking from the north lot). *MN1341 1106.1*

Priority 3- Lower the signs, so they are 60"-66" above the surface of the parking space (measured to the bottom of the sign). *MN1341 502.7*

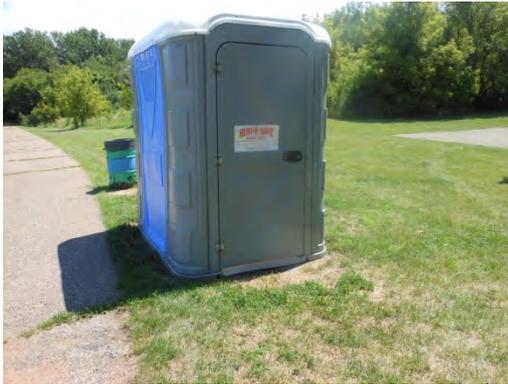
Portable Toilet

A portable toilet is located in the grass adjacent to the path near the basketball court. The portable toilet is a larger style that provides some features of accessibility.

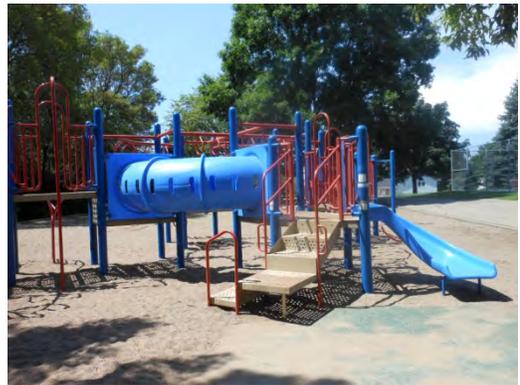
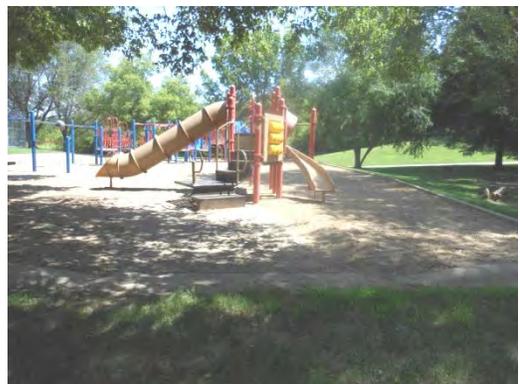
Equipment

There are 2 composite structures (2-5 year old by Landscape Structures, 5-12 year old by Game Time), each with a transfer system, and a 4 position to-fro swing.

No recommendations at this time.

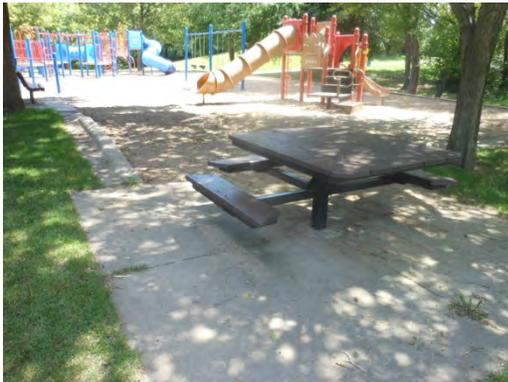
Picnic- Play

There is a picnic table positioned adjacent to the defined play area (on the west side). The table provides a section with knee and toe clearance. There is not currently a route to the picnic table.

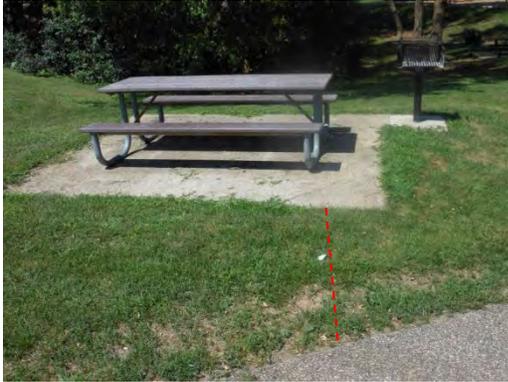
Picnic

There are 2 picnic table locations near the south parking lot. Each table is positioned on a concrete pad with a grill nearby. Neither table is located on an accessible route or provides knee and toe clearance.

Priority 2- Create an accessible route to 1 of the picnic tables and grills.

Priority 3- Replace 1 of the picnic tables with a style that provides knee and toe clearance.

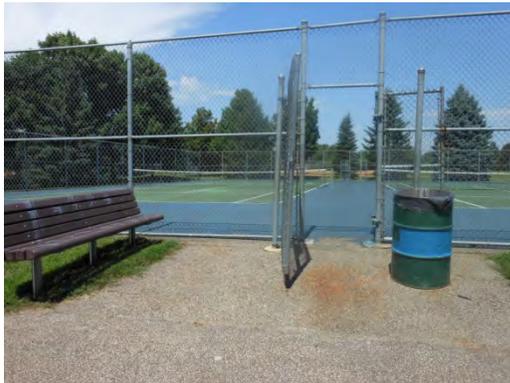
Entry

The tennis court is located on an accessible route and the gate has been modified to provide a 36" clear opening.

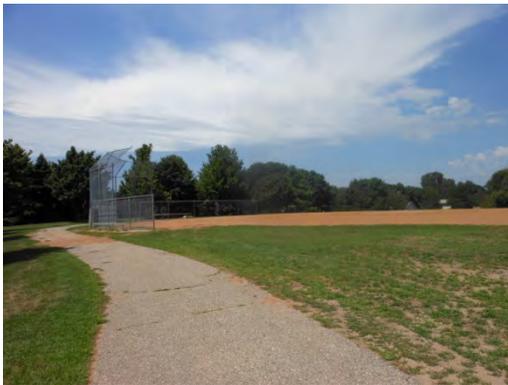
Route

The baseball field is located along the west boundary of the park. There are movable benches on concrete pads for player seating. The 1st base player seating is adjacent to the accessible route; the 3rd base player seating is 9' from the accessible route.

Priority 3- Create an accessible route to the boundary of the baseball field and the player seating on 3rd base. (Approximately 9'.) *ADA 206.2.2*

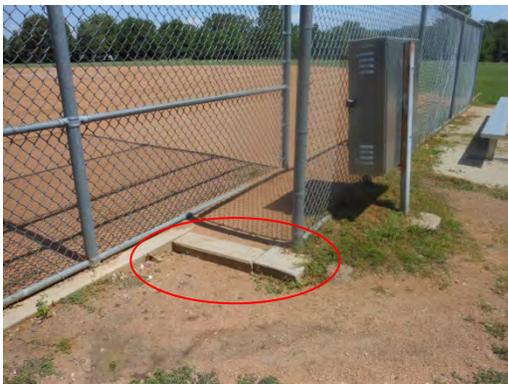
Access to field

There are fences that reduce the opening onto the field from the player seating. The opening on the 3rd base side is currently 33" wide for a distance of 36".

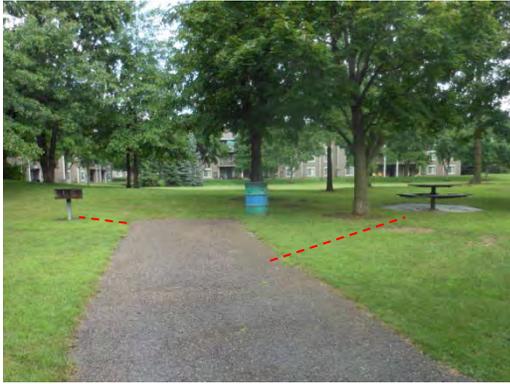
Picnic Table

There is a picnic table and a grill located in the grass. A section with knee and toe clearance is not currently provided and it is not located on an accessible route.

Priority 3- Replace the picnic table with a style that provides knee and toe clearance and is located on an accessible route. *Recommended based on Draft Accessibility Guidelines for Outdoor Developed Areas 1011.4*

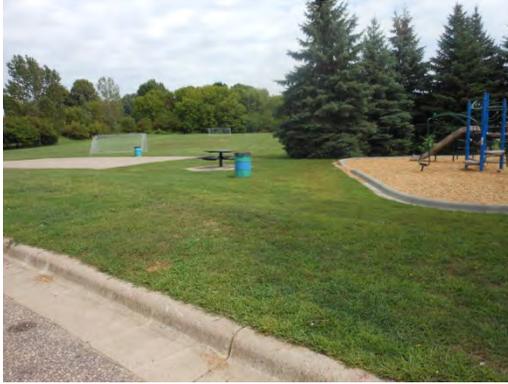
Route

There is not currently a route to the defined play area.

Priority 2- Create an accessible route to the entry to the defined play area. (Approximately 140' from the picnic table.) *ADA 206.2.17*

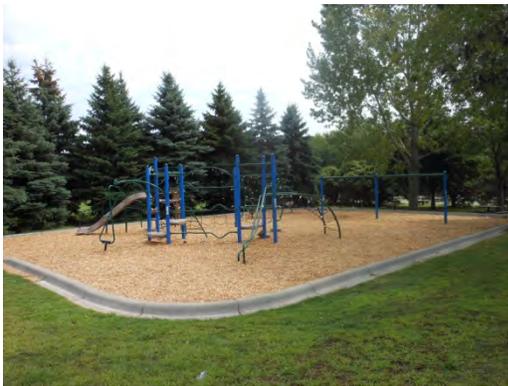
Defined Play Area

The defined play area includes 1 composite play structure, to-fro swings and 2 ground level spinners. Engineered wood fiber surface material is used throughout.

Priority 2- Ensure the loose fill surface material is maintained to provide an accessible surface material. *ADA 206.2.17*

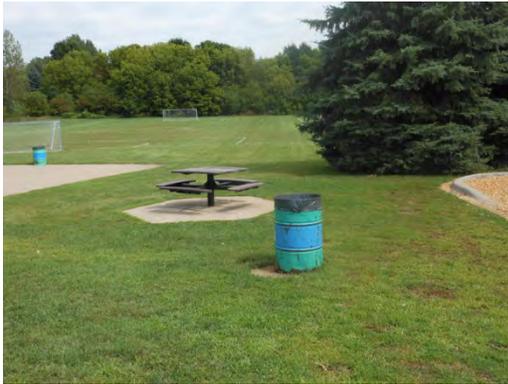
Picnic Table

There are 3 picnic tables located near the defined play area. A section with knee and toe clearance is not currently provided and none are located on an accessible route.

Priority 3- Replace 1 of the picnic tables with a style that provides knee and toe clearance and is located on an accessible route (approximately 36' from parking). *Recommended based on Draft Accessibility Guidelines for Outdoor Developed Areas 1011.4*

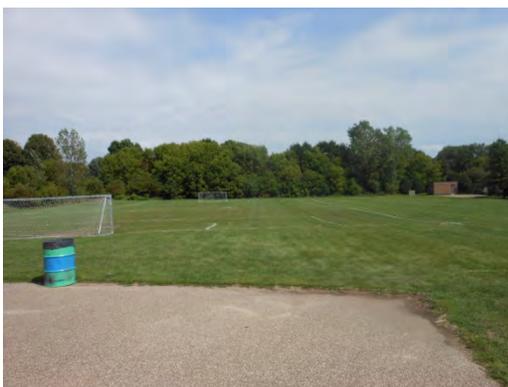
Route

There is not currently an accessible route to the soccer field.

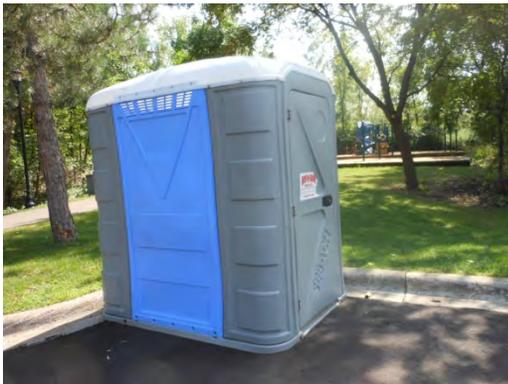
Portable Toilet

A portable toilet is located in the parking lot and is a larger style that provides features of accessibility.
