Acorn

Activities / Amenities

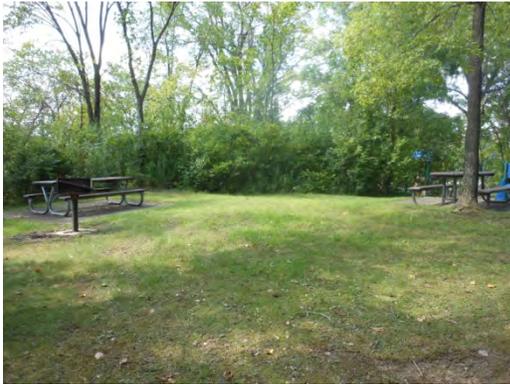
Picnic Table

There are 4 picnic tables (2 with nearby grills) scattered near the defined play area. A section with knee and toe clearance is not currently provided and it is not located on an accessible route.

Priority 3- Replace 1 of the picnic tables with a style that provides knee and toe clearance and is located on an accessible route. *Recommended based on Draft Accessibility Guidelines for Outdoor Developed Areas 1011.4*

Priority 3- Provide an accessible route to the grill associated with the replaced table.

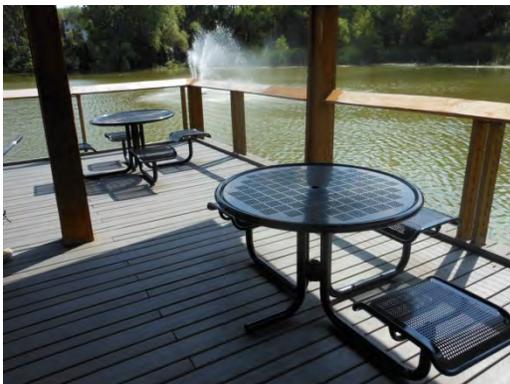
Picnic Tables

There are 4 picnic tables located on a covered portion of the pier. Currently 1 of the tables provides knee and toe clearance.

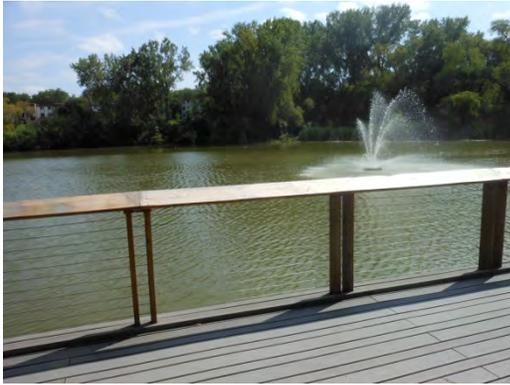
Fishing Pier

There are guardrails at 42" surrounding the boardwalk.

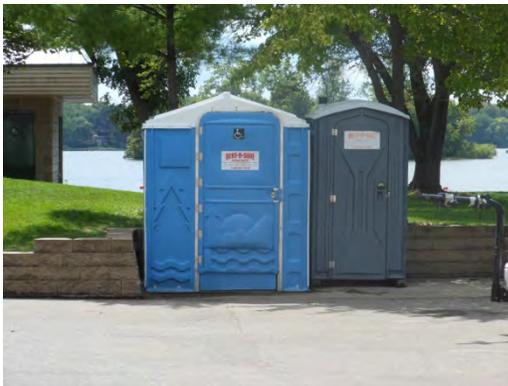
Portable Toilet

There are 2 portable toilets, located in the parking lot. One is a larger style that provides features of accessibility.

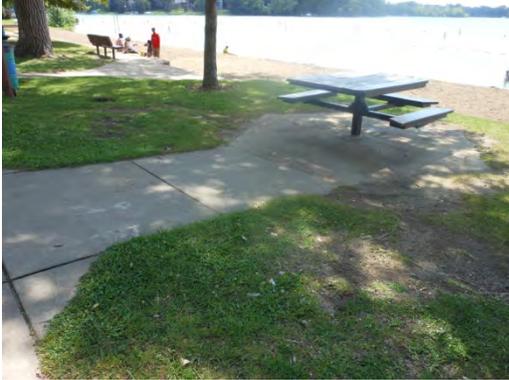
Picnic Tables- Beach

There are 9 single picnic tables on concrete pads scattered throughout the park in the grass near the beach area. Currently 2 of the tables are located on an accessible route and provide knee and toe clearance.

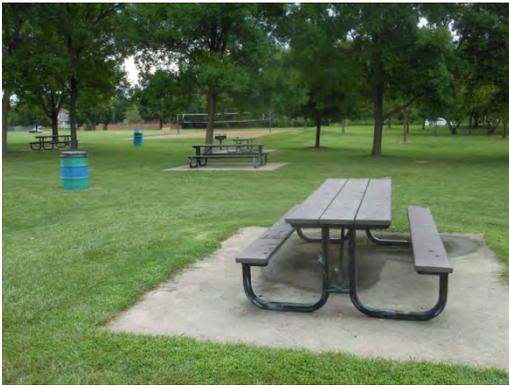
Picnic Table- Volleyball

There are 10 single picnic tables on concrete pads scattered throughout the park in the grass near the volleyball court. Currently 1 of the tables provides knee and toe clearance, but is not located on an accessible route.

Priority 3- Create an accessible route to the picnic table that provides knee and toe clearance. Recommended based on Draft Accessibility Guidelines for Outdoor Developed Areas 1011.4

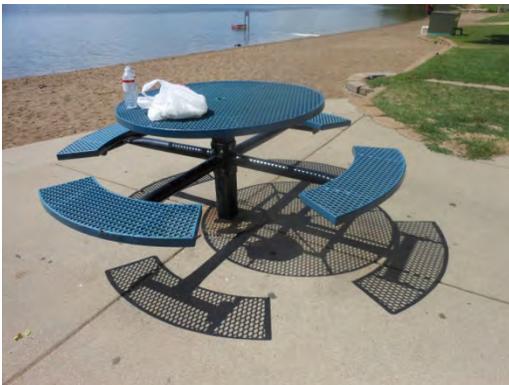
Picnic Table- Concession

There are 4 picnic tables located adjacent to the concession building. Currently none of the tables provide knee and toe clearance.

Priority 3- Replace 1 of the picnic tables with a style that provides knee and toe clearance. Recommended based on Draft Accessibility Guidelines for Outdoor Developed Areas 1011.4

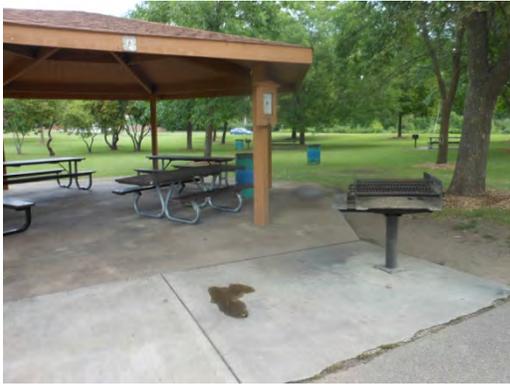
Picnic Shelters- A-B

There are 2 covered picnic shelters, each with 4 tables and a grill. Shelter A is located on an accessible route and 1 of the tables provides knee and toe clearance.

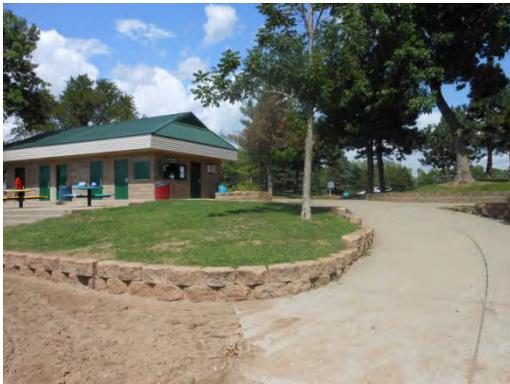
Beach Access

There is a concrete ramp from the shelter building towards the beach. The ramp ends approximately 7'-6" from the water's edge.

Priority 3- Extend the accessible route closer to the water and add additional beach access routes. *Based on Draft Accessibility Guidelines for Outdoor Developed Areas F248*

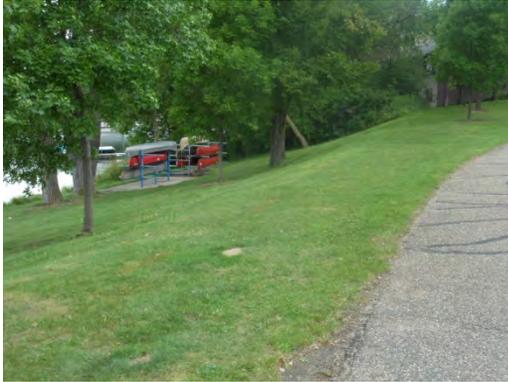
Canoe Storage

There are canoe storage racks available. There is not currently an accessible route.

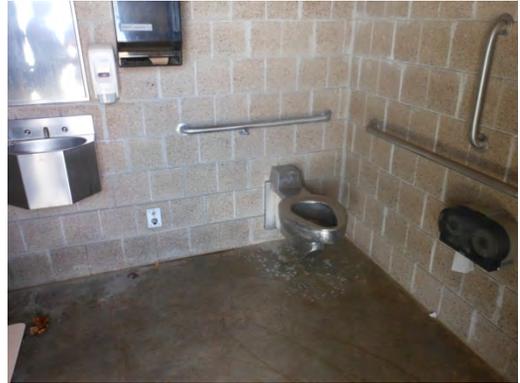
Toilet Rooms

The men's and women's toilet rooms in the shelter provide many features of accessibility.

Priority 3- Install compliant grab bars. *MN1341 604.5*

Priority 3- Replace the locking hardware on the stall door and add pull hardware. *MN1341 604.8.3*

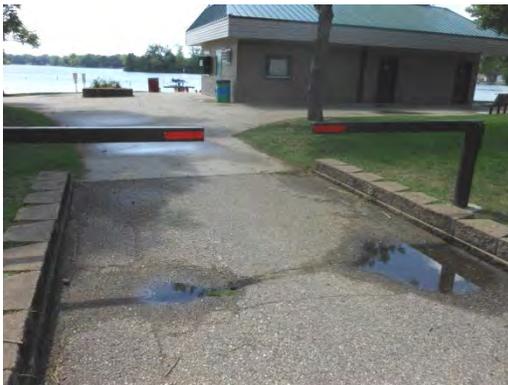
Route

The route from the parking lot to the beach currently has arms that reduce the clear width to prohibit vehicles from using the route. The style of arms used creates a protruding hazard (protruding 48" at a height of 38").

Priority 3- Modify the gates to eliminate the protruding hazard. *ADA 307*

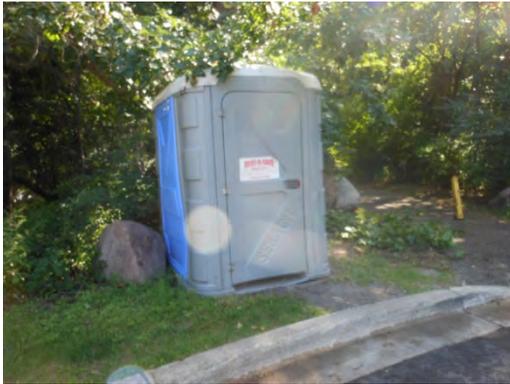
Portable Toilet

A portable toilet is located in the grass near the boat launch. The portable toilet is a larger style that provides some features of accessibility.

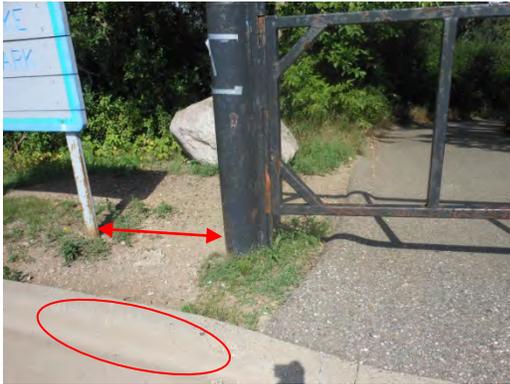
Route

There is a steep vehicle route / trail down to the beach. The route is asphalt for approximately 300' then switches to compacted dirt for 1,000'. At the parking lot there is a gate to prevent vehicles from driving down. The gate blocks the clear route to the route.

Priority 3- Modify the gate to provide a section that is 32" wide.

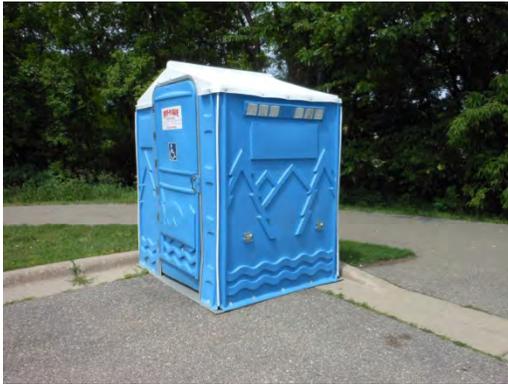
Portable Toilet

A portable toilet is located in the northeast corner of the parking lot. The portable toilet is a larger style that provides features of accessibility.

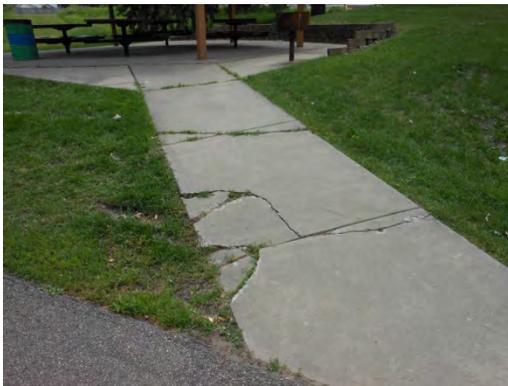
Picnic Table

There is a covered picnic shelter that can be rented/reserved. There are 4 tables, including 1 that has a bench removed to provide knee and toe clearance. An concrete link connects to the route along the lake. The concrete is cracked with a slope of 8.4% and a cross slope of 7.6%.

Priority 3- Replace the concrete link connecting to the route. Ensure the slope does not exceed 5% and the cross slope does not exceed 2%.

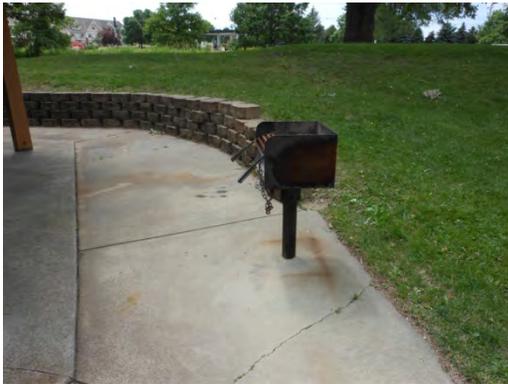
Grill

There is a grill positioned on the concrete pad, adjacent to the covered picnic shelter.

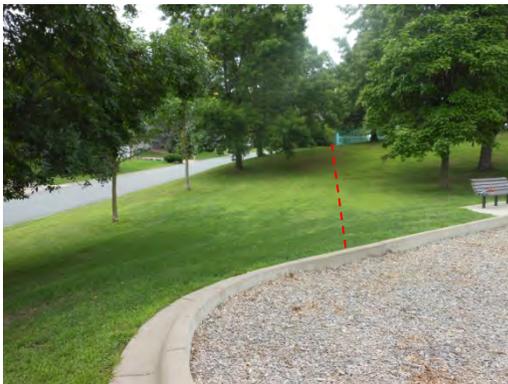
Route

There is not currently a route to the defined play area.

Priority 2- Create an accessible route to the entry to the defined play area. (Approximately 210' from the tennis court.) *ADA 206.2.17*

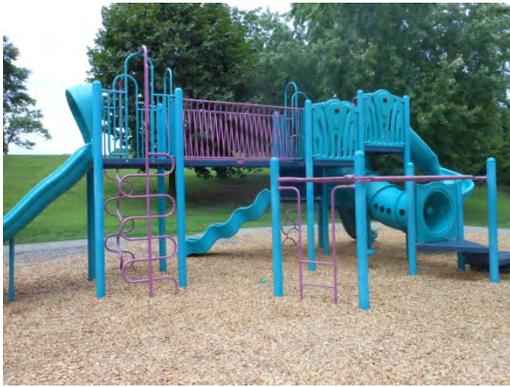
Defined Play Area

The defined play area includes 1 composite play structure, to-fro swings and a rocker. Engineered wood fiber surface material is used throughout.

Priority 2- Ensure the loose fill surface material is maintained to provide an accessible surface material. *ADA 206.2.17*

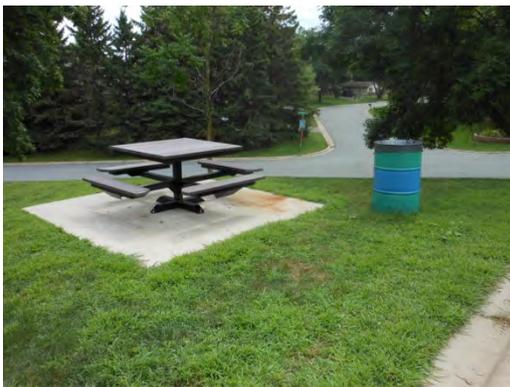
Picnic Table

There is a picnic table located adjacent to the defined play area. A section with knee and toe clearance is not currently provided and it is not located on an accessible route.

Priority 3- Replace the picnic table with a style that provides knee and toe clearance and is located on an accessible route. *Recommended based on Draft Accessibility Guidelines for Outdoor Developed Areas 1011.4*

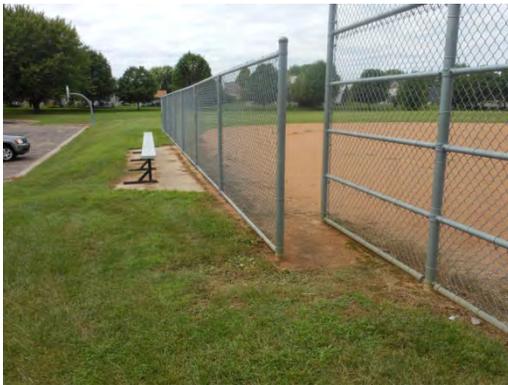
Route

There is not currently an accessible route to the baseball field or the player seating.

Priority 3- Create an accessible route to the boundary of the baseball field and the player seating (approximately 45'). ADA 206.2.2

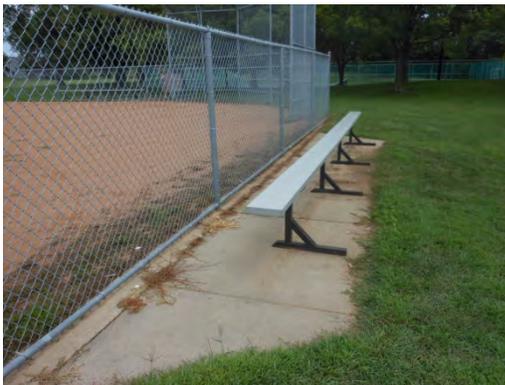
Player / Team Seating

There are fixed benches on concrete pads for team and player seating. The concrete pad is not currently large enough to provide clear ground space for a wheelchair adjacent to the bench.

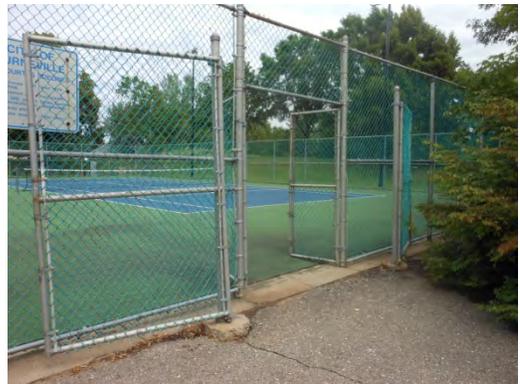
Light Controls

The controls that operate the lights have been relocated to inside the tennis court.

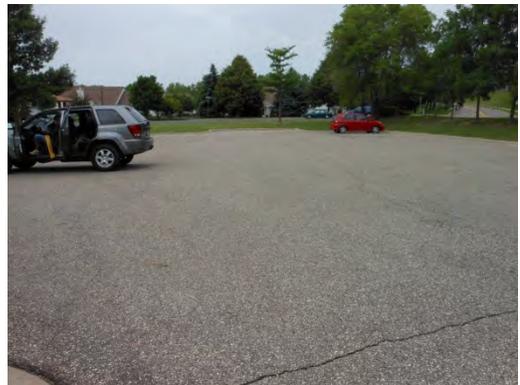
Parking

The sign for the accessible parking space is currently 90" above the surface of the parking space (versus 60"-66" maximum).

Priority 3- Relocate the permanent upright sign, so it is centered at the head-end of the accessible parking space and mounted 60"-66" above the surface of the parking space (measured to the bottom of the sign). *MN1341 502.7*

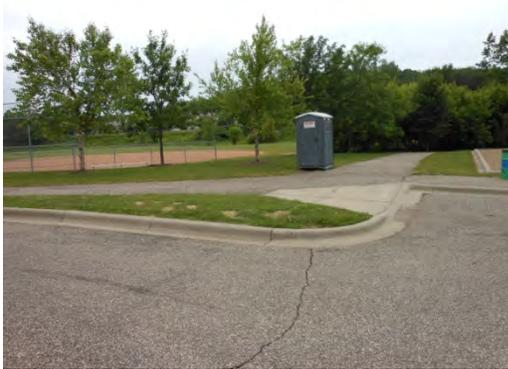
Portable Toilet

A portable toilet is located in the grass adjacent to the path near the parking lot.

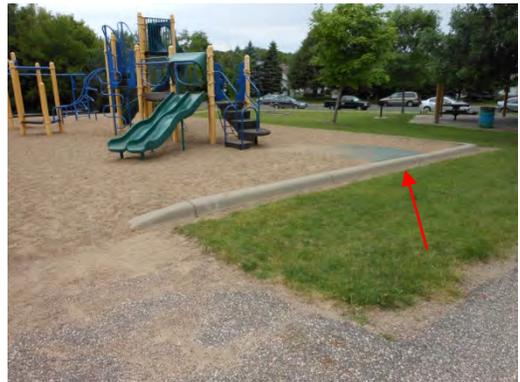
Surface Material

The surface material is currently a combination of loose fill sand and unitary surface material. The unitary surface material is provided up to the transfer deck and below the formed swing. The ground level events are not currently on an accessible route.

Priority 3- Replace the loose fill sand with a surface material that meets the accessibility requirements of ASTM 1951 as well as the impact attenuation requirements of ASTM 1292.

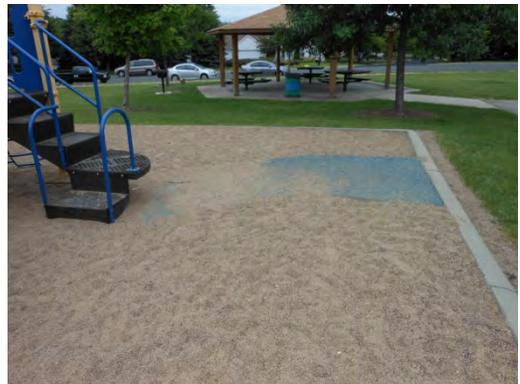
Equipment

The playground includes 1 composite structure with 16 elevated events and 4 ground level events. There is also a 4 position to-fro swing with 2 strap swings, 1 tot swing and 1 formed swing.

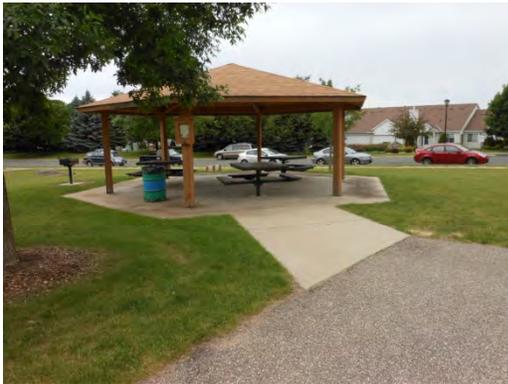
Picnic Table

There is a covered picnic shelter that can be rented/reserved. There are 3 tables, including 1 that has a bench removed to provide knee and toe clearance. An accessible route is provided.

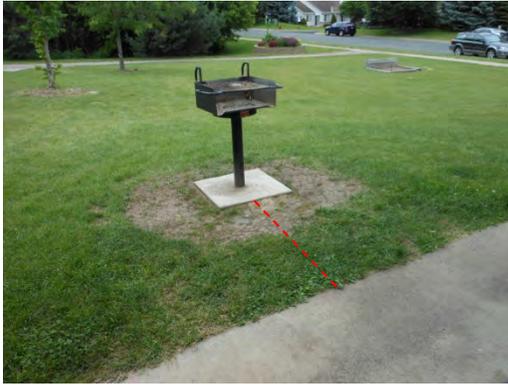
Grill

There is a grill positioned near the covered picnic shelter in the grass. A route to the grill is not currently provided.

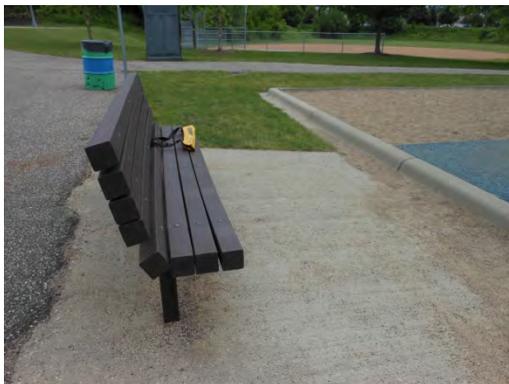
Bench

A bench has been provided adjacent to the defined play area. The bench is located adjacent to the accessible route and the concrete pad provides space for a wheelchair adjacent to the bench. The slope of the concrete pad is currently 4.5% (versus 2% maximum).

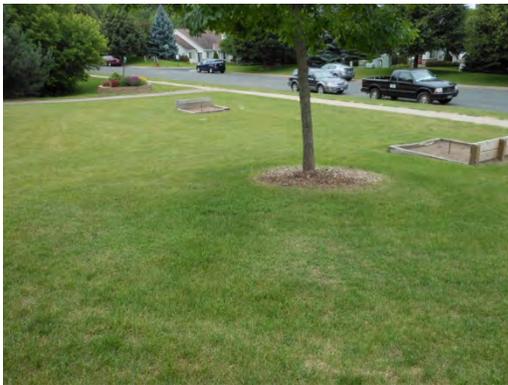
Horseshoe

The horseshoe pit is located along Greenhaven Lane. There is not currently a route from the sidewalk to the horseshoe pit.

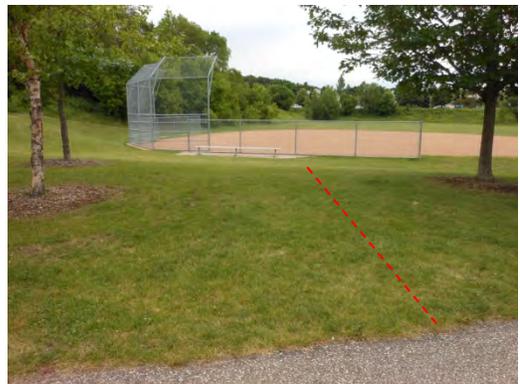
Access to field

There are fences that reduce the opening onto the field from the player seating. The opening is currently 31" wide for a distance of 36".

Priority 3- Modify the opening to 36" minimum.

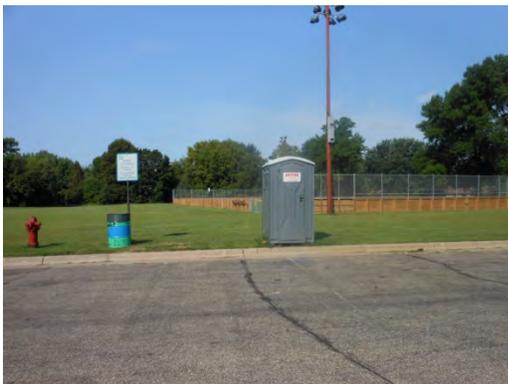
Portable Toilet

A portable toilet is located in the grass adjacent to the parking lot.

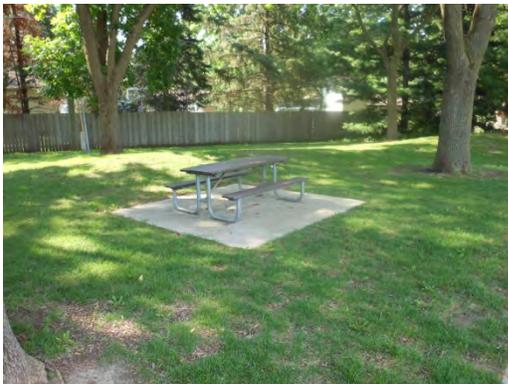
Picnic Table

There is a picnic table located approximately 9' from the defined play area. A section with knee and toe clearance is not currently provided and it is not located on an accessible route.

Priority 3- Replace the picnic table with a style that provides knee and toe clearance and is located on an accessible route. *Recommended based on Draft Accessibility Guidelines for Outdoor Developed Areas 1011.4*

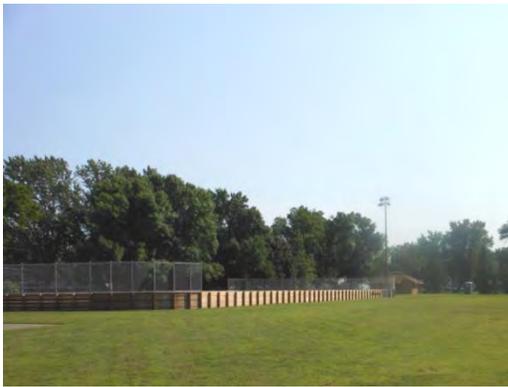
Route

There is not currently an accessible route from the parking lot or the shelter building to the hockey rink entry.

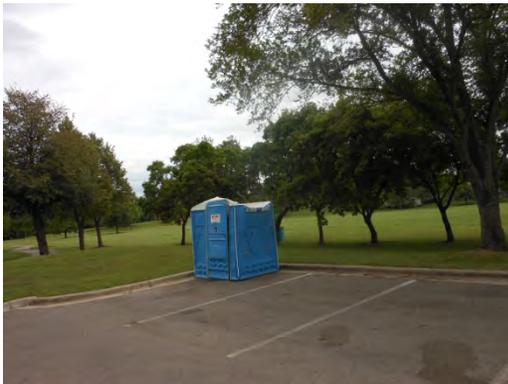
Portable Toilet

A portable toilet is located in the parking lot and is a larger style that provides features of accessibility.

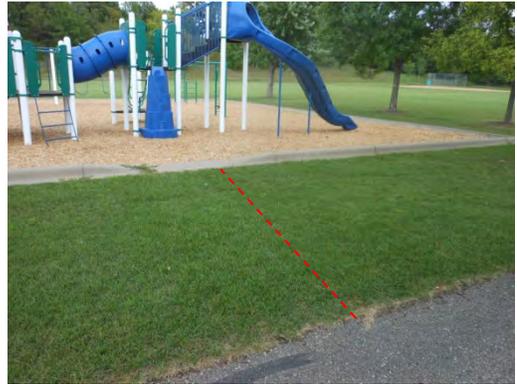
The defined play area includes 1 composite play structure, to-fro swings, freestanding climber and standing spinner. Engineered wood fiber surface material is used throughout.

Priority 2- Ensure the loose fill surface material is maintained to provide an accessible surface material. *ADA 206.2.17*

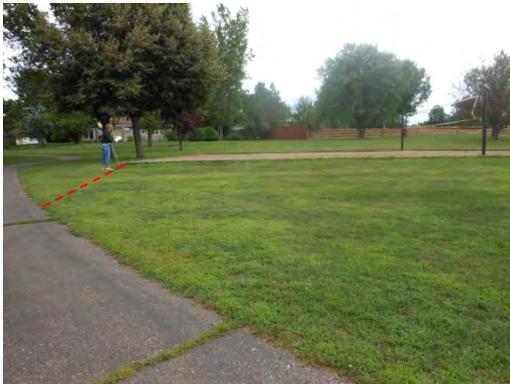
Route

There is not currently an accessible route to the sand volleyball court.

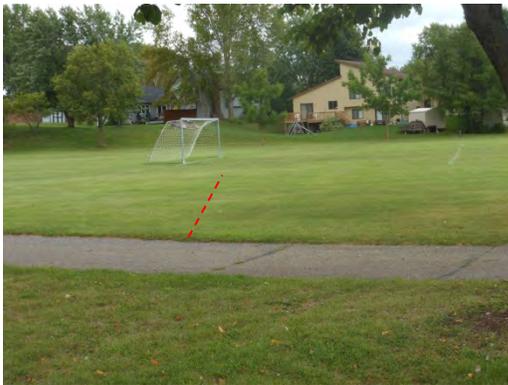
Route

There is not currently an accessible route to the soccer field.

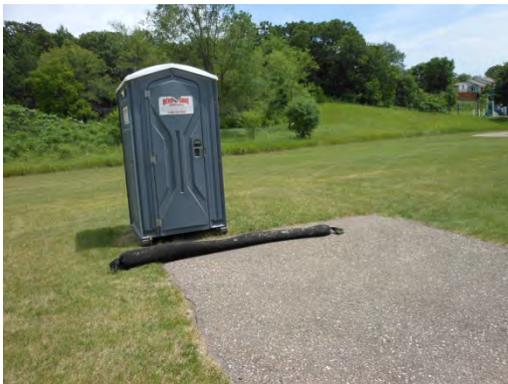
Portable Toilet

A portable toilet is located adjacent to the hard surface route in the middle of the park.

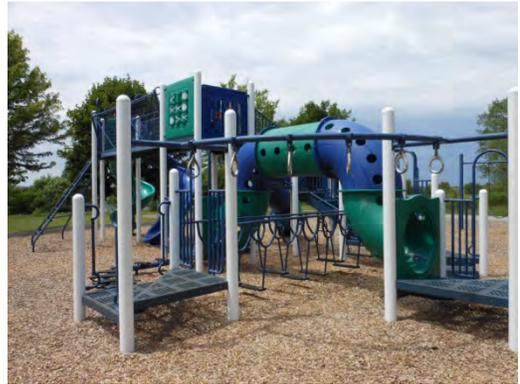
Route

An accessible route is provided to the defined play area. Currently the trash container is blocking the entry.

Priority 1- Relocate the trash container so it does not block the accessible route.

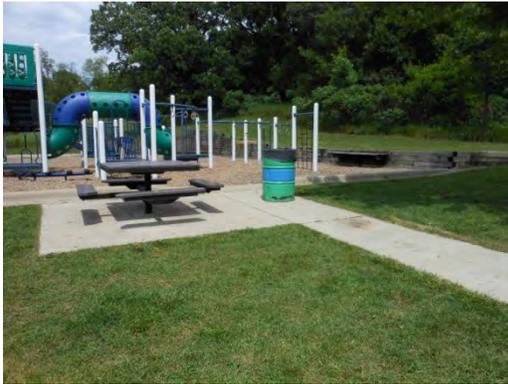
Picnic Table

There is a picnic table located adjacent to the defined play area. The table is linked to the accessible route. A section with knee and toe clearance is not currently provided.

Priority 3- Replace the picnic table with a style that provides knee and toe clearance.

Recommended based on Draft Accessibility Guidelines for Outdoor Developed Areas 1011.4

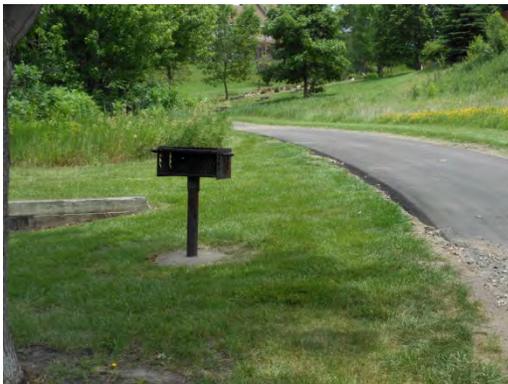
Grill

There is a grill positioned near the picnic table and the defined play area. A route to the grill is not currently provided.

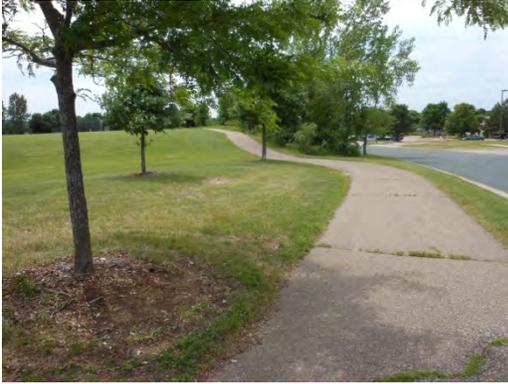
Route

An 8' wide asphalt route runs through the park. The route from the parking lot to the other park amenities is as steep as 7.2%. (Slopes between 5% and 8.33% are considered a ramp and require handrails.)

Priority 3- At such time the sidewalk/path is replaced, re-route to reduce the slope. *ADA 403.3, 405.2*

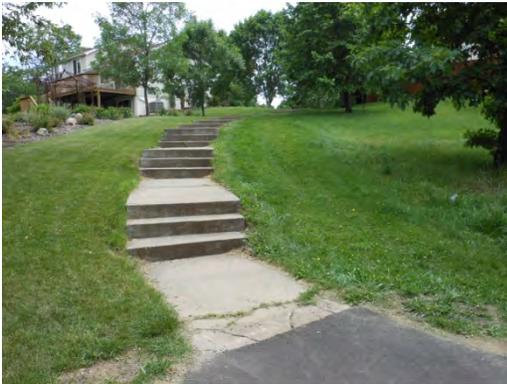
Route

There are stairs in the southeast corner of the park, connecting to the adjacent cul-de-sac.

There are no recommendations at this time.

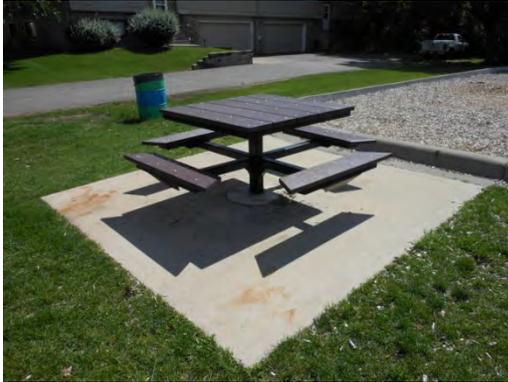
Picnic Table

There is a picnic table located adjacent to the defined play area. A section with knee and toe clearance is not currently provided and it is not located on an accessible route.

Priority 3- Replace the picnic table with a style that provides knee and toe clearance and is located on an accessible route. *Recommended based on Draft Accessibility Guidelines for Outdoor Developed Areas 1011.4*

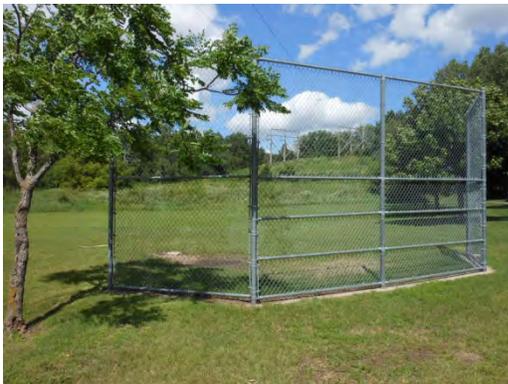
Baseball

The baseball field is located on the opposite side of the road as the defined play area and basketball court. There is not currently an accessible route to the baseball field. (It does not appear that the field is currently used or maintained.)

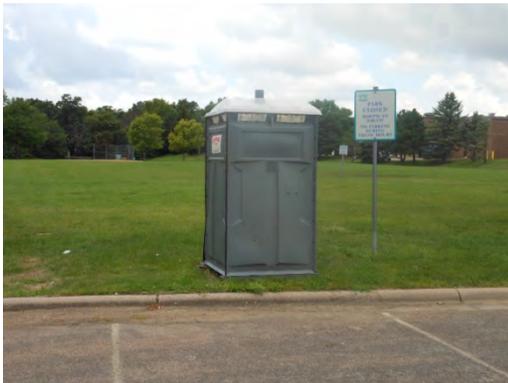
Portable Toilet

A portable toilet is located in the grass near the parking lot.

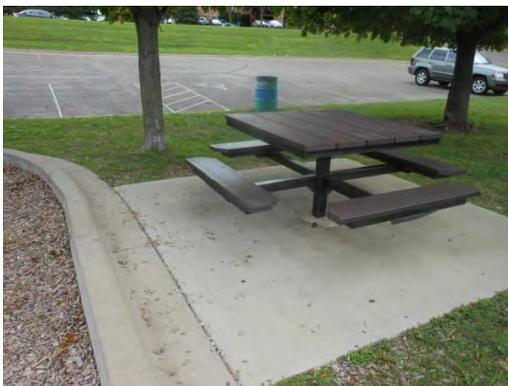
Picnic Table

There is a picnic table located adjacent to the defined play area. A section with knee and toe clearance is not currently provided and it is not located on an accessible route.

Priority 3- Replace the picnic table with a style that provides knee and toe clearance and is located on an accessible route. *Recommended based on Draft Accessibility Guidelines for Outdoor Developed Areas 1011.4*

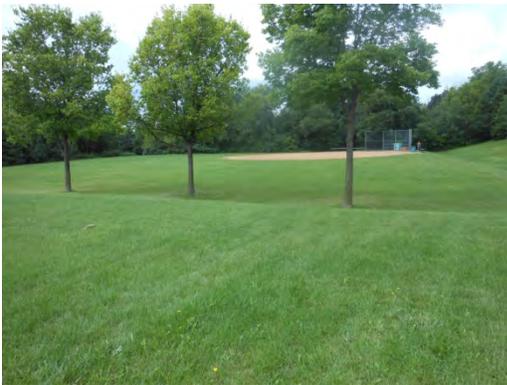
Route

The baseball field is located on the west boundary of the park. There are movable benches located on a concrete pad. There is not currently an accessible route to the field.

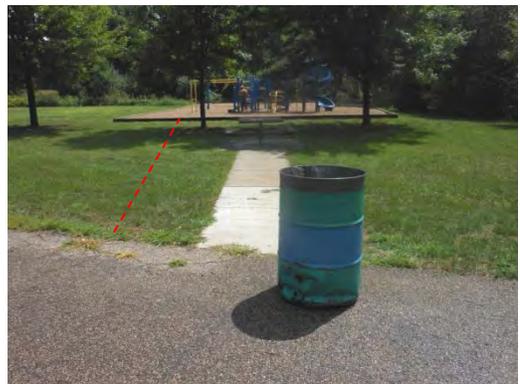
Surface Material

The surface material is currently loose fill sand throughout the defined play area. The ground level events are not currently on an accessible route.

Priority 3- Replace the loose fill sand with a surface material that meets the accessibility requirements of ASTM 1951 as well as the impact attenuation requirements of ASTM 1292.

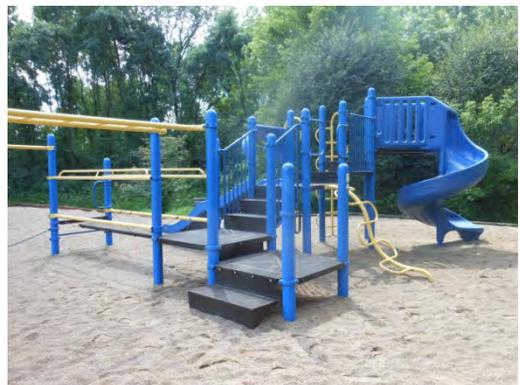
Equipment

There is a composite play structure with a transfer system, and a 4 position to-fro swing.

No recommendations at this time.

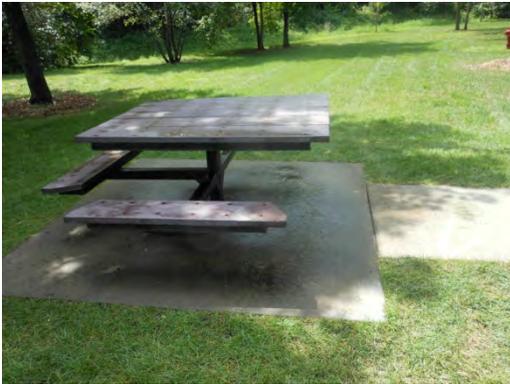
Picnic

There is a picnic table that provides knee and toe clearance and is located on an accessible route.

No recommendations at this time.

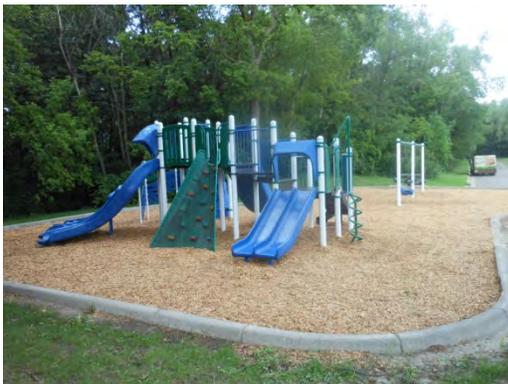
Defined Play Area

The defined play area includes 1 composite play structure and to-fro swings. Engineered wood fiber surface material is used throughout.

Priority 2- Ensure the loose fill surface material is maintained to provide an accessible surface material. ADA 206.2.17

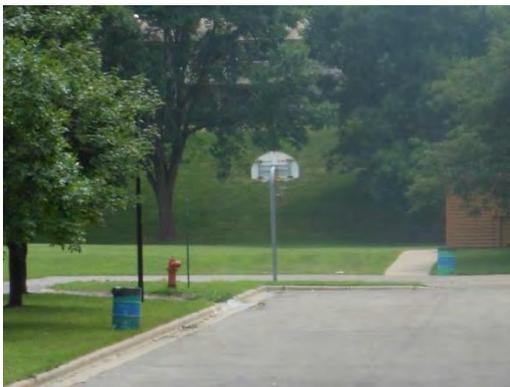
Basketball

There is an accessible route from the parking lot to the basketball court.

There are no recommendations at this time.

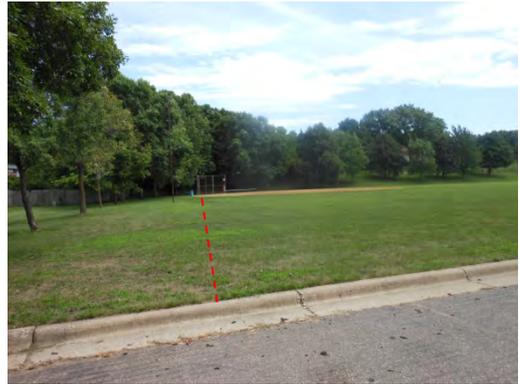
Route- Field 2

The baseball field is located in the southeast corner of the park. There are benches located on a concrete pads for player seating (movable bench on 1st base, fixed bench on 3rd base). There is not currently an accessible route to the field.

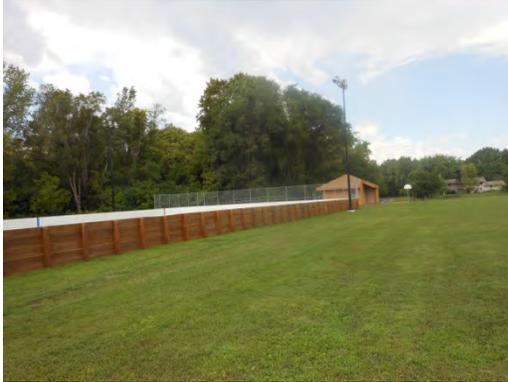
Route

There is not currently an accessible route from the parking lot or the shelter building to the hockey rink entry.

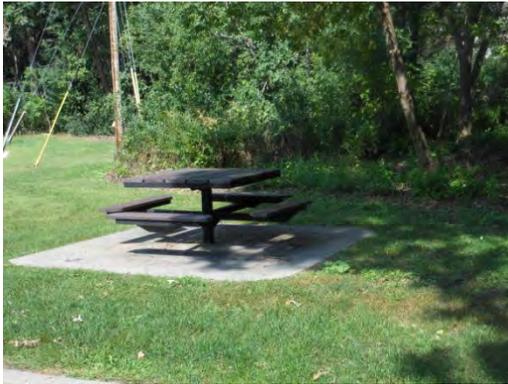
Picnic Table

There is a picnic table located near the defined play area. A section with knee and toe clearance is not currently provided and it is not located on an accessible route.

Priority 3- Replace the picnic table with a style that provides knee and toe clearance and is located on an accessible route (approximately 8' from play). *Recommended based on Draft Accessibility Guidelines for Outdoor Developed Areas 1011.4*

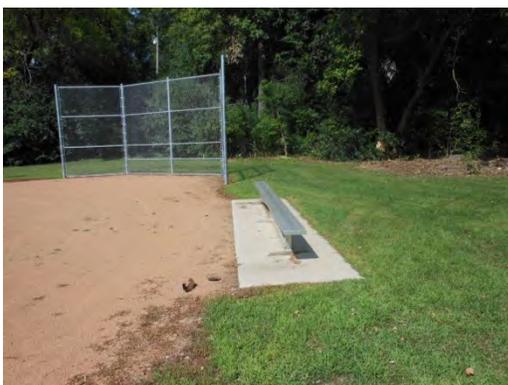
Baseball

There is not currently an accessible route from the street to the baseball field. There are fixed benches on a concrete pad; a clear ground space for a wheelchair adjacent to the bench is not currently provided.

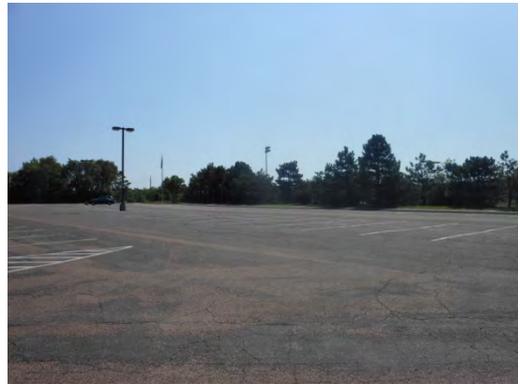
Parking- South

There are 86 parking spaces, including 4 spaces designated as accessible. The parking spaces and aisles currently have a cross slope of 3.9%.

Priority 3- Lower the signs, so they are 60"-66" above the surface of the parking space (measured to the bottom of the sign). *MN1341 502.7*

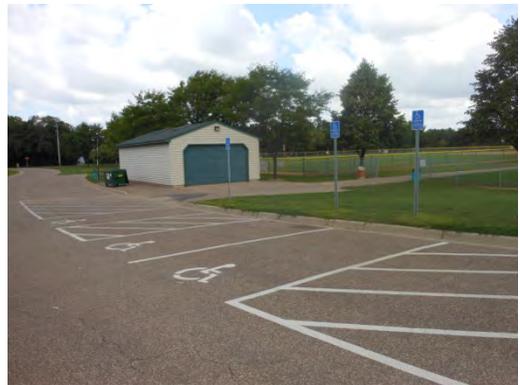
Parking- North

There are 33 parking spaces, including 1 designated as accessible. The space currently provides a 5'-4" aisle. The surface of the parking space is worn and washed-out. The curb cut is located near the head end of the parking space and can be obstructed by a parked vehicle.

Priority 3- Designate 1 additional accessible parking space. *MN1341 1106.1*

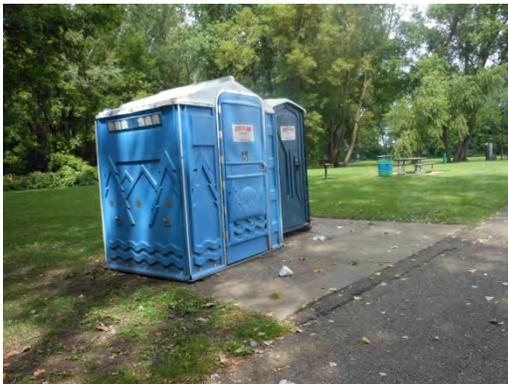
Portable Toilet- North Defined Play Area

There are 2 portable toilets, located on the accessible route. One is a larger style that provides features of accessibility.

No recommendations at this time.

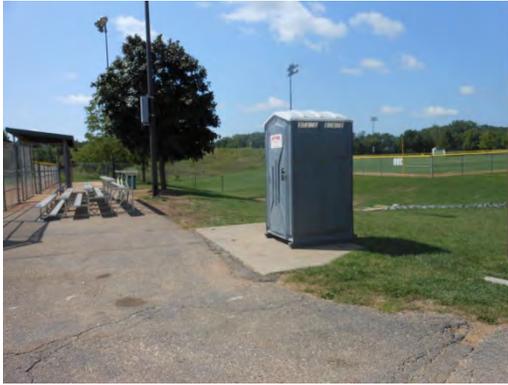
Portable Toilet- Fields E and F

A portable toilet is located near fields E and F. The toilet is currently located on an accessible route.

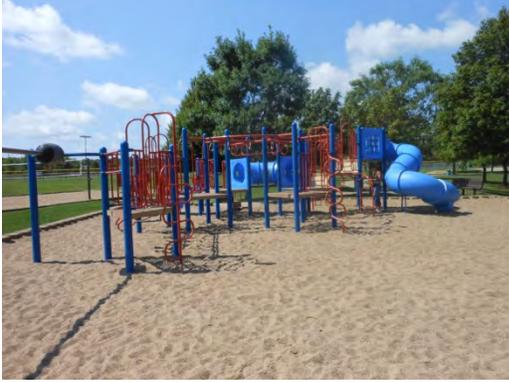
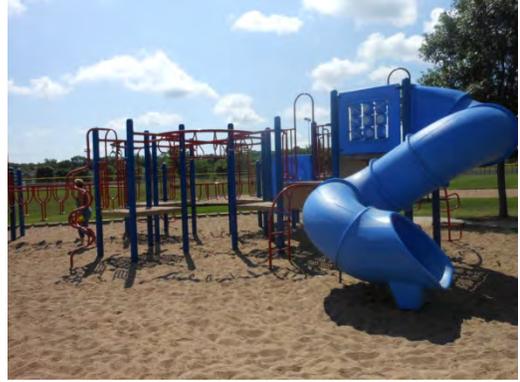
Equipment- South

The playground includes 1 composite structure and to-fro swings.

Priority 3- At such time equipment is added or replaced at this location, ensure additional ground level events are provided and are located on an accessible route. Based on the total number of elevated events (18) a total of 6 ground level play events are required. *ADA 240.2.1.2*

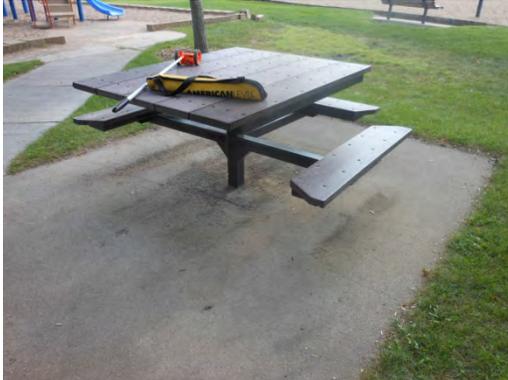
Picnic Table- South

There is a picnic table located near the south defined play area. The table provides knee and toe clearance and is located on an accessible route.

There are no recommendations at this time.

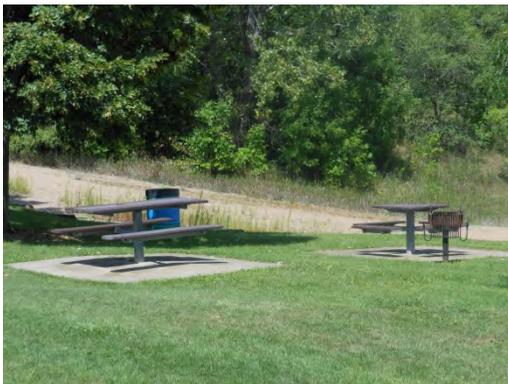
Picnic Tables- Beach

There are 5 tables on concrete pads located in the grass; 2 of the tables provide knee and toe clearance. There are also 2 grills.

Priority 3- Create an accessible route to 1 of the picnic tables that provides knee and toe clearance and 1 of the grills. *Recommended based on Draft Accessibility Guidelines for Outdoor Developed Areas 1011.4*

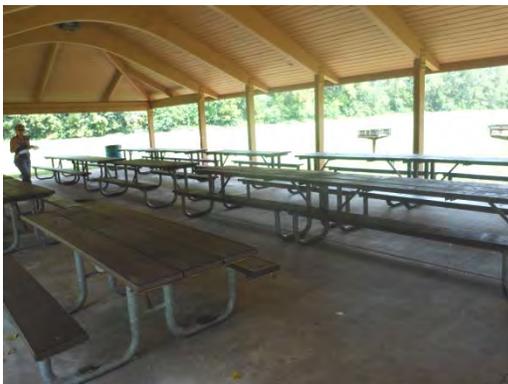
Picnic Pavilion

There are 14 tables; 2 of the tables provide knee and toe clearance at each end. The picnic pavilion is not currently located on an accessible route.

Priority 3- Provide additional picnic tables that provide knee and toe clearance. *Recommended based on Draft Accessibility Guidelines for Outdoor Developed Areas 1011.4*

Priority 2- Create an accessible route to the picnic pavilion. (Approximately 16')

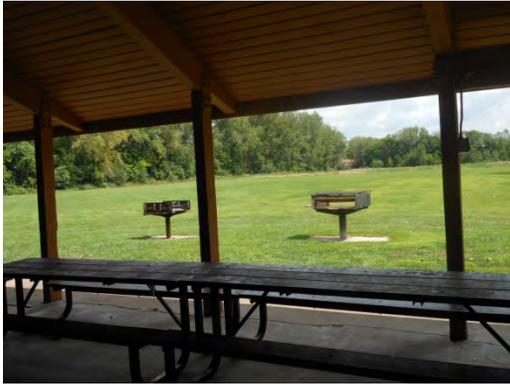
Picnic Pavilion- Grills

There are 2 grills for the picnic pavilion, they are not currently located on an accessible route.

Priority 3- Link the grill to picnic shelter to create an accessible route.

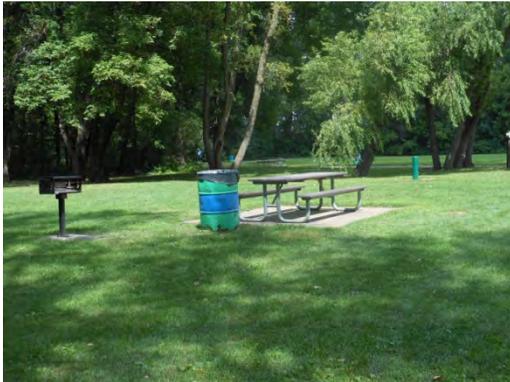
Picnic Tables- North

There are 10 tables on concrete pads located in the grass, including some with grills.

Priority 3- Create an accessible route to 1 of the picnic tables and 1 of the grills. *Recommended based on Draft Accessibility Guidelines for Outdoor Developed Areas 1011.4*

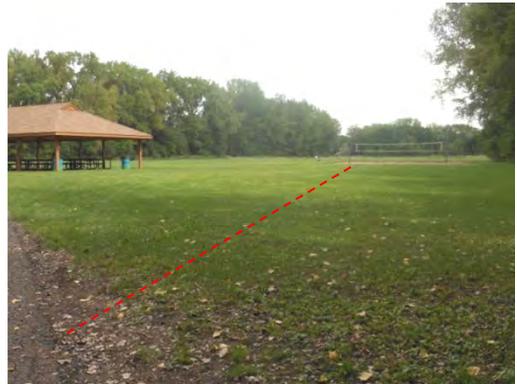
Accessible Route- South

There is not currently an accessible route to the sand volleyball court near the south defined play area.

Priority 3- Create an accessible route to the boundary of the sand volleyball court (approximately 22'). *ADA 206.2.2*

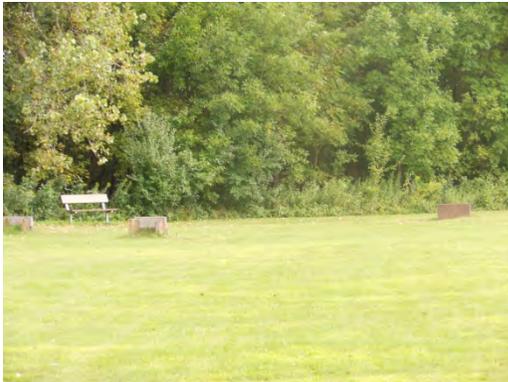
Accessible Route

There horseshoe pits located to the north of picnic pavilion. There is not currently a route from the sidewalk to the horseshoe pit.

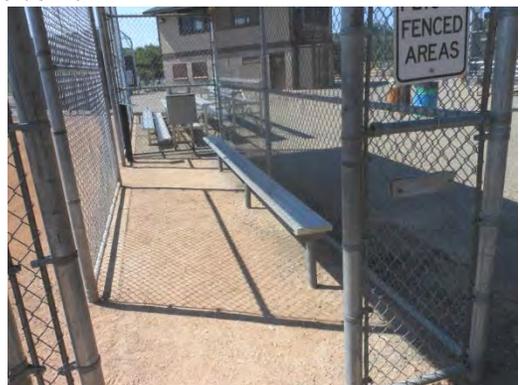
Spectator Seating- Fields A-F

Movable bleachers are provided at each of the fields. There is space for an adjacent wheelchair position at all of the bleachers.

No recommendations at this time.

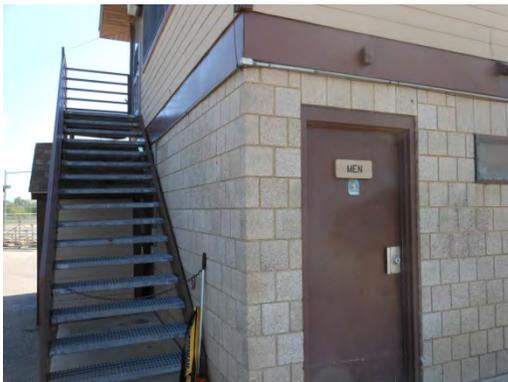
Upper Level

The concession building has an upper level office / viewing area that is approximately 30'x20'. Currently there is only stair access up to the upper level.

Priority 1- Relocate activities to an accessible location as necessary.

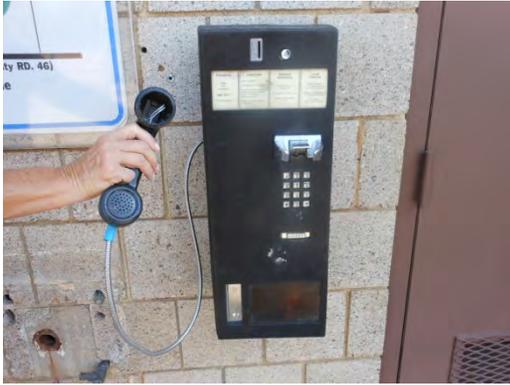
Telephone

The coin slot for the telephone is currently at 54".

Note: The phone was not working at the time of site visit.

Priority 3- Lower the telephone so the coin slot is no higher than 48". *ADA 704.2.2, 308*

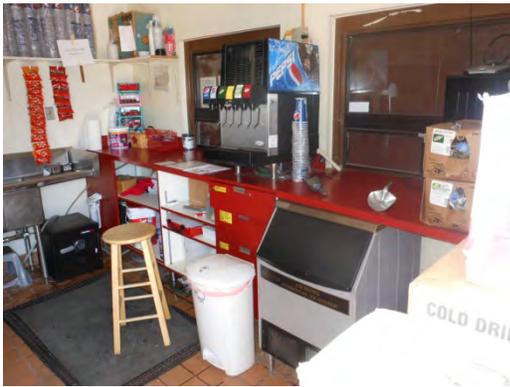
Concession Window

The service window of the concession stand is currently at 40".

Priority 3- Lower the counter to 36" maximum. *ADA 904.4*

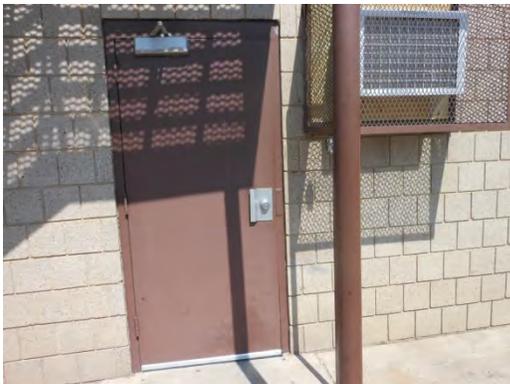
Concession- Entry

The entry to the service side of the concession counter is currently obstructed by the pole supporting the stairs and the AC unit mounted adjacent to the door. The door currently has knob style hardware.

Priority 3- Modify the entry to the concession building to provide maneuvering clearance. *ADA 404.2.4*

Priority 3- Replace the knob style hardware with lever style. *ADA 404.2.7*

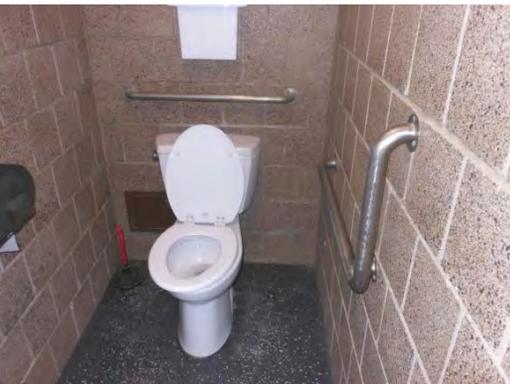
Toilet Rooms

The toilet rooms in the shelter provide features of ambulatory accessibility. There is not currently an accessible toilet room that provides a lateral transfer (60" clearance).

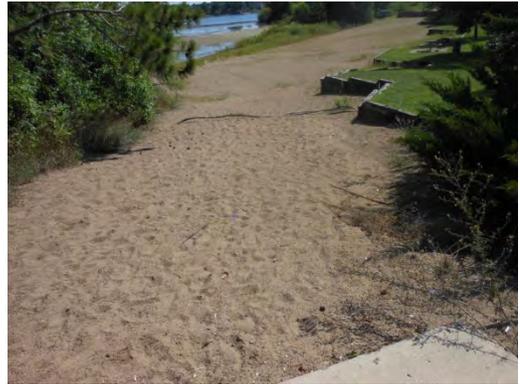
Canoe Storage

There are canoe storage racks available. There is not currently an accessible route.

No recommendations at this time.

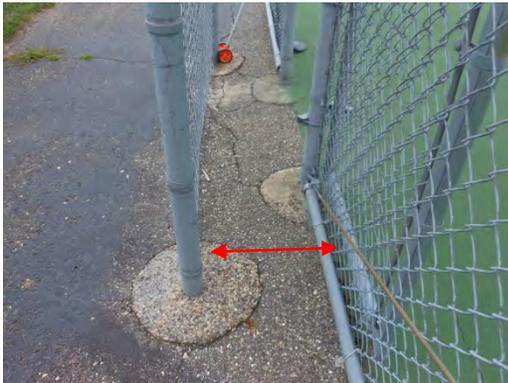
Entry

The opening onto the court is reduced to 16" (versus 32" minimum) due to the serpentine entry. (The gate provides a 39" clear opening.)

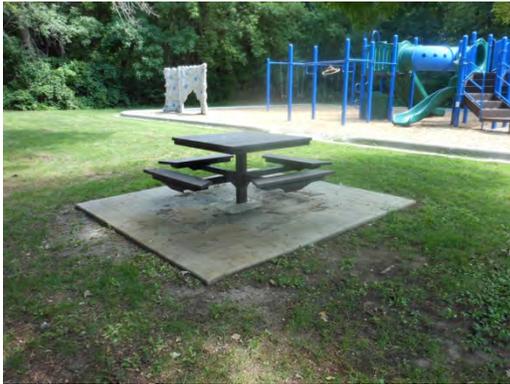
Picnic Table

There is a picnic table located near the defined play area. A section with knee and toe clearance is not currently provided and it is not located on an accessible route.

Priority 3- Replace the picnic table with a style that provides knee and toe clearance and is located on an accessible route. *Recommended based on Draft Accessibility Guidelines for Outdoor Developed Areas 1011.4*

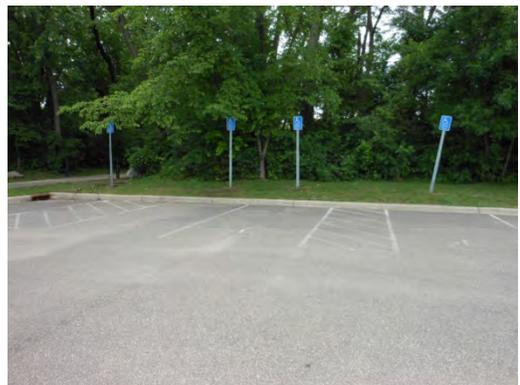
Parking- South

There are 32 parking spaces, including 2 spaces designated as accessible serving fields A and 1. The striping is very faded and there is 1 sign designating the 2 accessible spaces.

Priority 2- Re-stripe the accessible parking spaces and aisles. *MN1341 502.3, 502.4.4*

Priority 2- Add signs designating the accessible parking spaces, centered at the head end of each parking space. *MN1341 502.7*

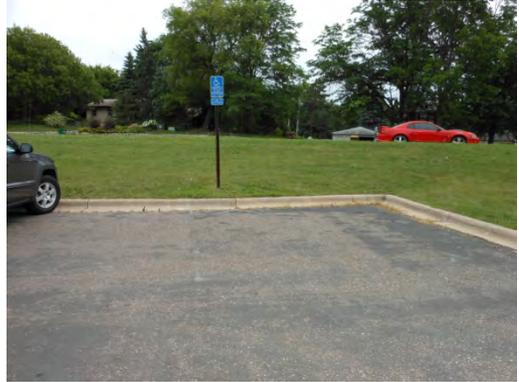
Parking- Southwest

There are 38 parking spaces, including 1 designated as accessible. There is a route with wood steps down the hill to field A.

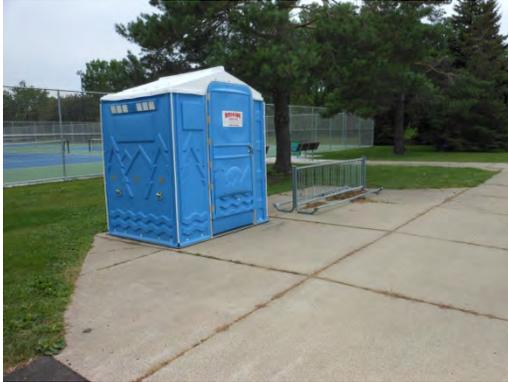
Portable Toilet- Tennis/Play/Basketball

A portable toilet is located on the accessible route and is a larger style that provides features of accessibility.

No recommendations at this time.

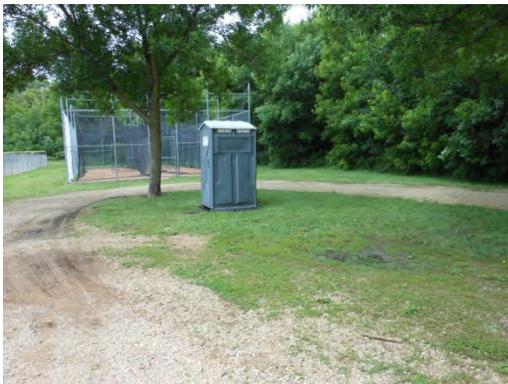
Portable Toilet- Field 2

A portable toilet is located in the grass adjacent to baseball field 2 and the batting cage.

Priority 2- Relocate the portable toilet so it is located along an accessible route.

Priority 2- Ensure an accessible portable toilet is available at the site.

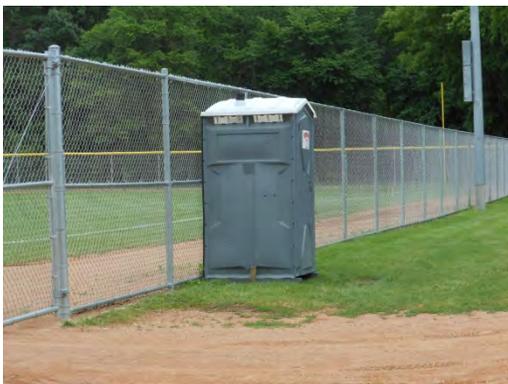
Portable Toilet- Fields 1 and A

A portable toilet is located in the grass adjacent to baseball fields 1 and A.

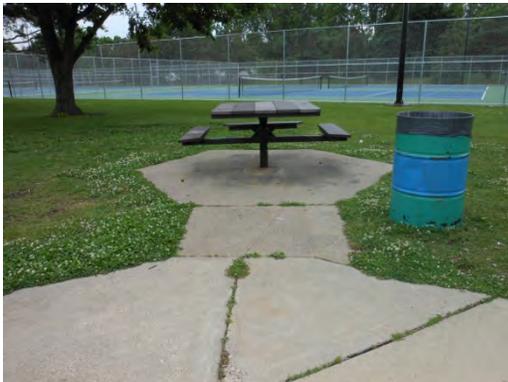
Picnic Table- West

There is a picnic table located near the defined play area. The table provides knee and toe clearance and is located on an accessible route.

There are no recommendations at this time.
