Acorn

Activities / Amenities

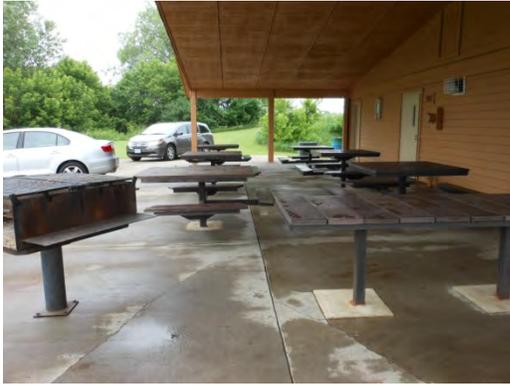
Picnic Shelter- West

There are 6 tables, a serving table and a grill in the sheltered picnic area and located on an accessible route. One table provides knee and toe clearance and is located on an accessible route.

Priority 3- Provide 1 additional picnic table that provides knee and toe clearance. Recommended based on Draft Accessibility Guidelines for Outdoor Developed Areas 1011.4

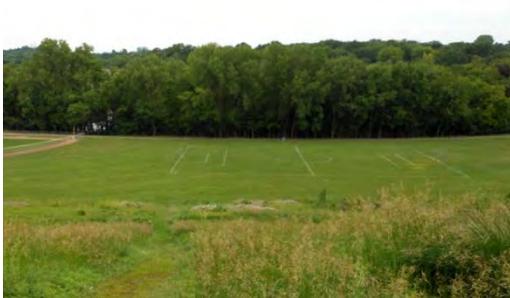
Accessible Route

There is not currently an accessible route to the soccer field.

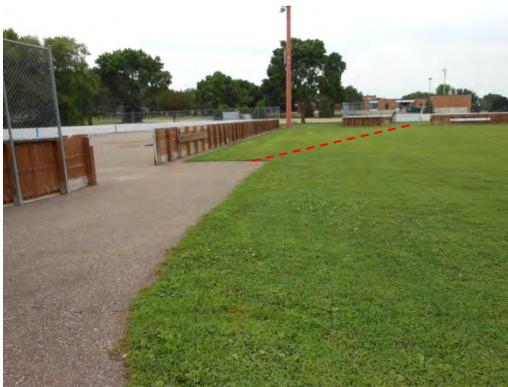
Accessible Route

There is currently an accessible route to one of the hockey rinks from the shelter building. There is not currently a route to the other rink, which was set up for lacrosse at the time of site visit.

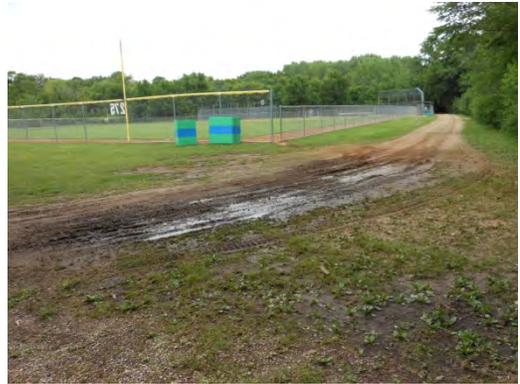
Route- Field 3

There is a paved vehicle route from parking to the field on the 3rd base side. The route does not extend to the player seating dugout.

Priority 3- Create an accessible route to the player seating. *ADA 221.2.1.4, 802.1*

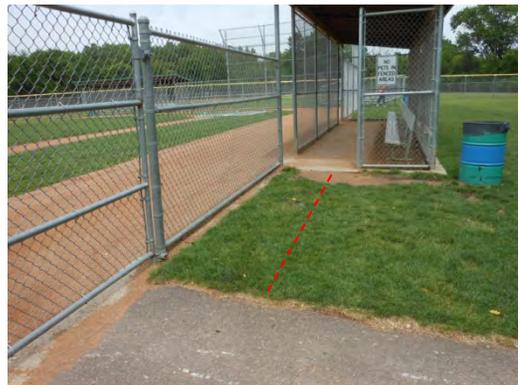
Route- Field A

There is a paved vehicle route from parking to the field on the 1st base side. The route does not extend to the player seating dugout.

Priority 3- Create an accessible route to the player seating. *ADA 221.2.1.4, 802.1*

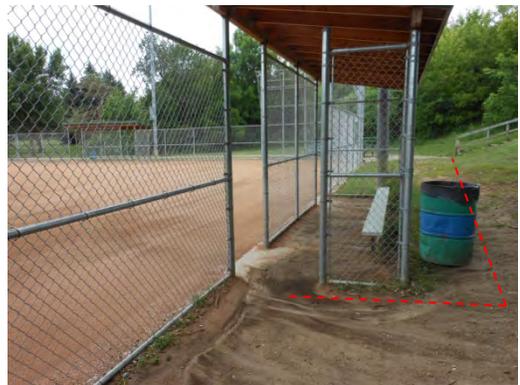
Route- Field 1 (West)

There is not currently an accessible route to the field or the player seating.

Priority 3- Create an accessible route to the boundary of the baseball field and the player seating. (Approximately 70') *ADA 206.2.2*

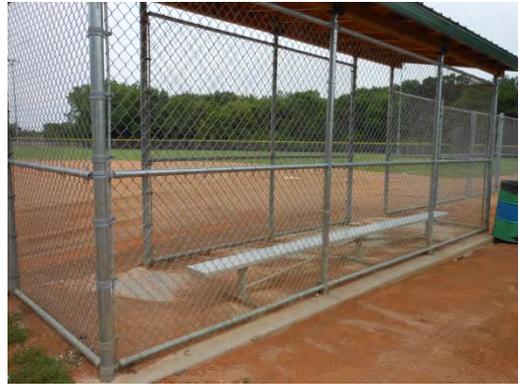
Player / Team Seating- Fields 2 and 3

The dugouts each have benches that extend the full length of the dugout for team/player seating.

Priority 3- Modify the bench in the dugout to provide a wheelchair position adjacent to the end of the bench. *ADA 221.2.1.4, 802.1*

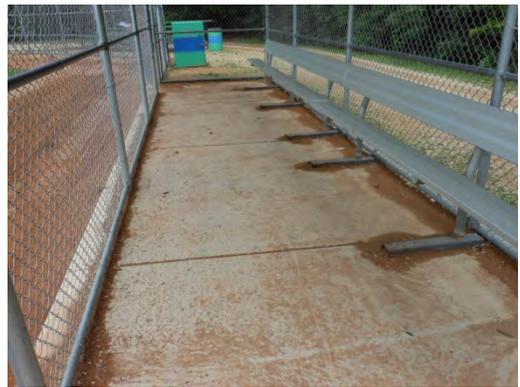
Spectator Seating- Fields 1-3

There are bleachers for spectator seating at fields 1-3. There is not currently an accessible route to the spectator seating and there is not a wheelchair position.

Priority 3- Create accessible spectator seating with an accessible route and adjacent wheelchair position. *ADA 221.2*

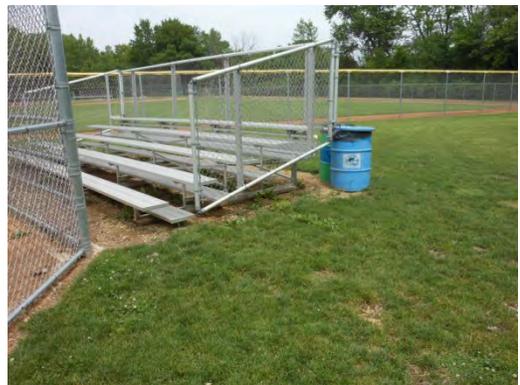
Spectator Seating- Field A

There are bleachers on an asphalt pad. Currently the position of the bleachers blocks the route to a wheelchair position.

Priority 3- Reposition the bleachers closer to the 3rd base side. *ADA 221.2*

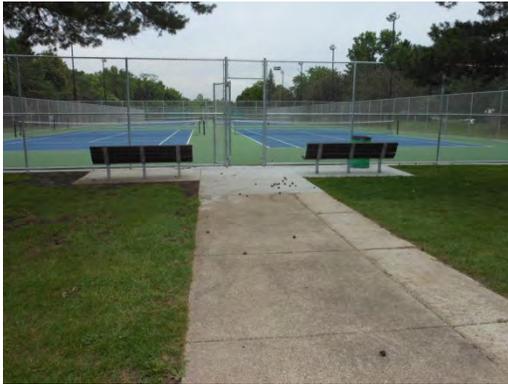
Entry

There is currently an accessible route into the tennis courts and to the light control switches.

No recommendations at this time.

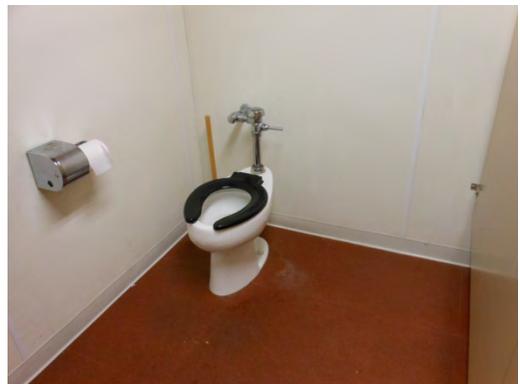
Toilet Rooms- Lower Level

There are 2 single user toilet rooms in the lower level. The rooms are currently too small to provide full features of accessibility.

Priority 3- Combine the 2 single user toilet rooms to create an accessible toilet room. *MN1341 1109.2*

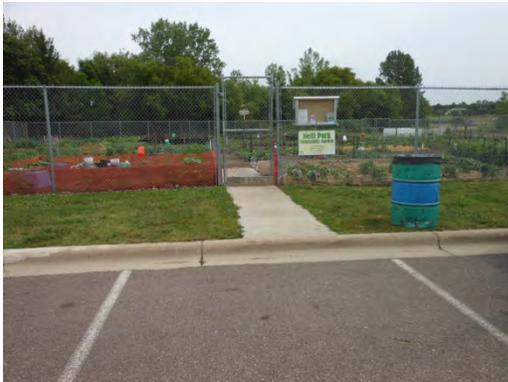
Route

A concrete route is currently provided from the parking lot into the community garden. There is not currently a curb cut.

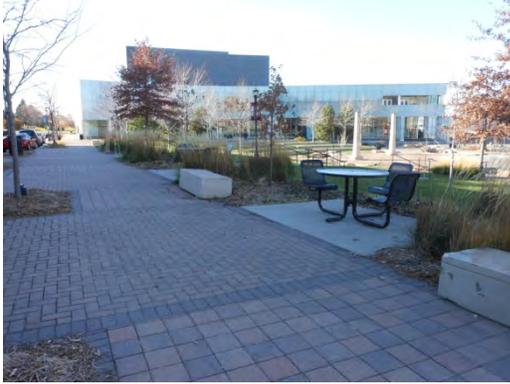
Picnic Table

There are picnic tables at the mid-level of the plaza area (stair access only) and on the top level along the sidewalk. The tables along the sidewalk provide knee and toe clearance.

No recommendations at this time.

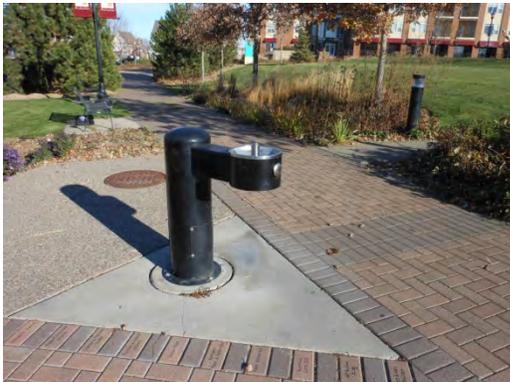
Drinking Fountain

There is 1 drinking fountain with a 36" high spout.

Priority 3- At such time the drinking fountain is replaced, provide a dual height style. ADA 211.2

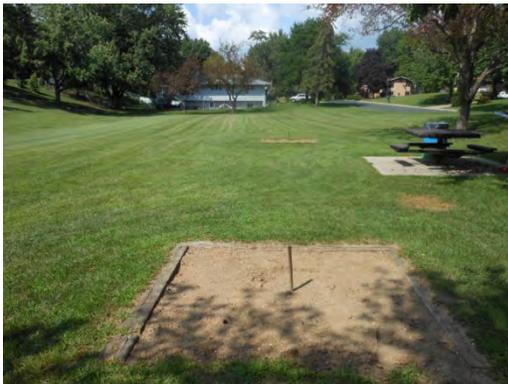
Route

There is not currently a route to the horseshoe pit.

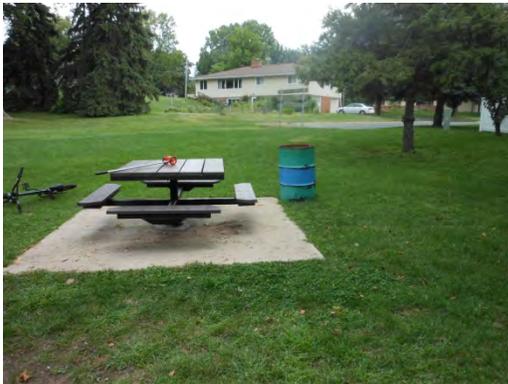
Picnic Table

There are 2 picnic tables located near the defined play area. A section with knee and toe clearance is not currently provided and it is not located on an accessible route.

Priority 3- Replace the picnic table with a style that provides knee and toe clearance and is located on an accessible route. *Recommended based on Draft Accessibility Guidelines for Outdoor Developed Areas 1011.4*

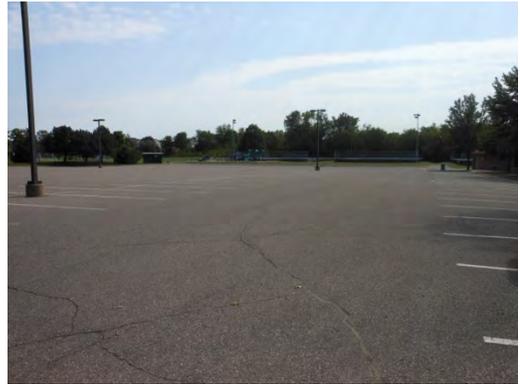
Parking- Tennis

There are 2 parking spaces designated as accessible near the tennis courts. The spaces share a 5' wide aisle. The signs are currently at 88".

Priority 3- Lower the signs, so they are 60"-66" above the surface of the parking space (measured to the bottom of the sign). *MN1341 502.7*

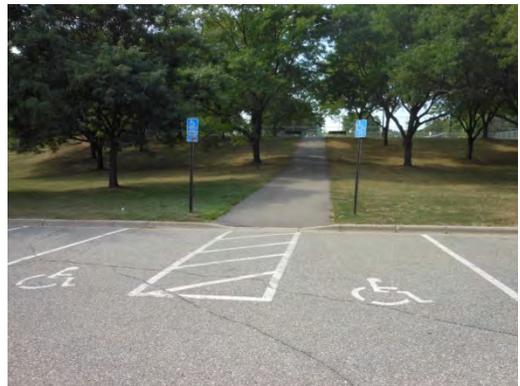
Parking- Soccer

There are 3 parking spaces designated as accessible near the soccer field (southeast corner of the parking lot). There is currently an 8' aisle shared by 2 of the spaces and a 5' aisle. The signs are currently at 83".

Priority 3- Lower the signs, so they are 60"-66" above the surface of the parking space (measured to the bottom of the sign). *MN1341 502.7*

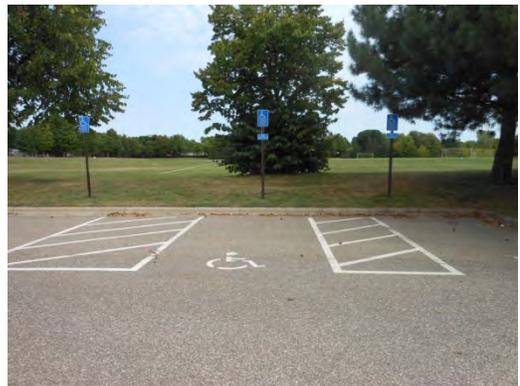
Parking- Location

The 3 accessible parking spaces near the soccer field (in the southeast corner of the parking lot) are not located on the shortest accessible route to any of the park amenities.

Priority 3- Relocate the accessible parking spaces so they are on a shorter route to amenities such as playground, picnic, hockey and shelter building.

MN1341 1106.6

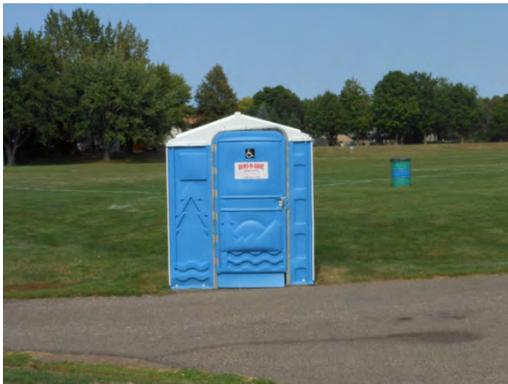
Portable Toilet

A portable toilet is located on the accessible route and is a larger style that provides features of accessibility.

No recommendations at this time.

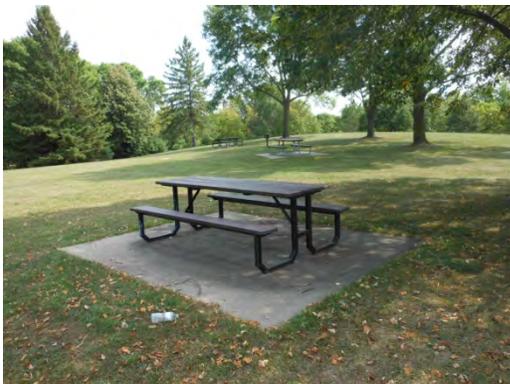
Picnic Tables

There are 6 single picnic tables on concrete pads scattered throughout the park in the grass. There is not currently an accessible route to any of the picnic tables and none of the tables provides knee and toe clearance.

Priority 3- Replace the picnic table with a style that provides knee and toe clearance and is located on an accessible route. *Recommended based on Draft Accessibility Guidelines for Outdoor Developed Areas 1011.4*

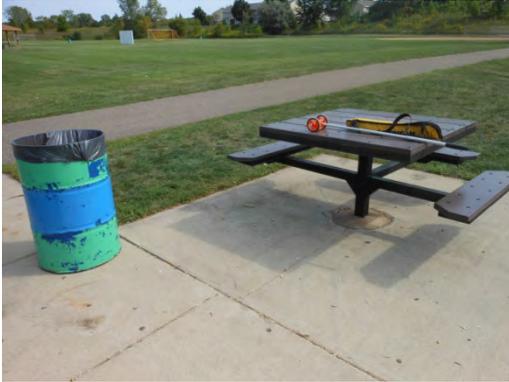
Picnic Table- Playground

The picnic table adjacent to the defined play area is located along an accessible route and provides knee and toe clearance.

JQP, Inc. Recommends
No recommendations at this time.

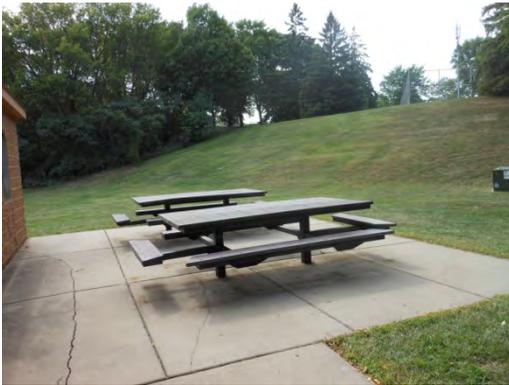
Picnic Table- Shelter
 There are 3 picnic tables located adjacent to the shelter building. They are on an accessible route. Currently none of the tables provide knee and toe clearance.

JQP, Inc. Recommends
Priority 3- Replace the picnic table with a style that provides knee and toe clearance.
Recommended based on Draft Accessibility Guidelines for Outdoor Developed Areas 1011.4

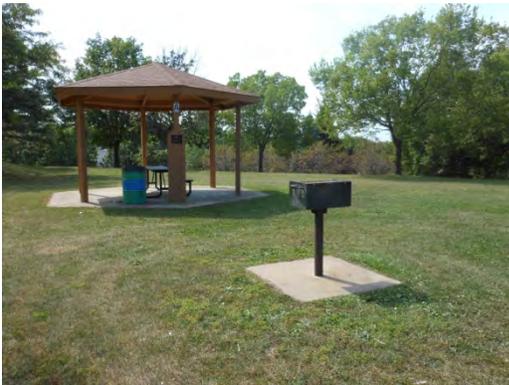
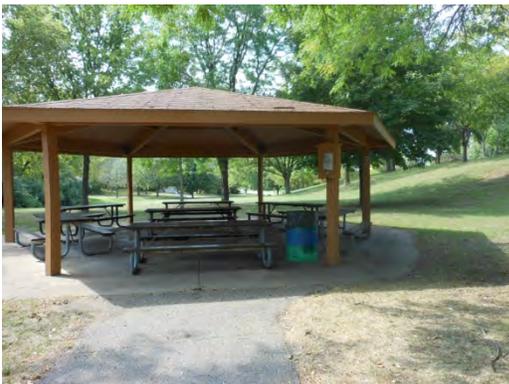
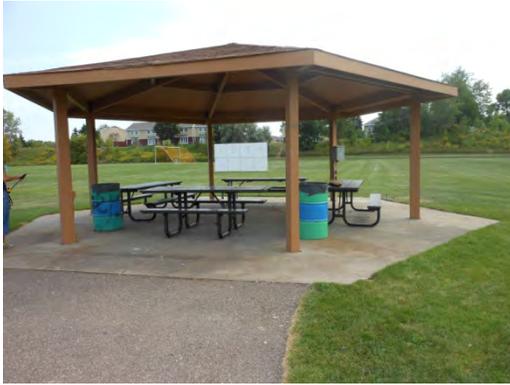
Picnic Shelters- A-C
 There are 3 covered picnic shelters- A and B are located on the west side of the park, C is located near the soccer fields. Shelters B and C are located on an accessible route. There is 1 table with knee and toe clearance at C.

JQP, Inc. Recommends
Priority 3- Provide a picnic table that provides knee and toe clearance at Shelter B.
Recommended based on Draft Accessibility Guidelines for Outdoor Developed Areas 1011.4

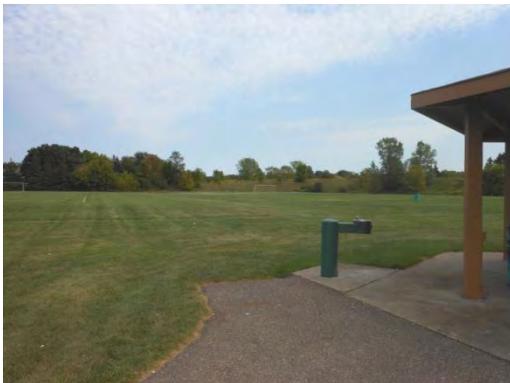
Accessible Route

There is not currently an accessible route to any of the 4 soccer fields.

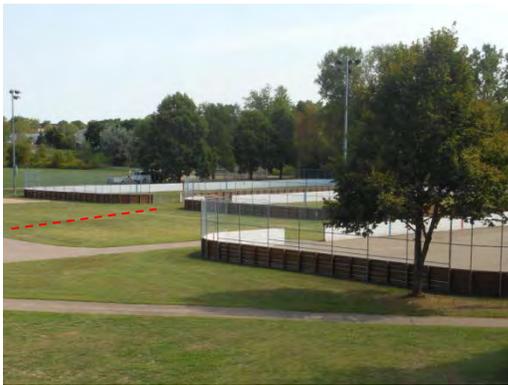
Accessible Route

There is currently an accessible route to one of the hockey rinks from the shelter building. There is not currently a route to the other 2 rinks.

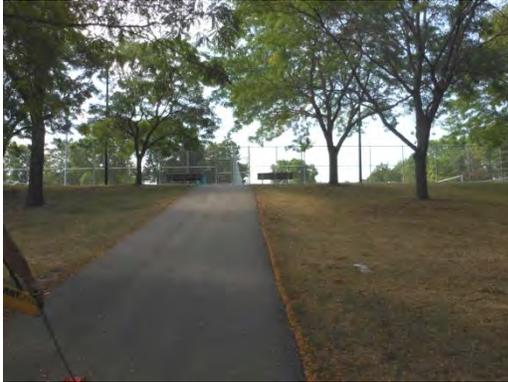
Route

The route from parking to the tennis court entry is currently as steep as 17.8%.

Priority 3- At such time the sidewalk/path is replaced, re-route to reduce the slope. *ADA 403.3, 405.2*

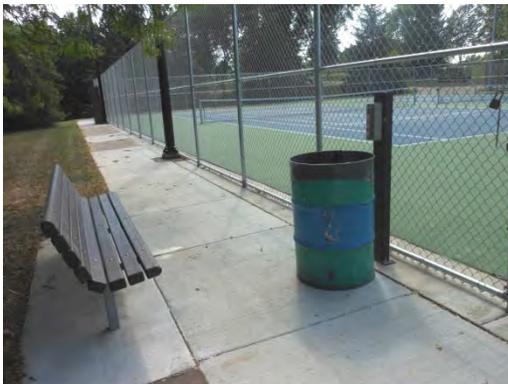
Light Control

The trash can is currently blocking the light control.

Priority 2- Relocate the trash can so it does not obstruct access to the light controls.

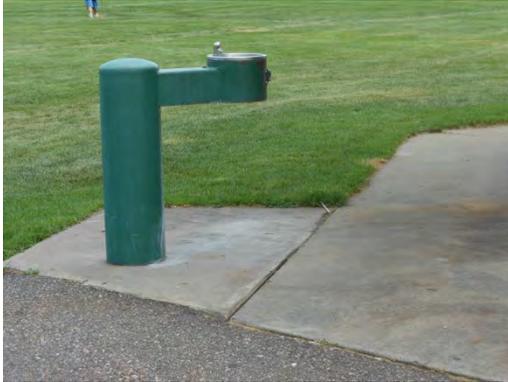
Drinking Fountain

There is a drinking fountain located near picnic shelter C. The spout is currently at 38".

Priority 3- At such time the drinking fountain is replaced, provide a dual height style. *ADA 211.2*

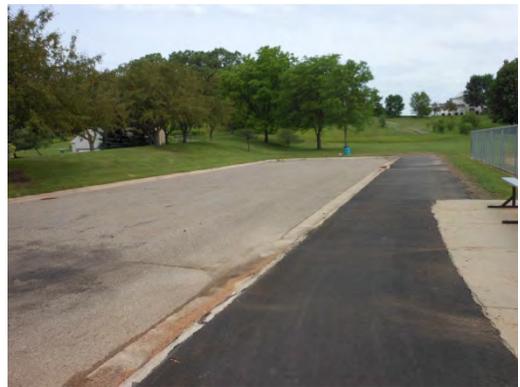
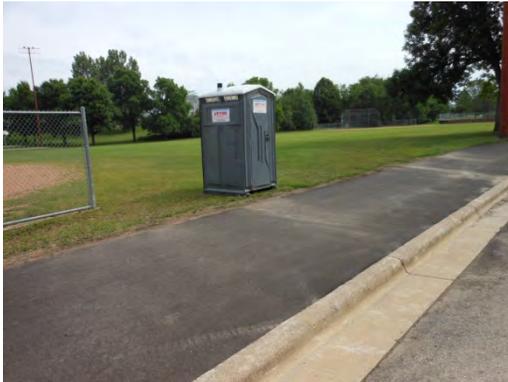
Portable Toilet

A portable toilet is located in the grass adjacent to the path near the parking lot.

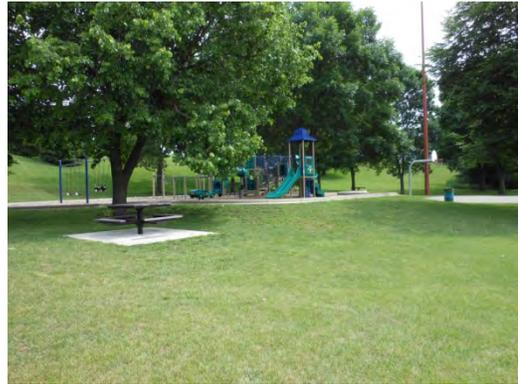
Defined Play Area

The defined play area includes 2 composite play structures, to-fro swings, a steering wheel and a rocker. Engineered wood fiber surface material is used throughout.

Priority 2- Ensure the loose fill surface material is maintained to provide an accessible surface material. ADA 206.2.17

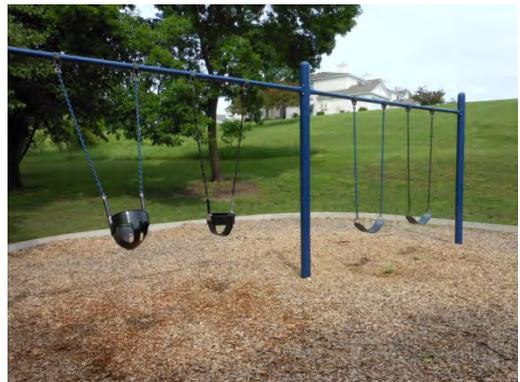
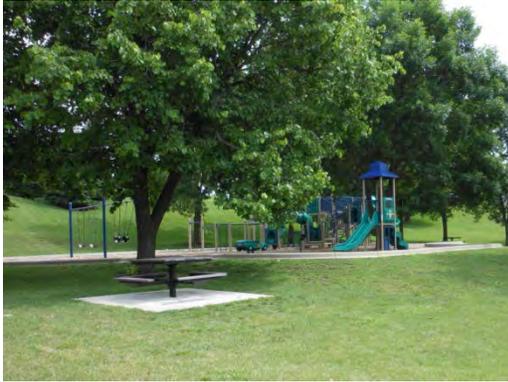
Picnic

There are 2 picnic tables located on concrete pads near the defined play area. Currently there is not a route to either of the tables and they do not provide knee and toe clearance.

Priority 3- Replace the picnic table with a style that provides knee and toe clearance.

Recommended based on Draft Accessibility Guidelines for Outdoor Developed Areas 1011.4

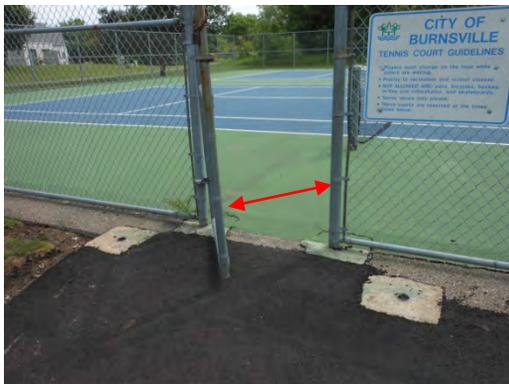
Entry

The tennis court is located on an accessible route. The entry gate is chained, reducing the clear opening to 29".

Priority 2- Remove the chain to provide a 32" minimum clear opening. *ADA 403.5.1*

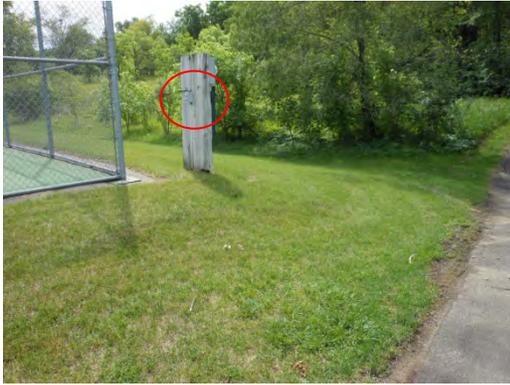
Light Controls

The controls that operate the lights on the tennis court are located near the southwest corner of the court. They are located approximately 12' from the accessible route.

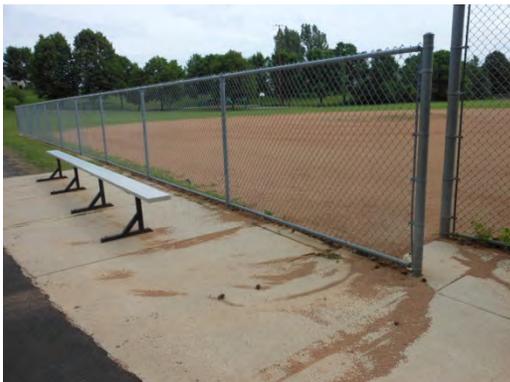
Field 1

An accessible route is provided to the player seating and onto the field at Field 1.

Schedule games to take place at this field.

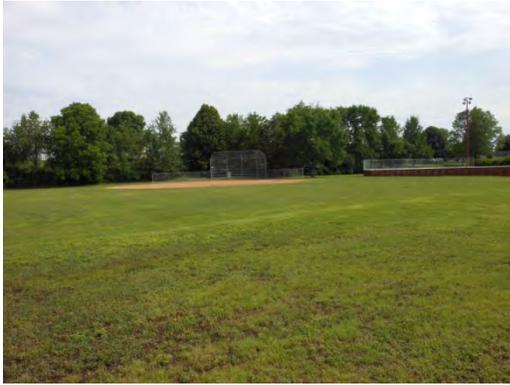
Field 2

There is not currently an accessible route to Field 2.

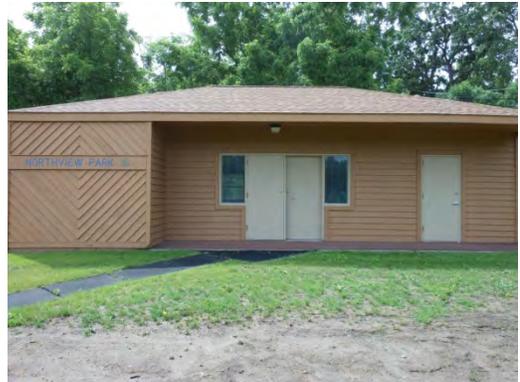
Toilet Room

The toilet room has been remodeled to provide features of accessibility.

Priority 3- Replace the privacy lock with a style that does not require tight grasping, pinching or twisting to operate. ADA 309.4

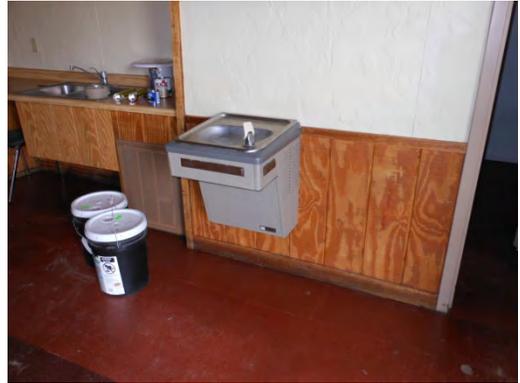
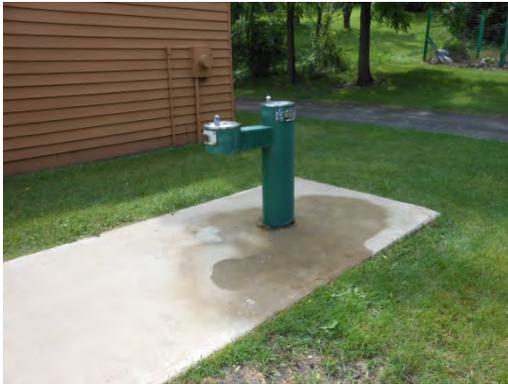
Drinking Fountain

There is an exterior drinking fountain located near the shelter building. It is located on an accessible route and provides 36" and 42" spout heights.

No recommendations at this time.

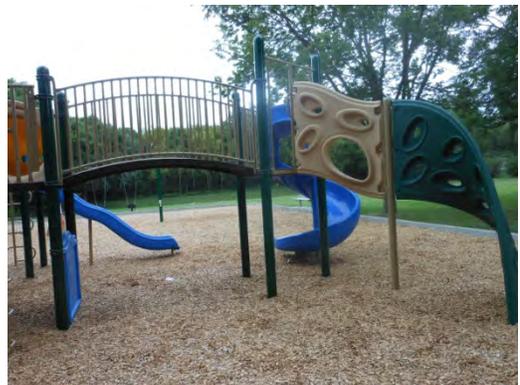
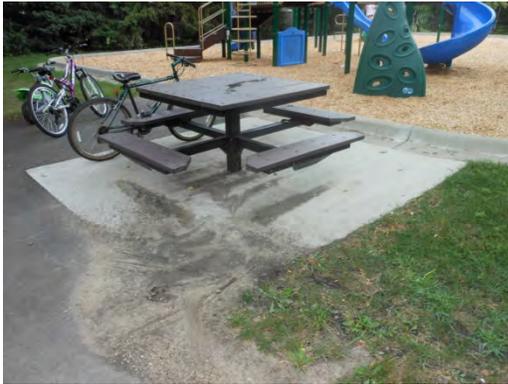
Picnic Table

There is a picnic table located adjacent to the defined play area. A section with knee and toe clearance is not currently provided.

Priority 3- Replace the picnic table with a style that provides knee and toe clearance.

Recommended based on Draft Accessibility Guidelines for Outdoor Developed Areas 1011.4

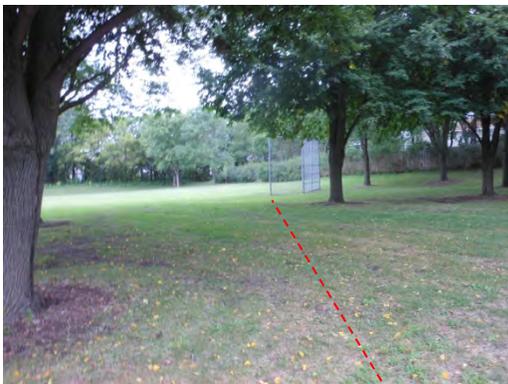
Route

There is not currently an accessible route to the baseball field or the player seating.

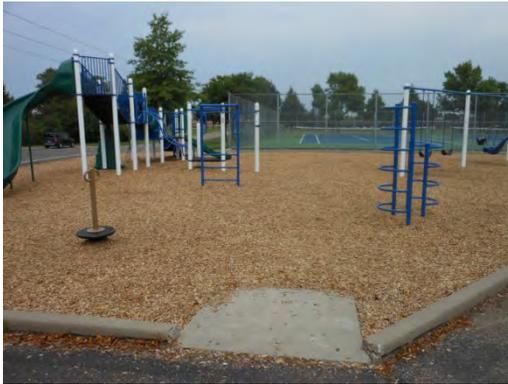
Defined Play Area

The defined play area includes 1 composite play structure, to-fro swings, freestanding climber and standing spinner. Engineered wood fiber surface material is used throughout.

Priority 2- Ensure the loose fill surface material is maintained to provide an accessible surface material. *ADA 206.2.17*

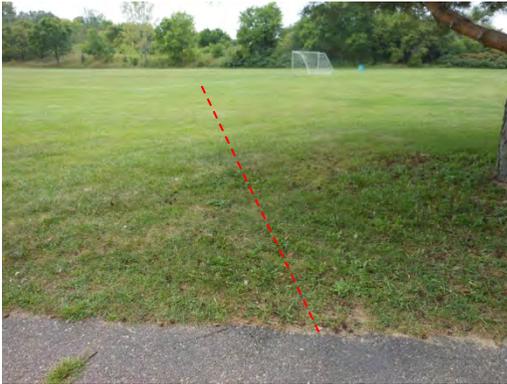
Route

There is not currently an accessible route to the soccer field from the path that runs through the park.

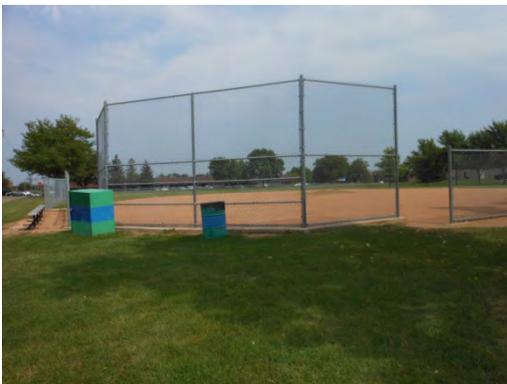
Route

There is not currently an accessible route to the baseball field.

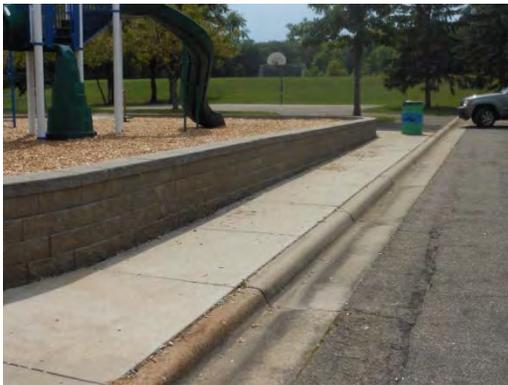
Accessible Route

The accessible route from parking to the park amenities is currently obstructed by the trash can. (The route between the defined play area and tennis court is too steep to be considered an accessible route- 9.9% slope and 7.3% cross slope.)

Priority 2- Relocate the trash can.

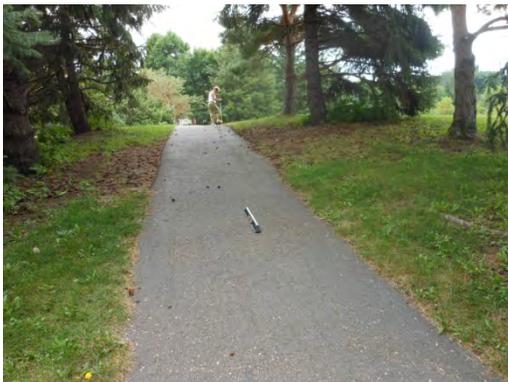
Accessible Route

The route along the east border of the park (serving the soccer field) is currently as steep as 11.9%. (Slopes between 5% and 8.33% are considered a ramp and require handrails.)

Priority 3- At such time the sidewalk/path is replaced, re-route to reduce the slope. *ADA 403.3, 405.2*

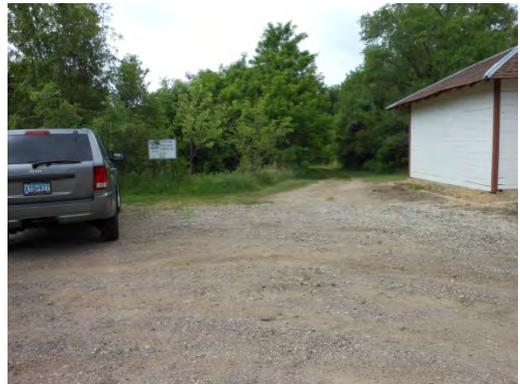
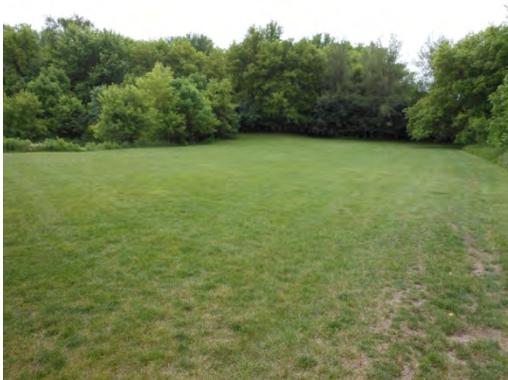
Open Field

There is an open multi-purpose field.

No recommendations at this time.

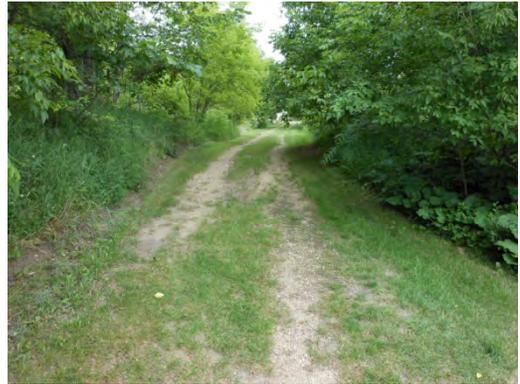
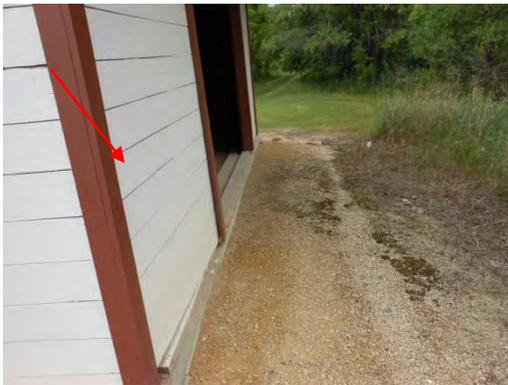
Shelter

There is a small shelter building (possibly a former railroad building). There is not currently an accessible route into the shelter.

Priority 3- Create an accessible route to the shelter.

Priority 3- Eliminate the change in level exceeding 1/2" at the entry to the shelter.

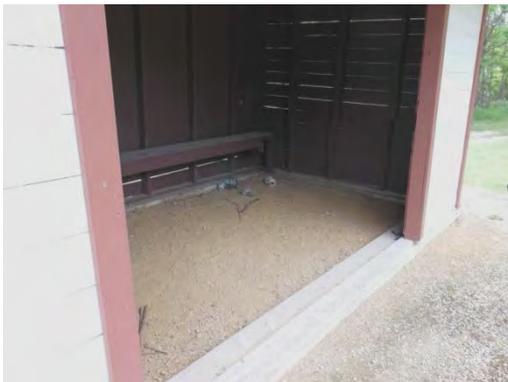
Bench

There is a bench extending the full length of the back wall of the shelter. There is not room adjacent to the bench to provide wheelchair position.

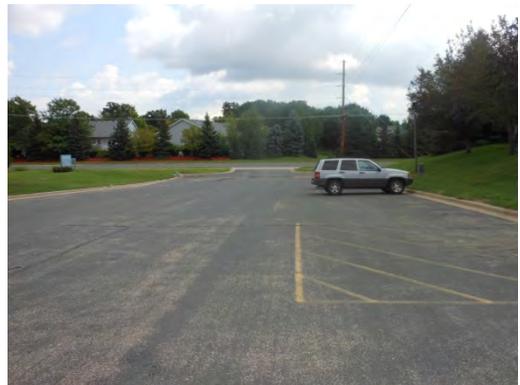
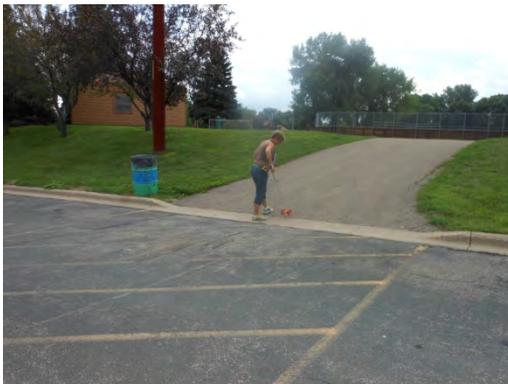
Route

There is a service driveway that creates a route to the shelter building, play equipment and hockey rink. The slope of the route currently exceeds 8.33%.

No recommendations at this time; an alternate route is available.

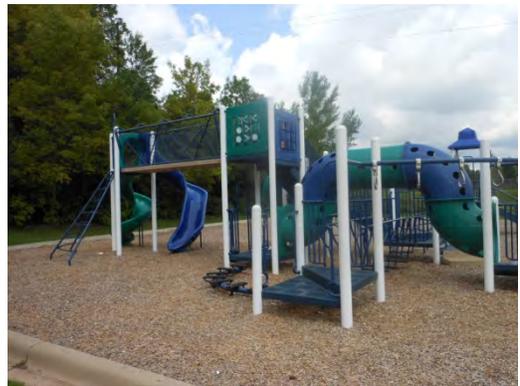
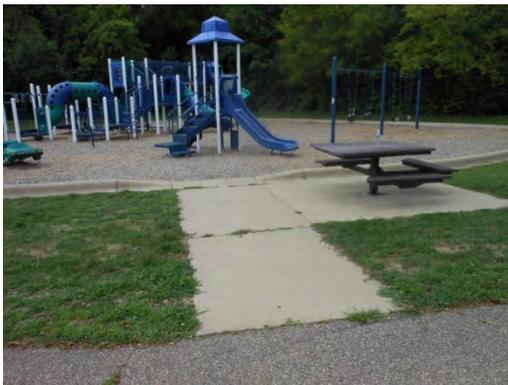
Picnic Table

There is a picnic table located adjacent to the defined play area. A section with knee and toe clearance is provided.

No recommendations at this time.

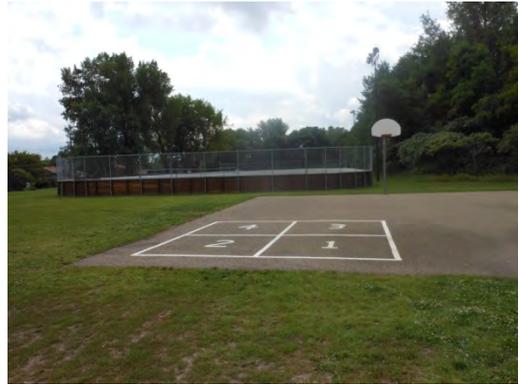
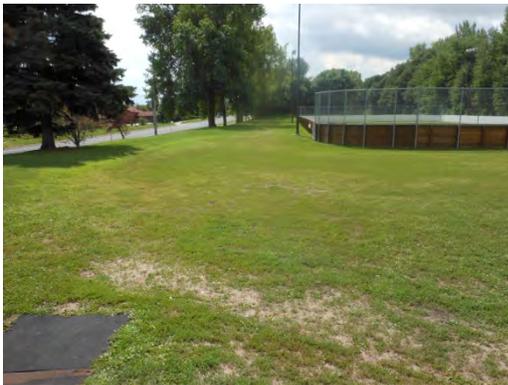
Route

There is not currently an accessible route from the parking lot or the shelter building to the hockey rink entry.

Priority 3- Create an accessible route to the hockey rink. (Approximately 95') ADA 206.2.2

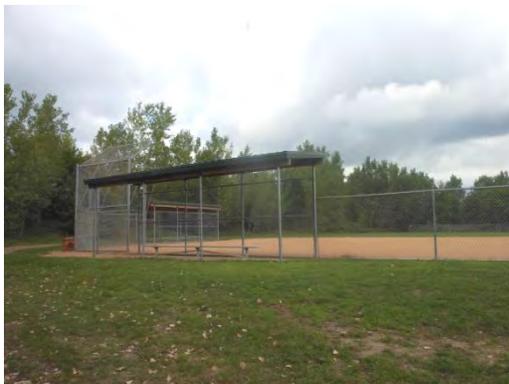
Route

There are fixed benches on concrete pads for player seating. The field is located near the accessible route, but the route does not currently link to the player seating.

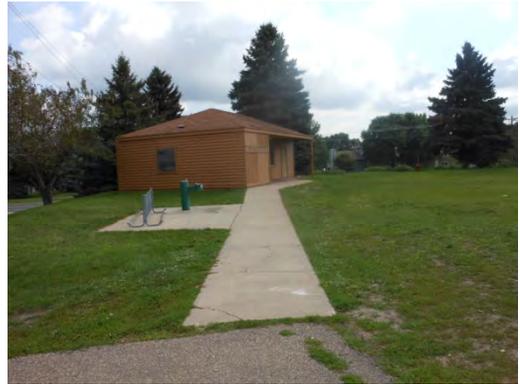
Entry

There is currently a 1" gap and a 2" change in level at the entry.

Priority 2- Modify the entry so the change in level and gap are 1/2" maximum. *ADA 302.3, 303.1*

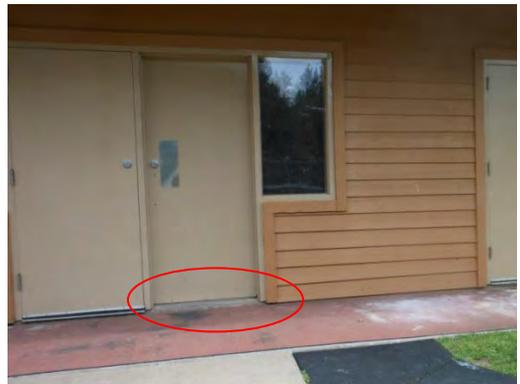
Toilet Room

There are features of accessibility provided in the single user toilet rooms.

Priority 2- Add signs with raised and braille characters at the exterior entry to the toilet room.

Priority 3- Replace the privacy lock with a style that does not require tight grasping, pinching or twisting to operate. *ADA 309.4*

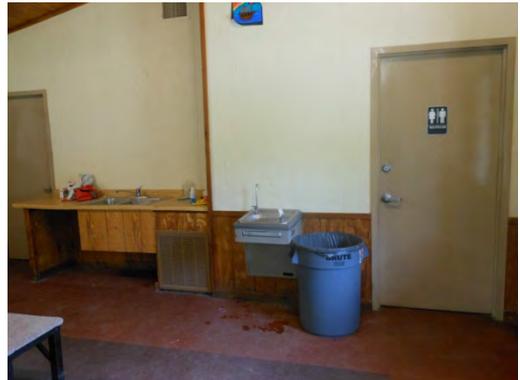
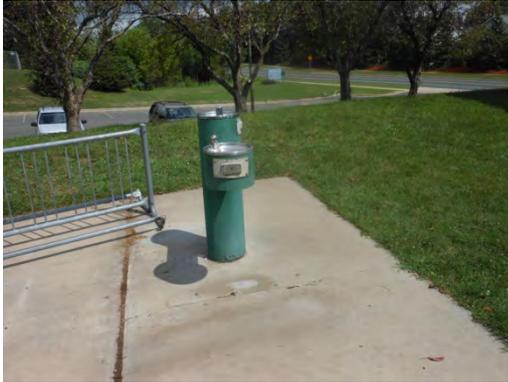
Drinking Fountain

There is an exterior drinking fountain located near the shelter building. It is located on an accessible route and provides 36" and 42" spout heights.

No recommendations at this time.

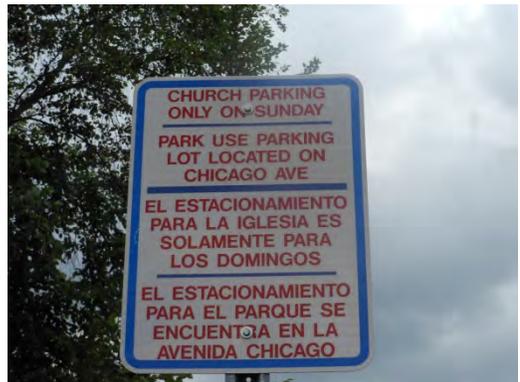
Soccer

There is not currently an accessible route from the church parking lot to the soccer field.

Priority 3- Create an accessible route to the boundary of the soccer field. *ADA 206.2.2*

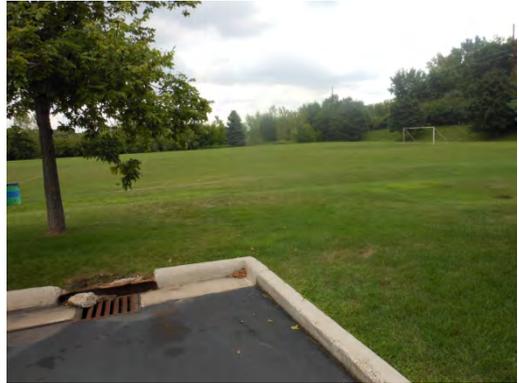
Tennis

There is not currently an accessible route from the church parking lot to the soccer field.

Priority 3- Create an accessible route to the entry to the tennis courts. (Approximately 31') *ADA 206.2.2*

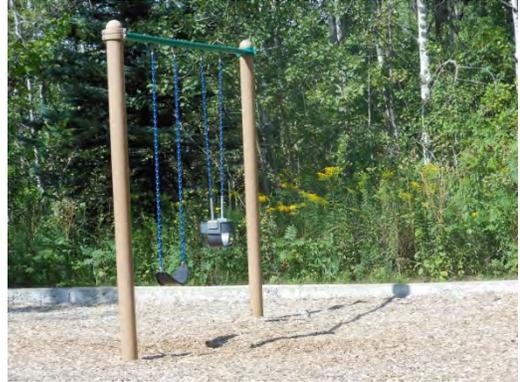
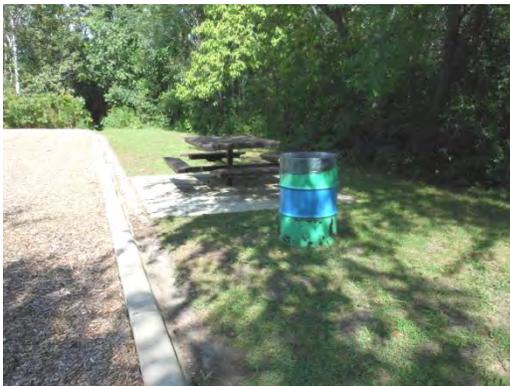
Picnic Table

There is a picnic table located adjacent to the defined play area. A section with knee and toe clearance is not currently provided and it is not located on an accessible route.

Priority 3- Replace the picnic table with a style that provides knee and toe clearance and is located on an accessible route. *Recommended based on Draft Accessibility Guidelines for Outdoor Developed Areas 1011.4*

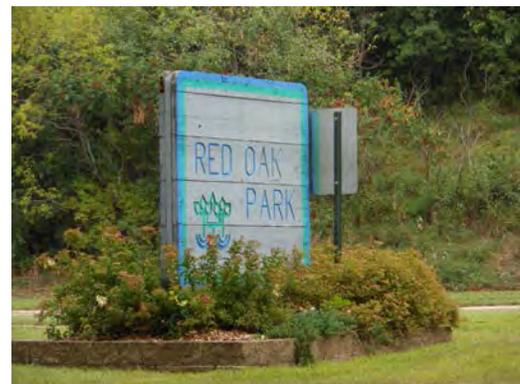
Parking

There are 2 locations of off street parking- south lot serving the disc golf course and a north lot.

Priority 3- Designate 2 accessible parking spaces. *MN1341 1106.1*

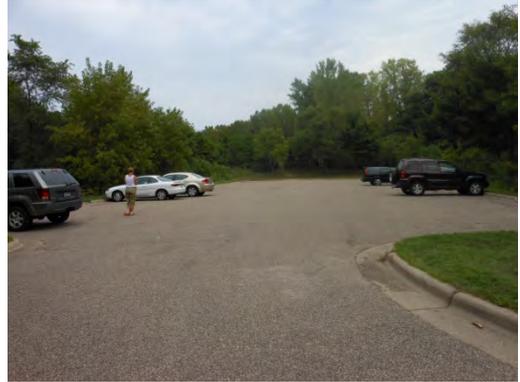
Parking- North

The north parking lot has approximately 49 parking spaces, including 1 space that is designated as accessible. (The striping is very faded.) The sign designating the accessible parking space is 95" high.

MN1341 502.3, 502.4.4

Priority 3- Lower the sign, so it is 60"-66" above the surface of the parking space (measured to the bottom of the sign). *MN1341 502.7*

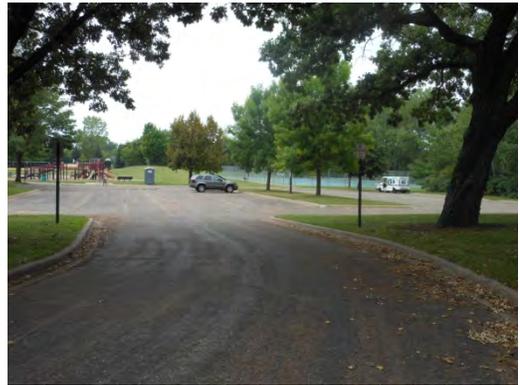
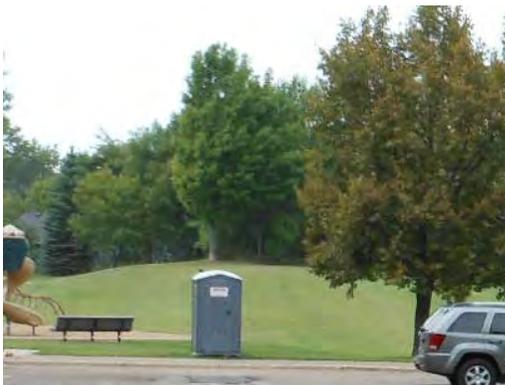
Portable Toilet

A portable toilet is located in the grass along the west border of the north parking lot.

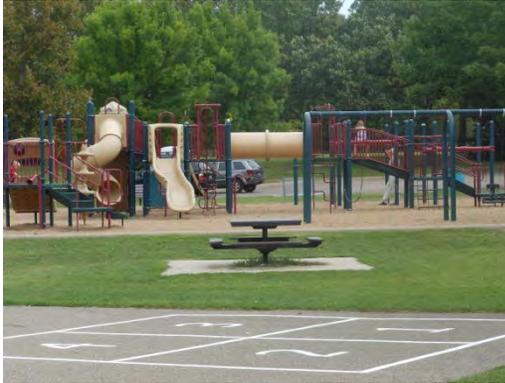
Picnic Table- Play Area

There is a picnic table located near the defined play area. The table does not currently provide knee and toe clearance and is not located on an accessible route.

Priority 3- Provide a picnic table that provides knee and toe clearance and link to an accessible route. *Recommended based on Draft Accessibility Guidelines for Outdoor Developed Areas 1011.4*

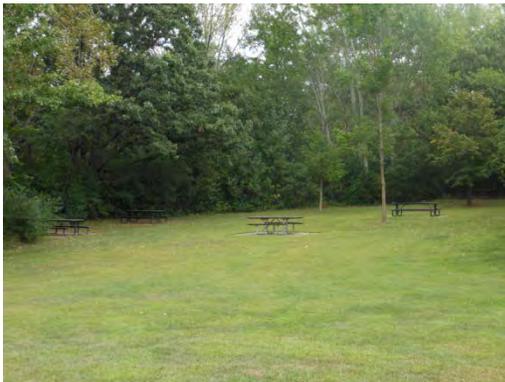
Picnic Tables

There are 5 tables on concrete pads located in the grass to the north of the north parking lot; 1 of the tables provide knee and toe clearance.

Priority 3- Create an accessible route to the picnic tables that provides knee and toe clearance. *Recommended based on Draft Accessibility Guidelines for Outdoor Developed Areas 1011.4*

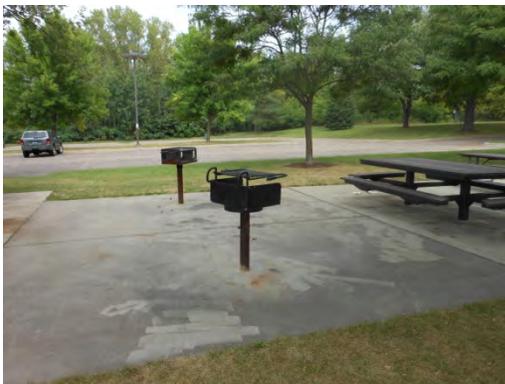
Picnic- Shelter

There are 3 tables in the picnic area adjacent to the shelter building as well as 2 grills. Currently none of the tables provide knee and toe clearance.

Priority 3- Provide a picnic table that provides knee and toe clearance. *Recommended based on Draft Accessibility Guidelines for Outdoor Developed Areas 1011.4*

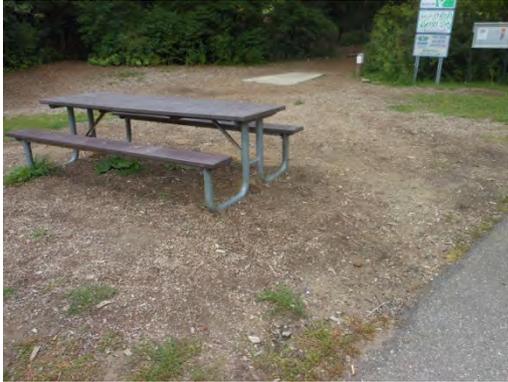
Picnic Table- Disc Golf

There are 2 picnic tables located on wood chips near the beginning of the disc golf course. Currently neither of the picnic tables provide knee and toe clearance.

Priority 3- Provide a picnic table that provides knee and toe clearance and link to an accessible route. *Recommended based on Draft Accessibility Guidelines for Outdoor Developed Areas 1011.4*

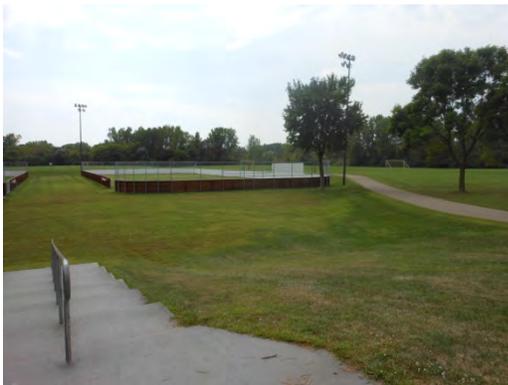
Accessible Route

There is not currently an accessible route to either of the hockey rinks from the parking or the shelter building.

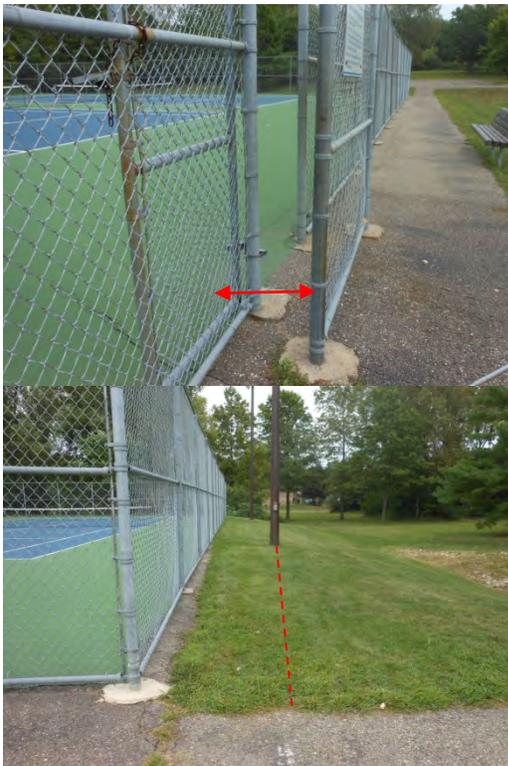
Entry

The opening onto the court is reduced to 15" (versus 32" minimum) due to the serpentine entry. (The gate provides a 39" clear opening.)

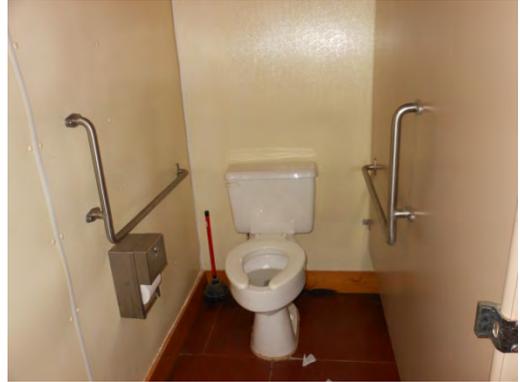
Toilet Room- Entry

The entry door currently has knob style hardware.

Priority 3- Replace the knob style hardware with lever style. ADA 404.2.7

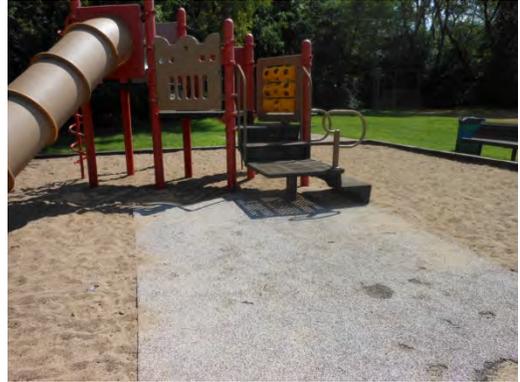
Route

There is not currently an accessible route to the defined play area.

Priority 2- Create an accessible route to the entry to the defined play area. (Approximately 13' from the basketball court) ADA 206.2.17

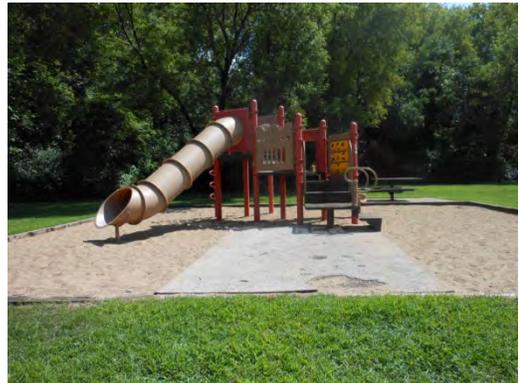
Equipment

There is a composite play structure with a transfer system. There are 6 elevated events and 1 ground level event.

Priority 3- Add 1 additional ground level event.

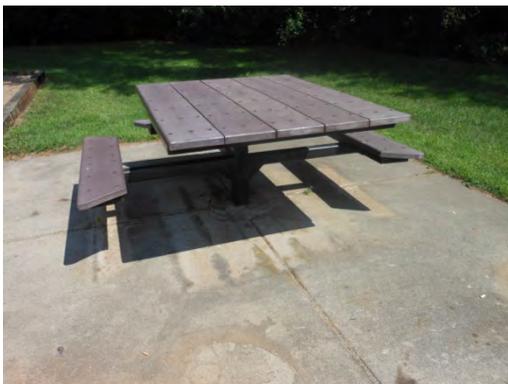
Picnic Table

There is a picnic table with knee and toe clearance is located adjacent to the defined play area. It is not currently located on an accessible route.

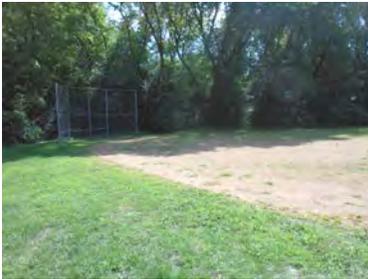
Route

There is not currently an accessible route to the baseball field. The field does not provide any player seating and does not appear to be used.

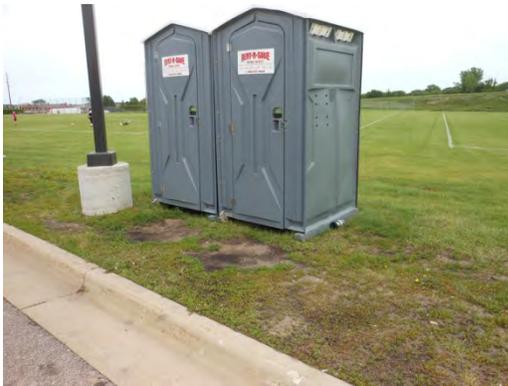
Portable Toilets

Two portable toilets are located in the grass near the parking lot. They are not currently on a route and they do not provide features of accessibility.

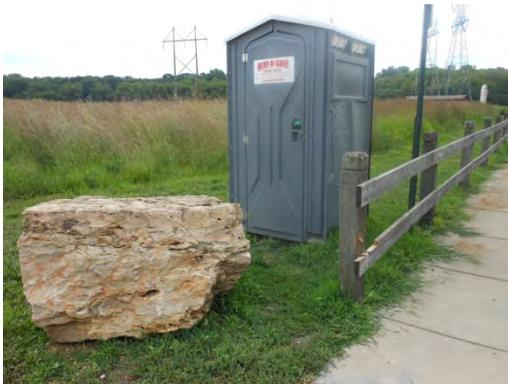
Portable Toilet

A portable toilet is located in the grass adjacent to the parking lot. The route is partially blocked by a boulder.

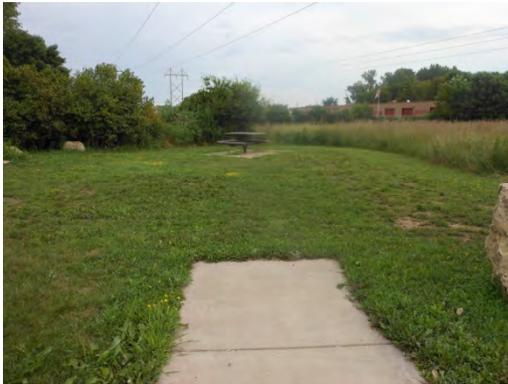
Picnic Table

There is a picnic table located in the grass near the northeast corner of the parking lot. The table provides a section with knee and toe clearance. There is not currently an accessible route to the picnic table.

Priority 3- Create an accessible route to at least 1 of the picnic tables. *Recommended based on Draft Accessibility Guidelines for Outdoor Developed Areas 1011.4*

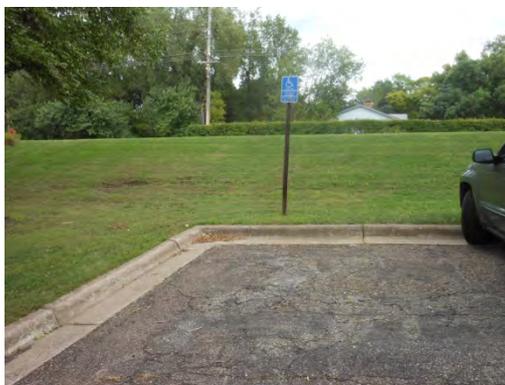
Parking

The cross slope in the parking lot is currently 8.8%.

Priority 3- Provide accessible parking with 2% maximum slope.

Options: Modify the slope of the parking lot OR create accessible parking at the bottom of the hill near the baseball field (a service drive exists).

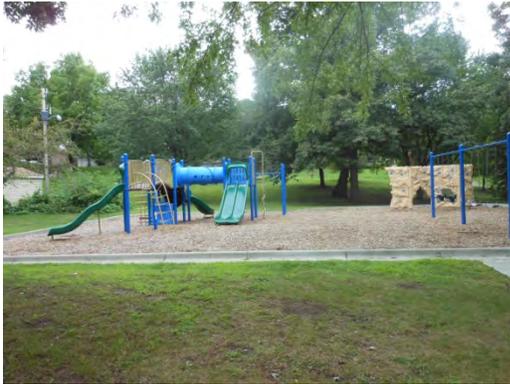
Route

The defined play area is not currently located on an accessible route.

Priority 2- Create an accessible route to the entry to the defined play area. ADA 206.2.17

It is approximately 228' from the basketball court and hilly. The route to street on the west border of the playground is less hilly and 186'.
