Acorn

Activities / Amenities

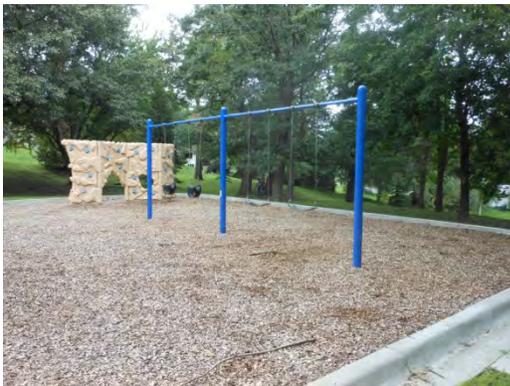
Defined Play Area

The defined play area includes 1 composite play structure, a free standing rock wall climber and to-fro swings. Engineered wood fiber surface material is used throughout.

Priority 2- Ensure the loose fill surface material is maintained to provide an accessible surface material. ADA 206.2.17

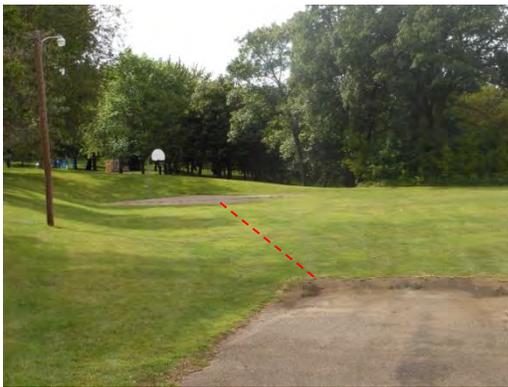
Basketball

There is not currently an accessible route to the basketball court.

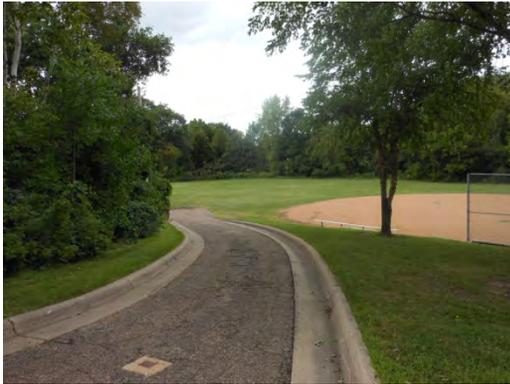
Route

The route from parking to the park amenities is as steep as 12.2% for a distance of approximately 110'. (Slopes between 5% and 8.33% are considered a ramp and require handrails.)

Priority 3- At such time the sidewalk/path is replaced, re-route to reduce the slope. *ADA 403.3, 405.2*

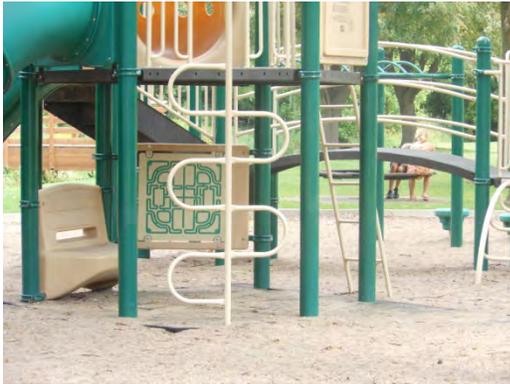
Surface Material

The surface material is currently a combination of loose fill sand and unitary tiles. The unitary tiles are provided up to the transfer deck, swing and ground level events.

Priority 3- Replace the loose fill sand with a surface material that meets the accessibility requirements of ASTM 1951 as well as the impact attenuation requirements of ASTM 1292.

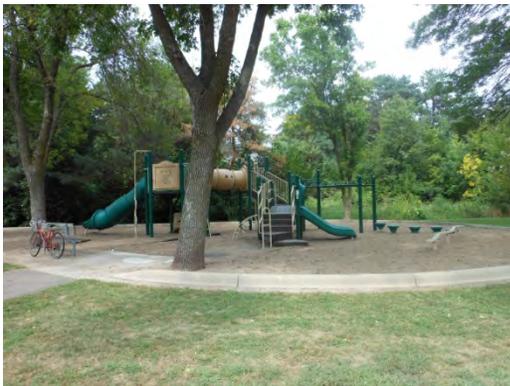
Defined Play Area

The defined play area includes 1 composite play structure and to-fro swings.

Priority 2- Ensure the loose fill surface material is maintained to provide an accessible surface material. *ADA 206.2.17*

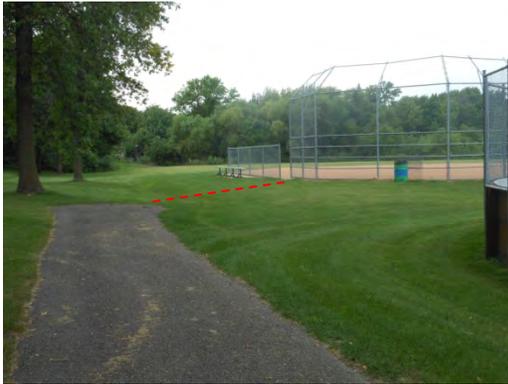
Route

The baseball field is located on the west side of the park. There are movable player benches located on concrete pads. There is not currently an accessible route to the field or the player seating.

Priority 3- Create an accessible route to the boundary of the baseball field and the player seating. (Approximately 52'.) ADA 206.2.2

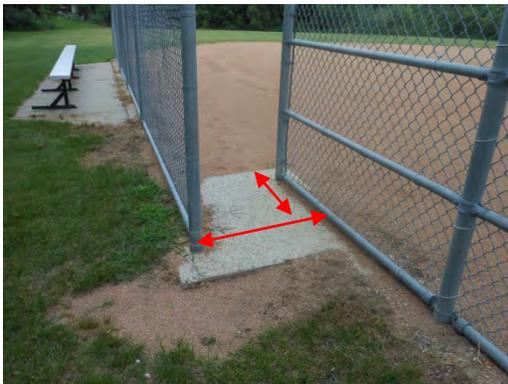
Access to field

There are fences that reduce the opening onto the field from the player seating. The opening is currently 33" wide for a distance of 36" on the 3rd base side. (The 1st base side is 35" wide.)

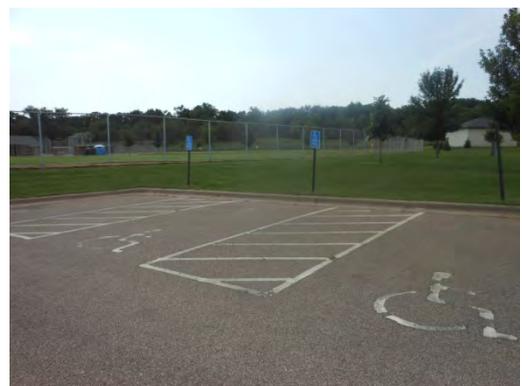
Parking- Location

Three of the designated accessible parking spaces are located in the east corner of the parking lot.

Priority 2- Relocate the parking spaces from the east corner of the lot to a location closer to the accessible route to the baseball fields. *ADA 208.3.1*

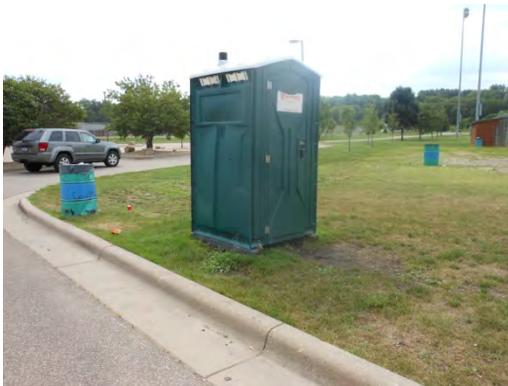
Portable Toilet- Field 5

A portable toilet is located in the grass adjacent to the parking lot near Field 5.

Priority 2- Relocate the portable toilet so it is located along an accessible route.

Priority 3- Ensure an accessible portable toilet is available at the site.

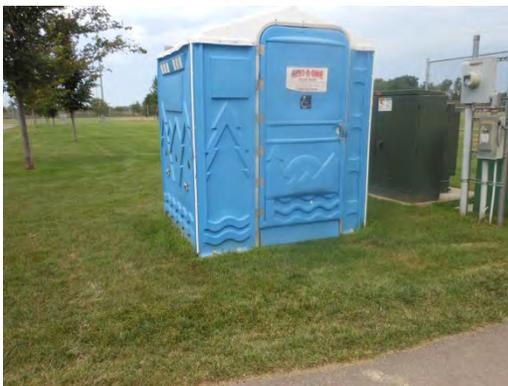
Portable Toilet- Field 1

A portable toilet is located in the grass adjacent to Field 1. The portable toilet is a larger style that provides features of accessibility.

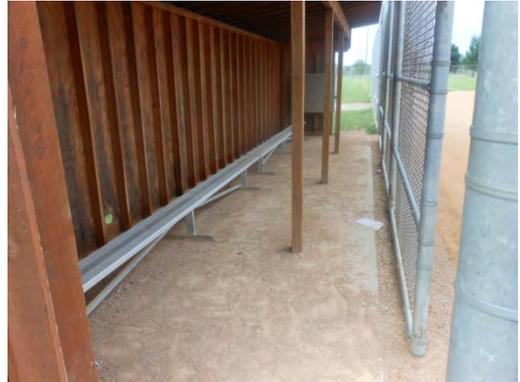
Route- Field 5

There is not currently an accessible route from the parking lot to Field 5.

Priority 2- Create an accessible route to the boundary of the baseball field, the player seating and the spectator seating at Field 5. *ADA 206.2.2*

***Note: Field 5 is the only field that is always available and cannot be locked.*

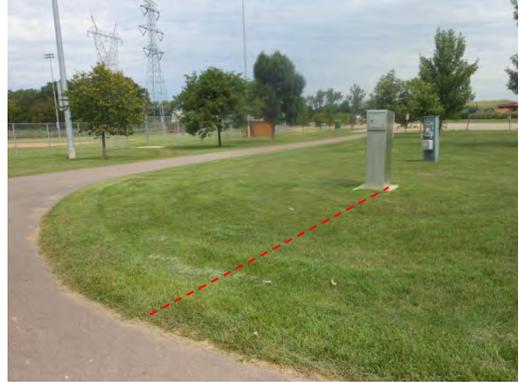
Light Control- Fields 1-4

The control for the lights serving fields 1-4 is currently at 55".

Priority 3- Lower the light controls to 48" maximum. *ADA 308*

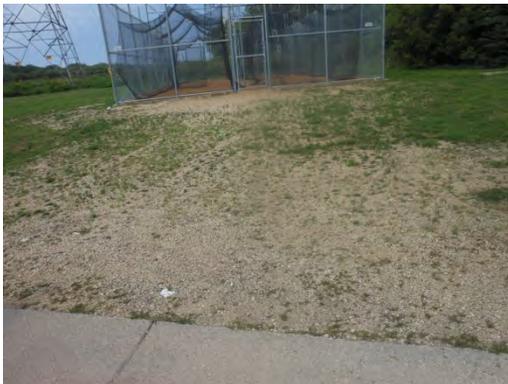
Route

There are batting cages located near Field 5. There is not currently an accessible route to the entry.

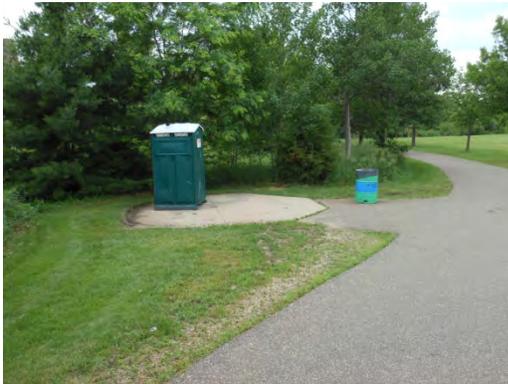
Portable Toilet

A portable toilet is located near the defined play area and is located on a concrete pad that connects to the accessible route.

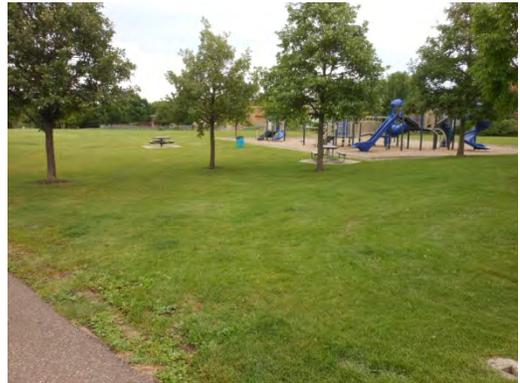
Defined Play Area

The defined play area includes 2 composite play structures, to-fro swings, a steering wheel and a rocker. Engineered wood fiber surface material is used throughout.

Priority 2- Ensure the loose fill surface material is maintained to provide an accessible surface material. *ADA 206.2.17*

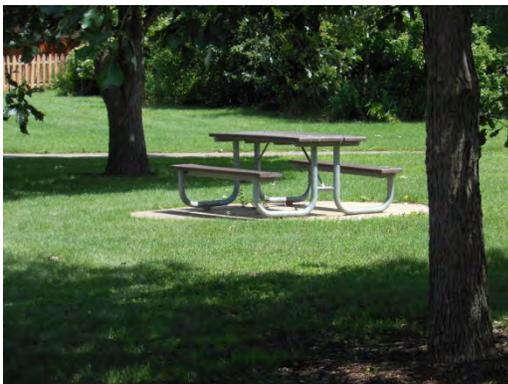
Picnic Table

The picnic tables on concrete pads are located throughout the park. A route has not been provided to any of the tables and they do not currently provide knee and toe clearance.

Priority 3- Replace the picnic table with a style that provides knee and toe clearance.

Recommended based on Draft Accessibility Guidelines for Outdoor Developed Areas 1011.4

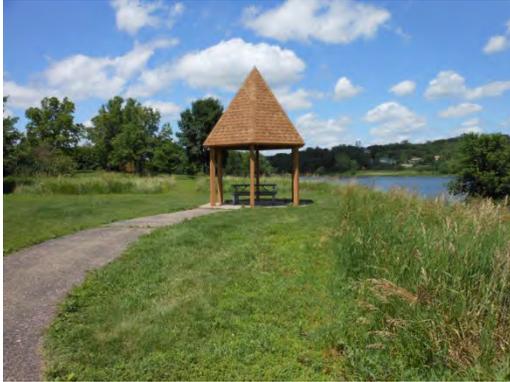
Picnic Pavilions

The picnic tables covered by pavilions are typically located on an accessible route. The tables do not currently provide knee and toe clearance.

Priority 2- Replace the picnic table with a style that provides knee and toe clearance at a minimum of 1 pavilion location. *Recommended based on Draft Accessibility Guidelines for Outdoor Developed Areas 1011.4*

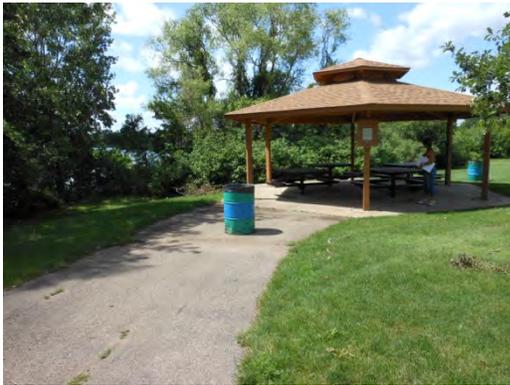
Picnic Pavilion- Large

There is a large group picnic pavilion site (which can be reserved) with 4 tables, 1 of which has knee and toe clearance. An accessible route has been provided to this location.

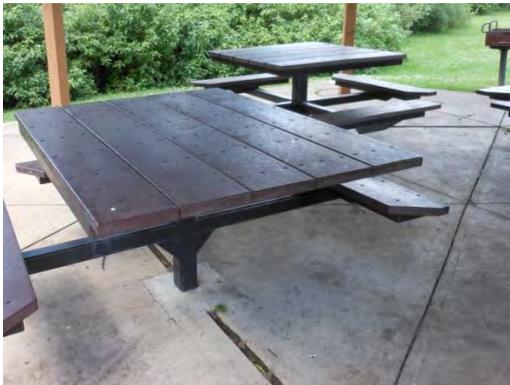
Picnic Pavilion- Large

A 2" gap has formed between the sections of concrete the picnic table is positioned on. The position of the tables and support columns reduces the clear width to less than 32"

Priority 3- Fill the gap between the sections of concrete to provide an accessible route. *ADA 302.3*

Priority 3- At such time the tables are replaced, ensure they are positioned to provide a clear route. *ADA 403.5.1*

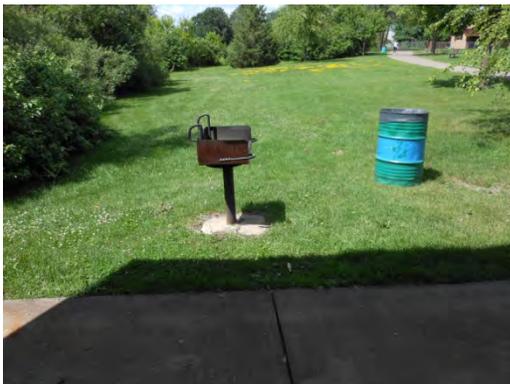
Picnic Pavilion- Large

There is a grill associated with the large picnic pavilion. The grill is not currently located on an accessible route.

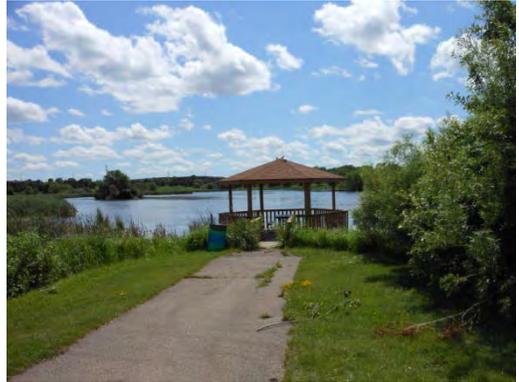
Route

The route onto the gazebo rough near the entry, with changes in level exceeding 1/2".

Priority 3- Repair the route onto the gazebo. *ADA 303.1*

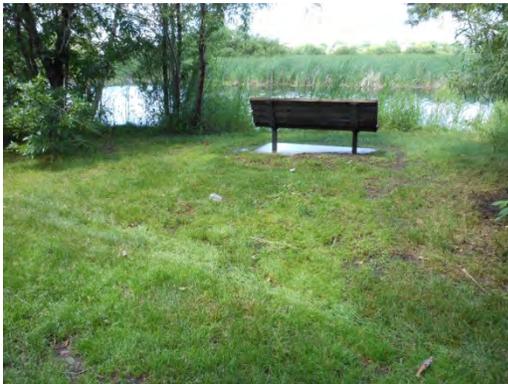
Benches

There are benches located throughout the park. Some of the benches are located in the grass and others are located along the route.

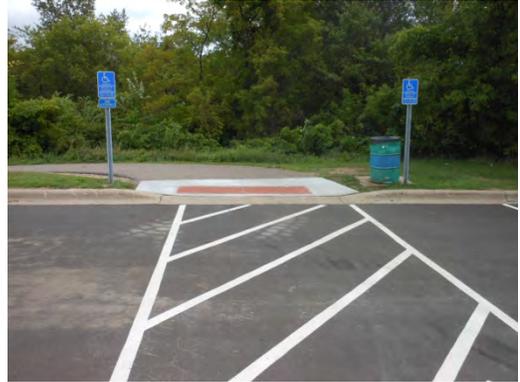
Parking- North

The north lot has room for approximately 30 vehicles (not striped). There are 2 signs designating accessible parking spaces.

Priority 2- Re-stripe the accessible parking spaces and aisles. *MN1341 502.3, 502.4.4*

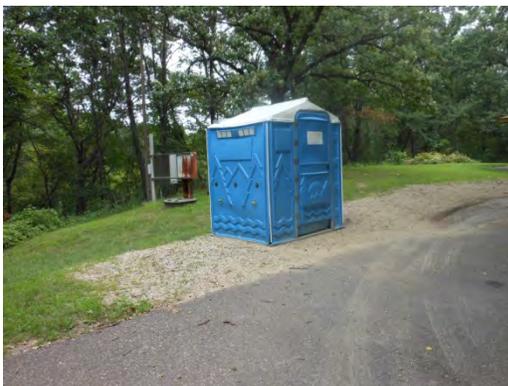
Portable Toilet- West

A portable toilet is located adjacent to the accessible route and is a larger style that provides features of accessibility.

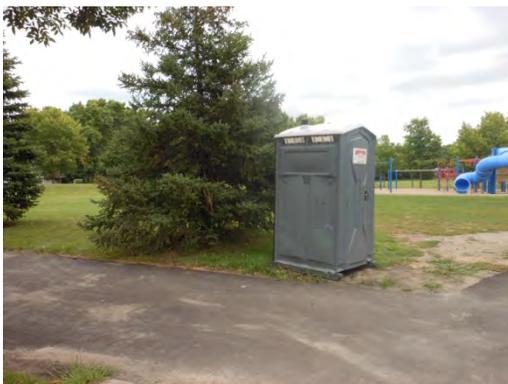
Portable Toilet- North

A portable toilet is located in the grass adjacent to the path near the parking lot.

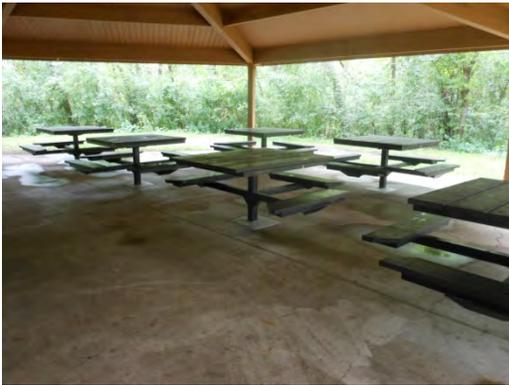
Picnic Shelter- West

There are 6 tables in the sheltered picnic area and located on an accessible route. One table provides knee and toe clearance and is located on an accessible route.

Priority 3- Provide 1 additional picnic table that provides knee and toe clearance. Recommended based on Draft Accessibility Guidelines for Outdoor Developed Areas 1011.4

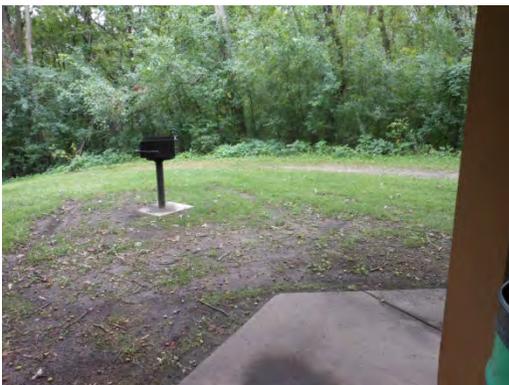
Picnic Shelter Grill- West

There is a grill positioned near the covered picnic shelter in the grass. A route to the grill is not currently provided.

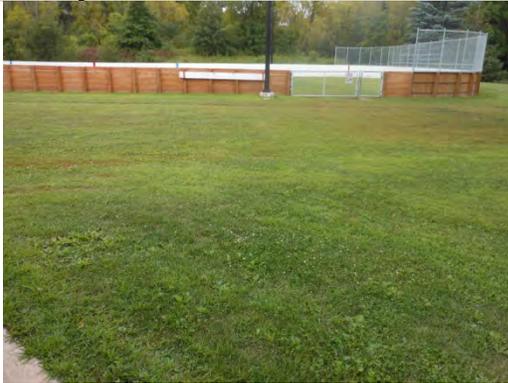
Accessible Route

There is not currently an accessible route to the rink from the parking or the shelter building.

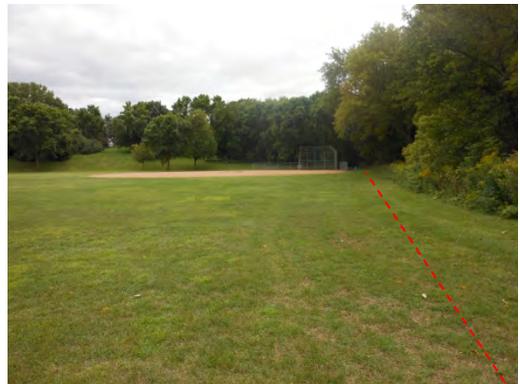
Player / Team Seating

There are fixed benches on concrete pads for team and player seating. The concrete pad on the 3rd base side is not currently large enough to provide clear ground space for a wheelchair adjacent to the bench.

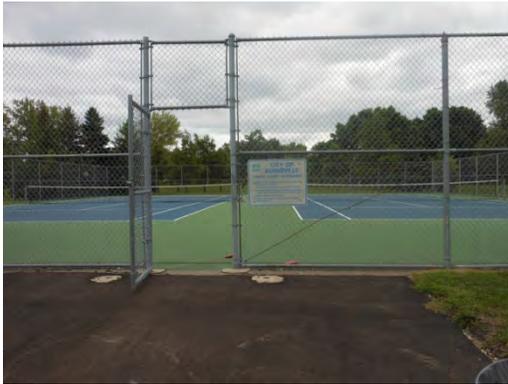
Entry

The entry to the tennis court is linked to an accessible route. The slope at the entry gate is currently 8% (versus 2% maximum).

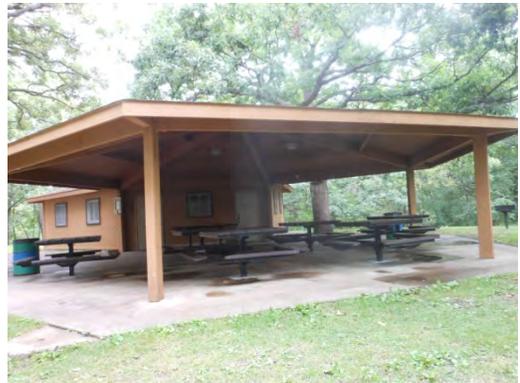
Toilet Room- West Shelter

The toilet rooms in the shelter have been modified to provide features of ambulatory accessibility. There is not currently an accessible toilet room that provides a lateral transfer (60" clearance).

Priority 2- Remodel the toilet rooms to create a fully accessible, single user toilet room. *MN1341 1109.2*

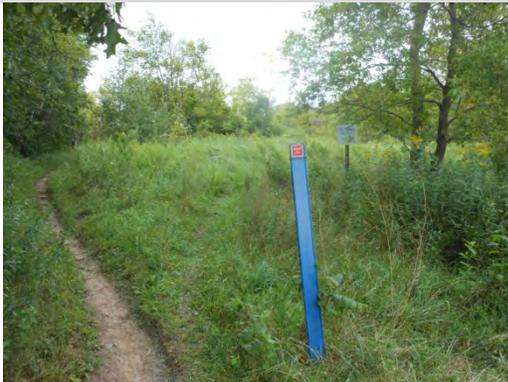
Trails

There are cross country ski trails and mountain bike trails throughout the park. The trails are not currently accessible.

Priority 2- At such time new trails are being created or as part of a planned re-route of existing trails, use the *Draft Final Accessibility Guidelines for Outdoor Developed Areas* as a 'best practice' for trail design.

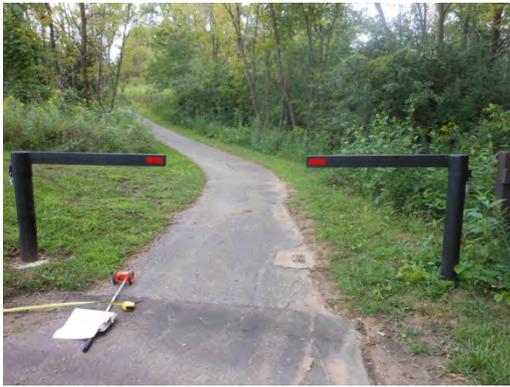
Trailhead

The hiking trailhead to the west of the north parking lot currently has arms that reduce the clear width to prohibit vehicles from using the trail. The style of arms used creates a protruding hazard (protruding 48" at a height of 38").

Priority 3- Modify the gates to eliminate the protruding hazard. *ADA 307*

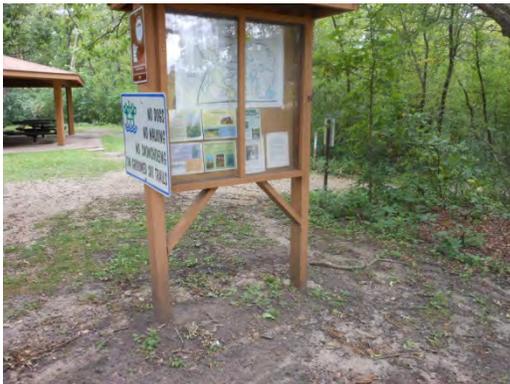
Trailhead Signs- West and North

The trailhead / information signs at the west and north trailhead are not currently located on an accessible route.

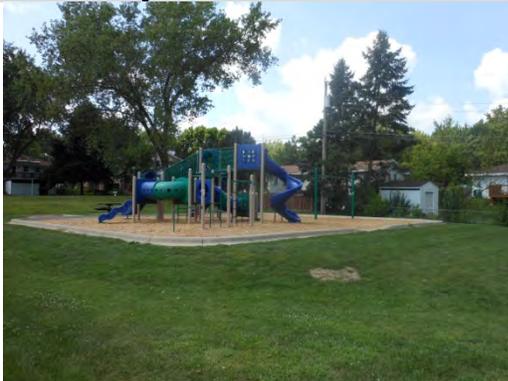
Route

The defined play area is not currently located on an accessible route.

Priority 2- Create an accessible route to the entry to the defined play area. ADA 206.2.17

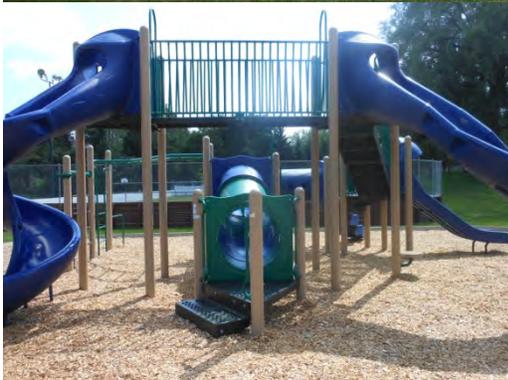
Defined Play Area

The defined play area includes 1 composite play structure and to-fro swings. Engineered wood fiber surface material is used throughout.

Priority 2- Ensure the loose fill surface material is maintained to provide an accessible surface material. ADA 206.2.17

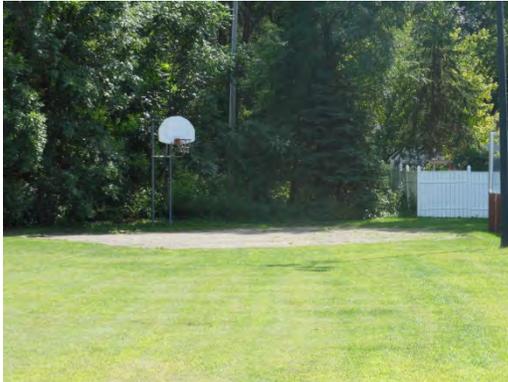
Basketball

There is not currently an accessible route to the basketball court.

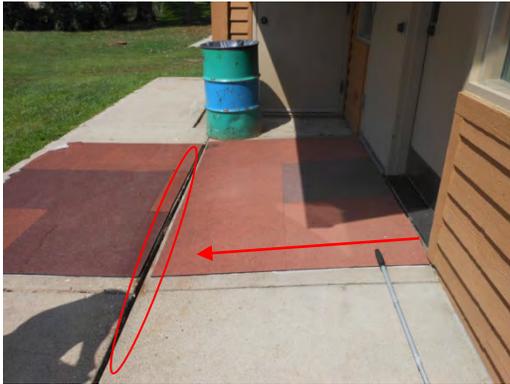
Route

There is a shelter building that also serves as a warming building in the winter. There is an accessible route to the entry from the parking lot. The slope at the entry currently exceeds 2%. There is a gap exceeding 1/2" where the sections of concrete come together.

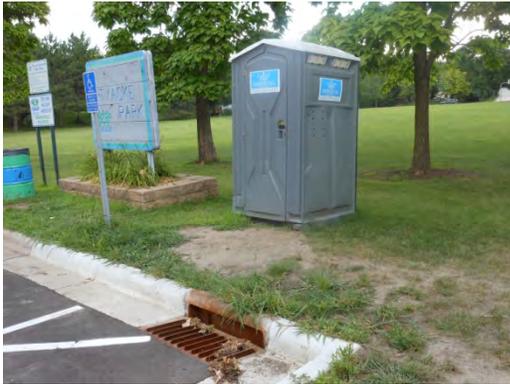
Portable Toilet

A portable toilet is located in the grass adjacent to the parking lot.

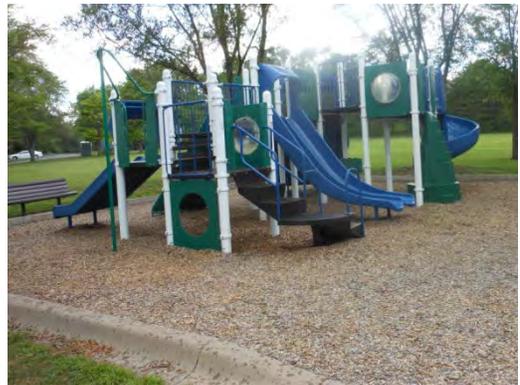
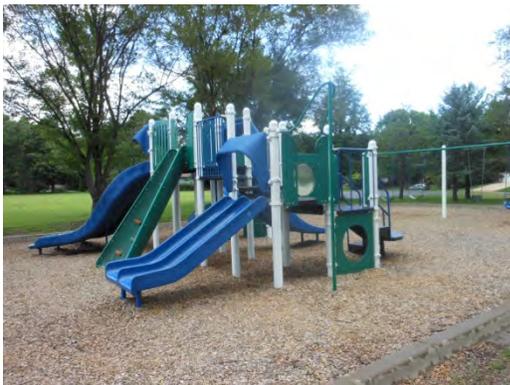
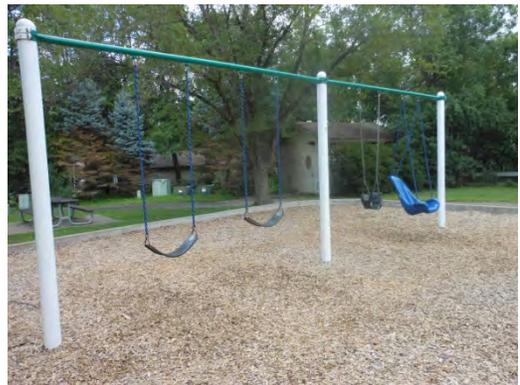
Picnic Table- Play

There is a picnic table located near the defined play area. A section with knee and toe clearance is not currently provided and it is not located on an accessible route.

Priority 3- Replace the picnic table with a style that provides knee and toe clearance and is located on an accessible route (approximately 16').
Recommended based on Draft Accessibility Guidelines for Outdoor Developed Areas 1011.4

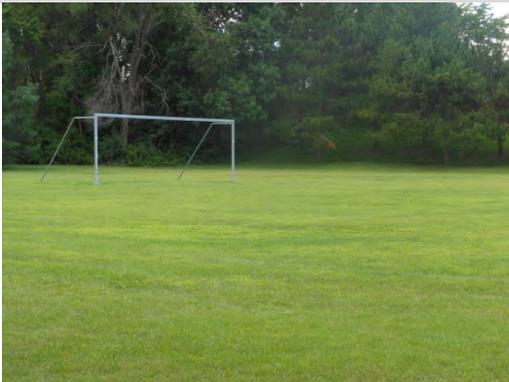
Route

There is not currently an accessible route to the soccer field.

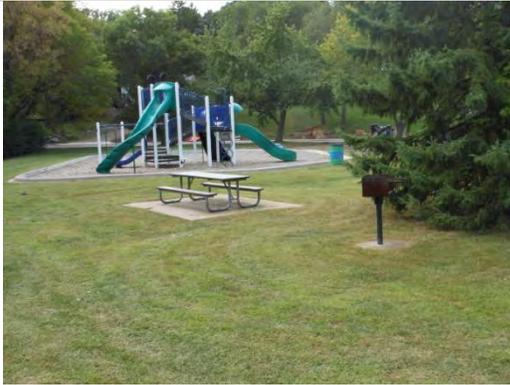
Picnic Table

There is a picnic table and a grill located on a concrete pad near the defined play area. The table does not currently provide knee and toe clearance and there is not an accessible route to the table or grill.

Priority 3- Replace the picnic table with a style that provides knee and toe clearance and is located on an accessible route. *Recommended based on Draft Accessibility Guidelines for Outdoor Developed Areas 1011.4*

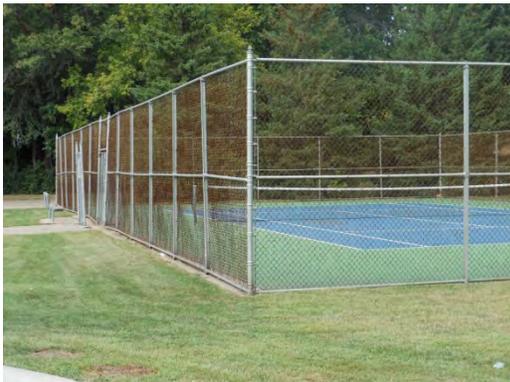
Route

There is not currently an accessible route to the tennis court.

Priority 3- Create an accessible route to the tennis court *ADA 206.2.2*

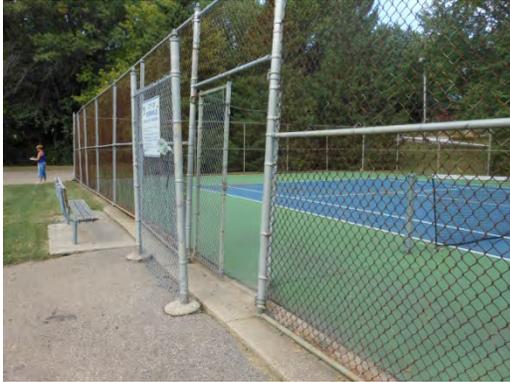
Entry Gate

There is currently a serpentine entry that reduces the clear route to the gate 27". The entry doors are chained to reduce the opening to 19".

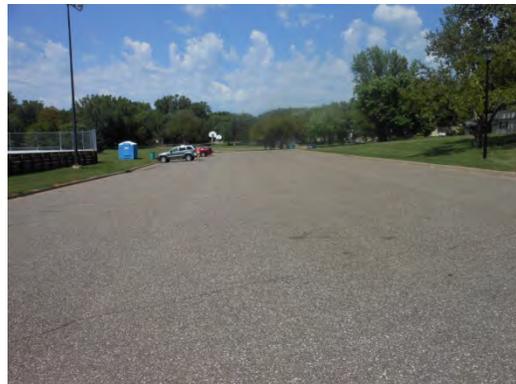
Parking- Location

The designated accessible space is located in the south end of the parking lot and not located near any of the amenities. The space is not striped and the sign is currently 84" high.

Priority 3- Relocate the parking space so it is a shorter accessible route to amenities (near shelter building). *ADA 208.3.1*

Priority 3- Lower the sign designating the accessible parking space so it is 60"-66" above the surface of the parking space (measured to the bottom of the sign). *MN1341 502.7*

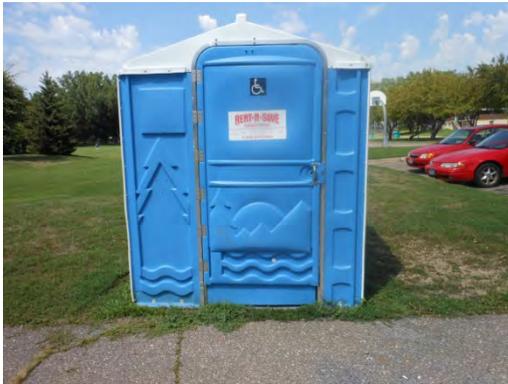
Portable Toilet

A portable toilet is located in the grass adjacent to the accessible route. The portable toilet is a larger style and provides some features of accessibility.

No recommendations at this time.

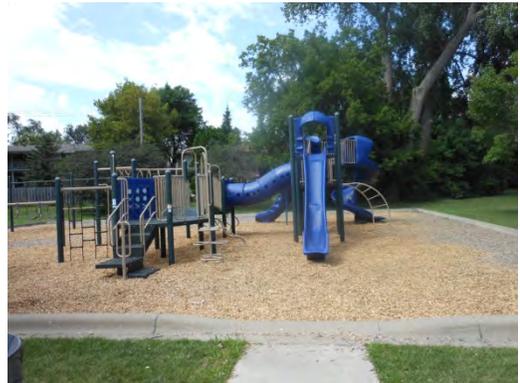
The defined play area includes 2 composite play structures and to-fro swings. Engineered wood fiber surface material is used throughout. There is a route from the street corner (Girard & Burnsville Pkwy), but not from the shelter building.

Priority 2- Ensure the loose fill surface material is maintained to provide an accessible surface material. *ADA 206.2.17*

Priority 3- Create an accessible route to the entry to the defined play area from the shelter building. *ADA 206.2.17*

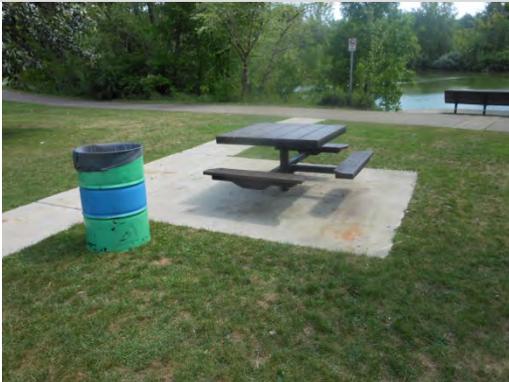
Picnic Table

There is a picnic table located adjacent to the defined play area. A section with knee and toe clearance is provided.

No recommendations at this time.

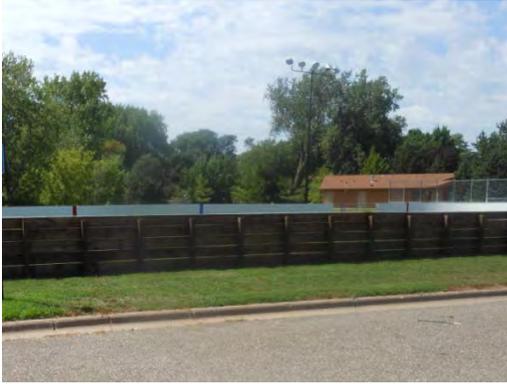
Hockey

There is not currently an accessible route from the parking lot or the shelter building to the hockey rink entry.

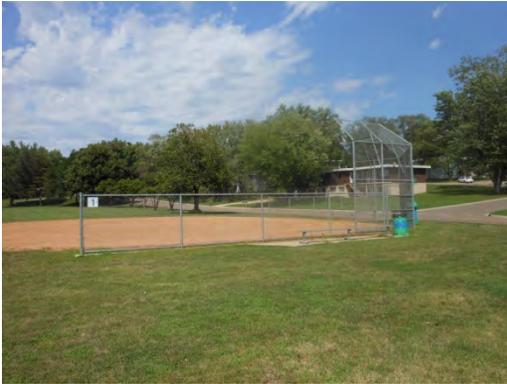
Field 1

There are fixed benches on concrete pads for player seating. There is not currently an accessible route to the field or player seating.

Priority 3- Create an accessible route to the boundary of the baseball field and the player seating. (Approximately 66' from the north end of the basketball court) ADA 206.2.2

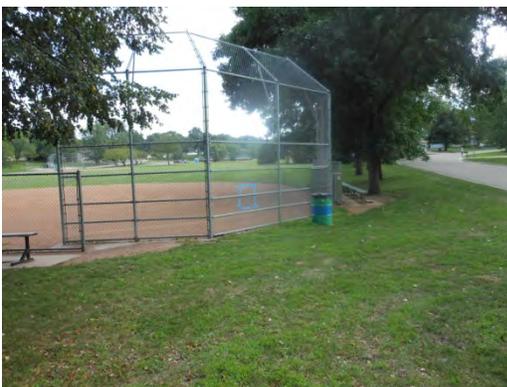
Field 2

There are fixed benches on concrete pads for player seating. There is not currently an accessible route to the field or player seating.

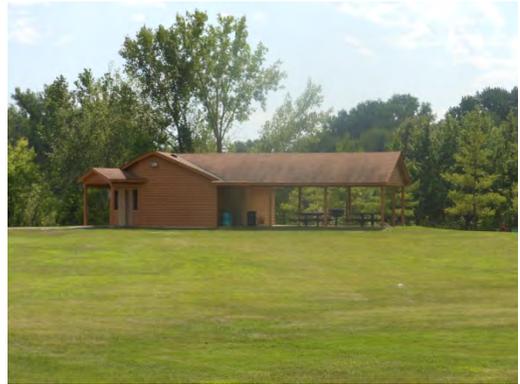
Route

There is a route from the parking lot to the main entry of the building. The sidewalk wraps around the building, but the corners are missing, so the route does not extend to the picnic area.

Priority 2- Replace the missing segments of the sidewalk to create an accessible route.

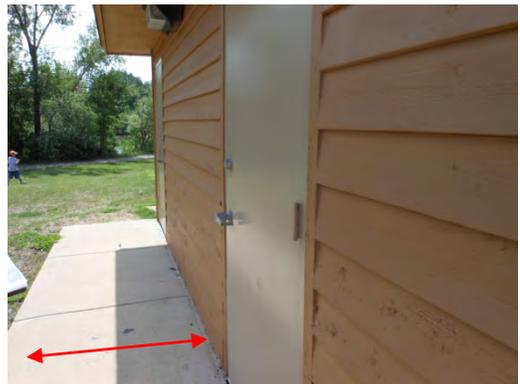
Shelter Building

The shelter building provides a kitchenette style sink with a parallel approach, a drinking fountain with a 36" spout height and picnic tables

Priority 3- At such time the drinking fountain is replaced, provide a dual height style. *ADA 211.2*

Priority 3- Provide a table with knee and toe clearance.

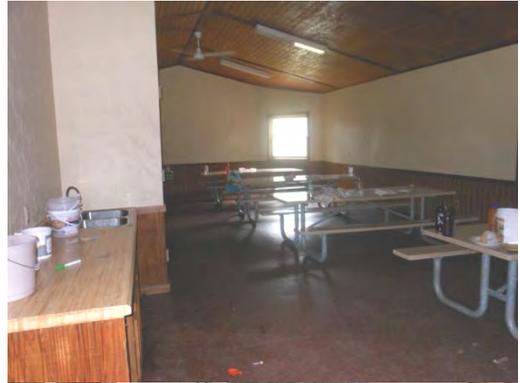
Picnic Area

There are 4 tables located under the shelter, including 1 that provides knee and toe clearance. There is also a grill located on an accessible route.

There are no recommendations at this time.

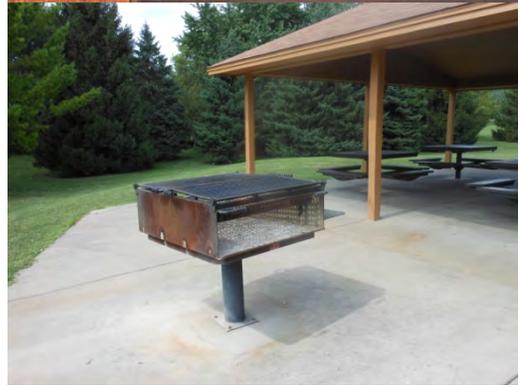
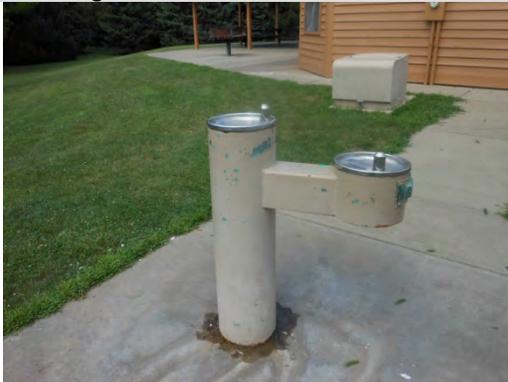
Drinking Fountain

There is an exterior drinking fountain located near the shelter building. It is located on an accessible route and provides 36" and 42" spout heights.

No recommendations at this time.
